# Sample Report - Practical Completion Inspection

Inspection Date: 2 Jul 2026

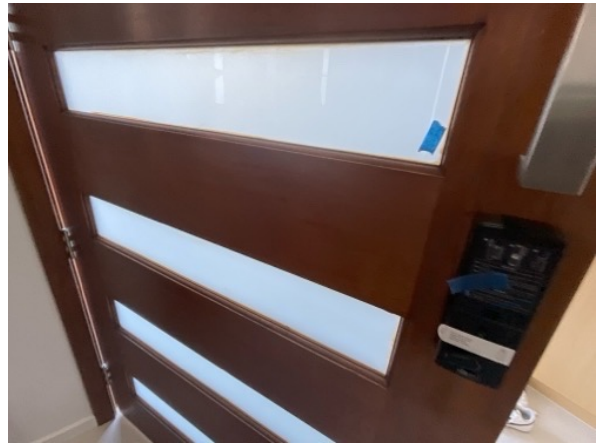
**Finding:** Window/door glass to be cleaned

Glass to be cleaned to ensure there is no damage

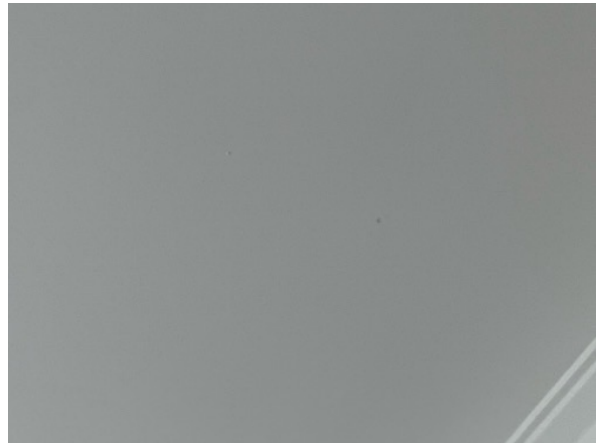
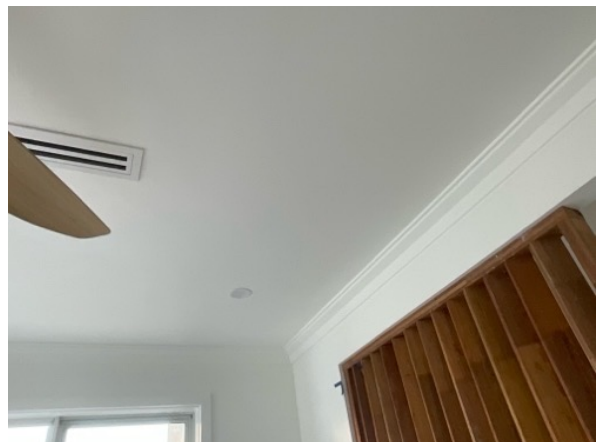
**Finding:** Popped nail to the wall/ceiling

Popped nail heads to the wall/ceiling to be repaired to restore appearance

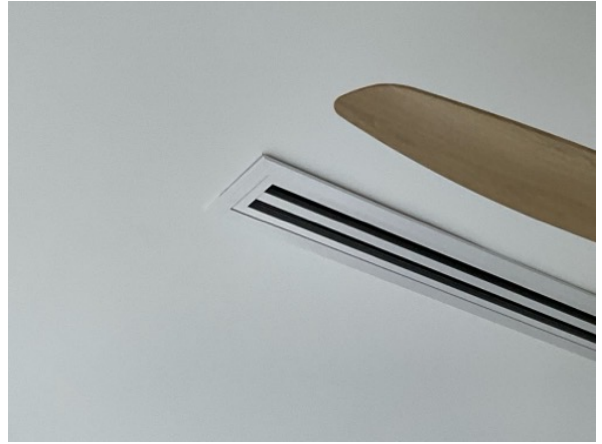
## Incomplete 1.10

**Finding:** Air-conditioner vent is not sitting tight to the plaster board

The air-conditioner vent is observed to not sit flush against the plasterboard, leading to potential inefficiencies and aesthetic concerns. It is recommended to refit or realign the vent to

ensure a secure and tight installation.

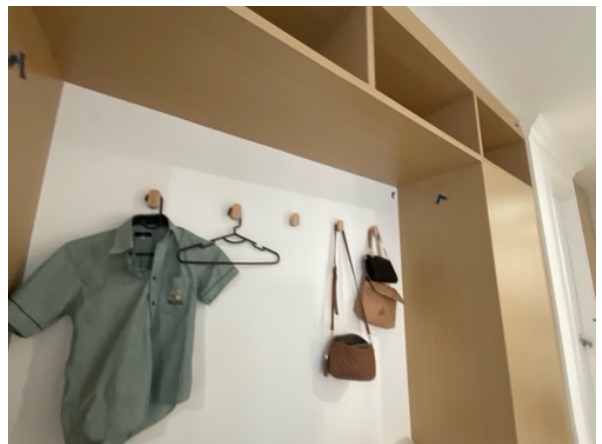
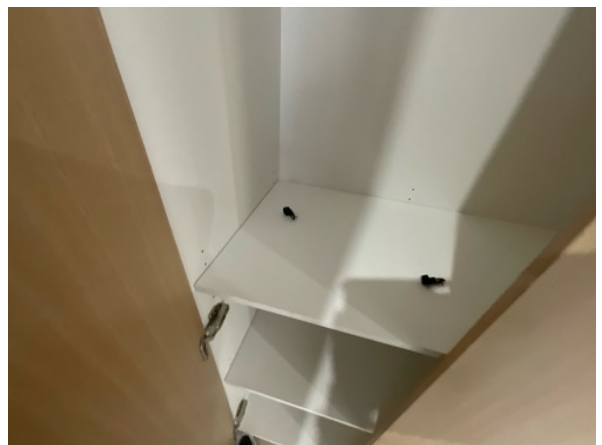
## Incomplete 1.11

**Location:** Piano Room And Entry  
**Finding:** Hanging rod is missing  
Hanging rod to be installed

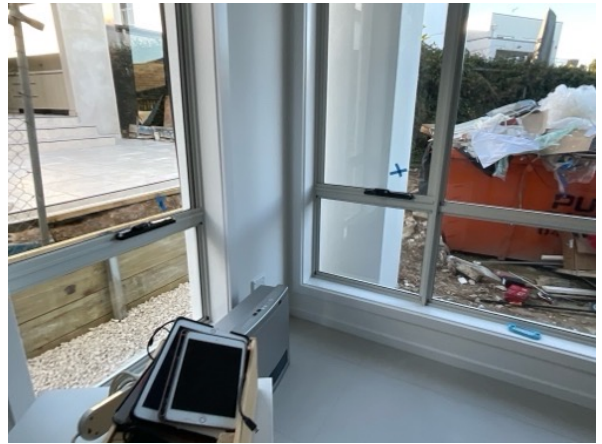
## Incomplete 1.14

**Location:** Piano Room And Entry  
**Finding:** Window is binding  
The window is currently binding and will need adjustment and servicing. To resolve this defect, it is recommended that a window servicing is carried out to restore smooth operation of the openable portion of the window.

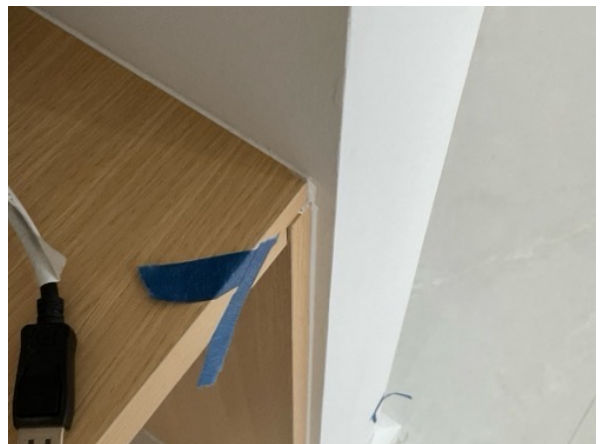
## Incomplete 1.15

**Finding:** Cabinet edge not aligned

Missing cabinet edge not aligned and will need to be repositioned to restore appearance

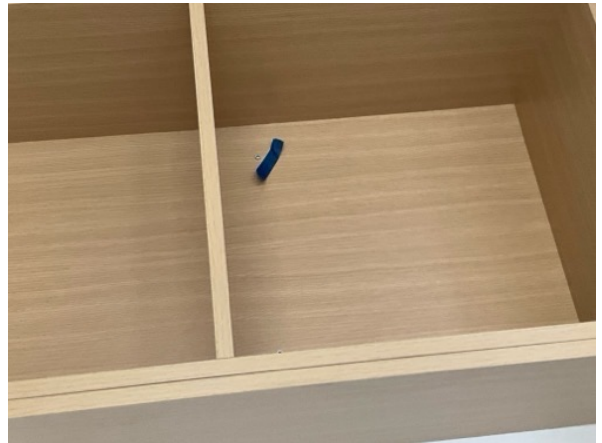
## Incomplete 1.16

**Location:** Piano Room And Entry  
**Finding:** Missing screw head sticker  
Missing screw head sticker cover to be installed

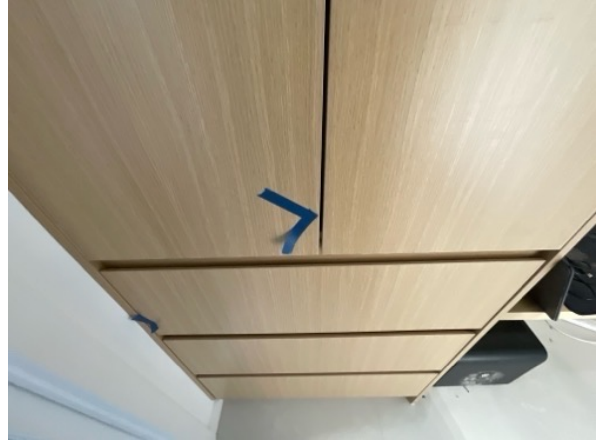
**Finding:** Cabinet doors need adjusting

Cabinet doors require adjustment, as they are not functioning correctly. It is recommended that the cabinet doors be realigned and adjusted to ensure smooth operation.

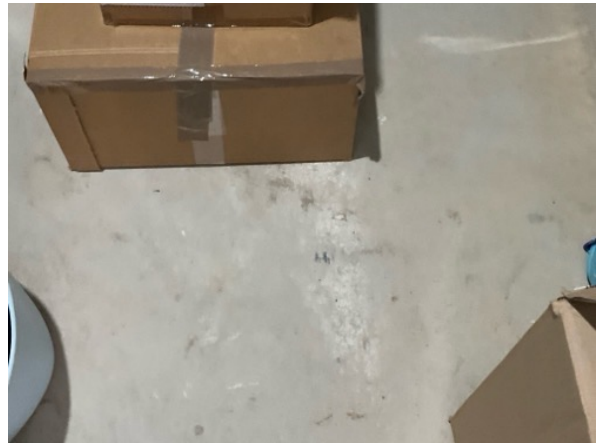
**Finding:** Chipped concrete

Damaged concrete to be repaired to restore appearance

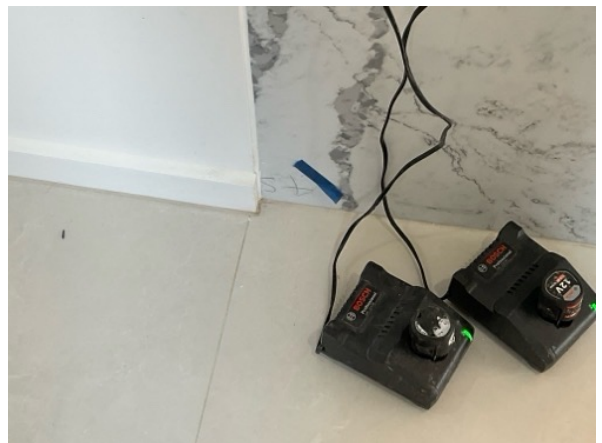
**Finding:** Benchtop surface and edge to be cleaned

The benchtop surface and edges are required to be cleaned to ensure there is no damage or imperfections to the surface, If necessary, minor repairs should be conducted to restore appearance.

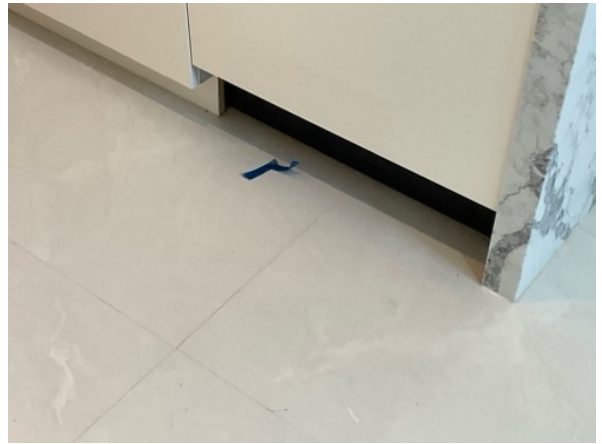
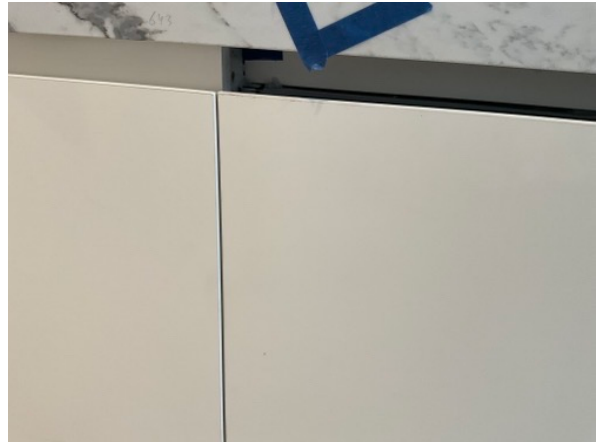
## Incomplete 1.24

**Finding:** Missing kicker and filler piece to the dishwasher

It was noted that the dishwasher in the kitchen is missing its kicker panel filler piece to both the top and bottom sections. This absence detracts from the overall appearance and finish of the appliance, leaving the installation looking incomplete.

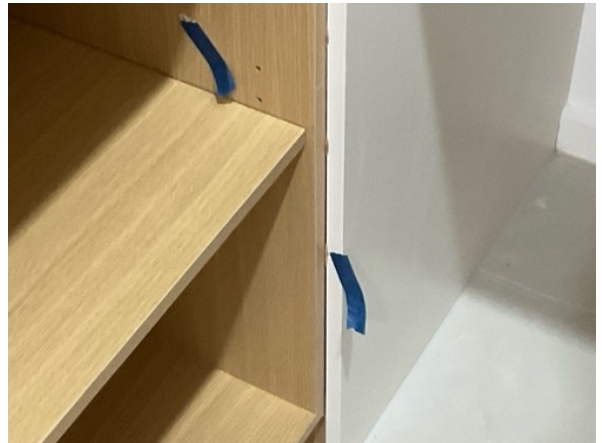
**Finding:** Cabinet surfaces to be cleaned  
Surfaces to be cleaned to ensure no damage

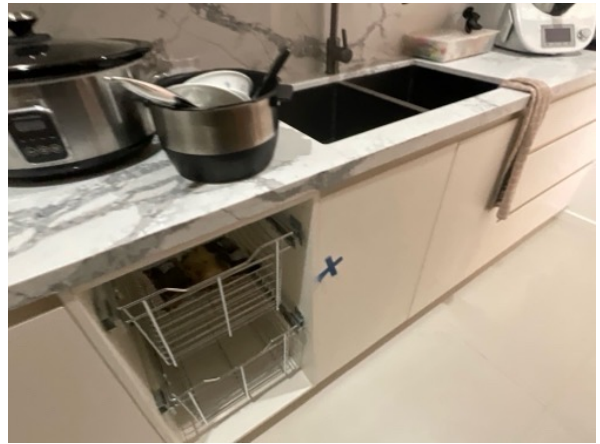
## Incomplete 1.32

**Finding:** Cabinet alignment is required  
Cabinets are not sitting even with each other and will need to be repositioned

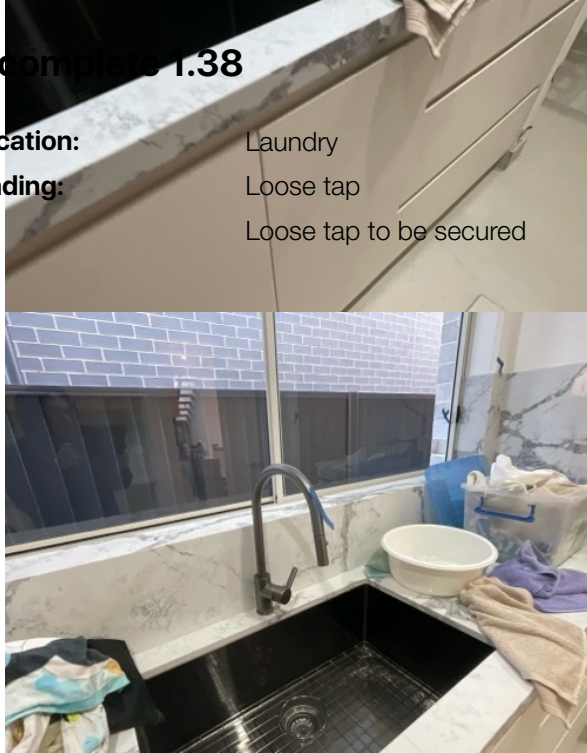
**Finding:** Loose tap

Loose tap to be secured

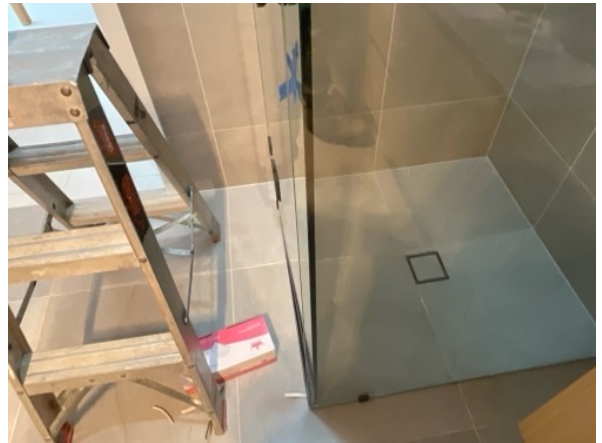
**Finding:** Shower screen door is not sitting tight  
Shower screen door is not sitting tight and will need to be repaired

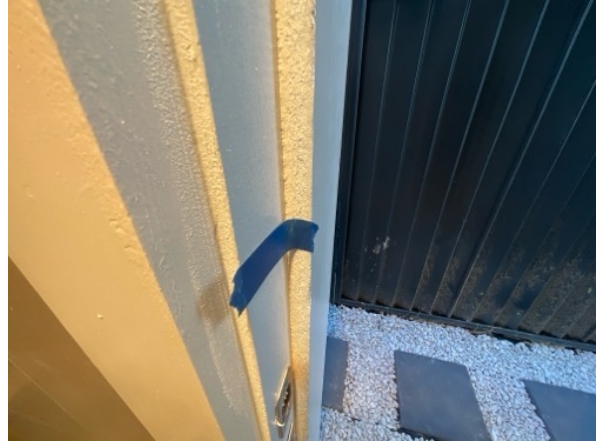
**Finding:** Damaged door jam

Damaged door jam will need repair to restore appearance

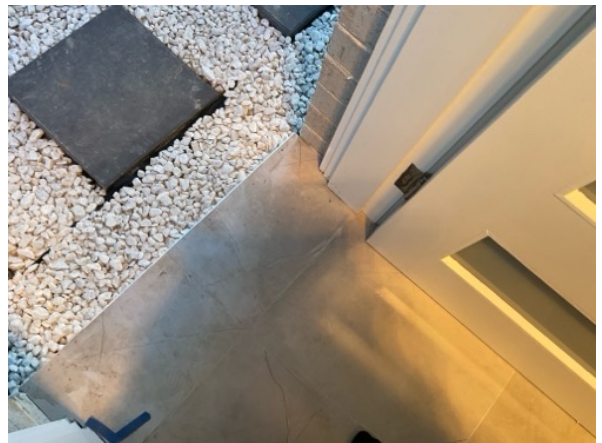
## Incomplete 1.57

**Finding:** Incomplete silicon/grout to the floor

Incomplete silicon to the to floor to be completed to restore appearance

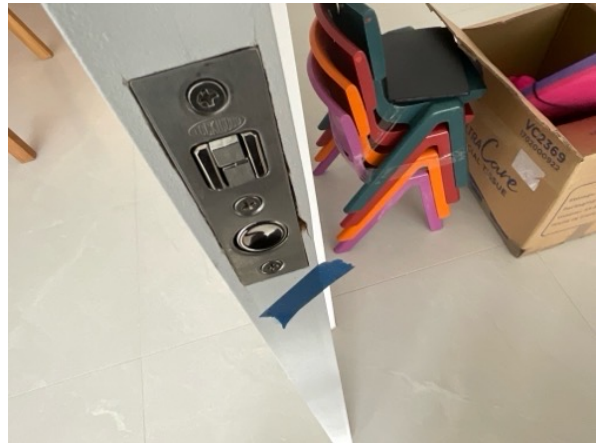
**Finding:** Damaged door

Damaged edge needs repair to restore appearance

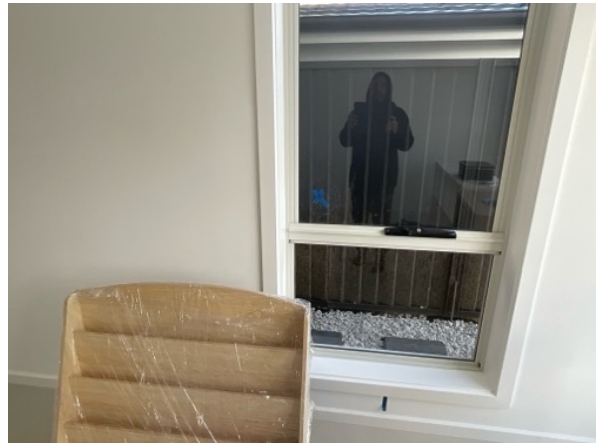
**Finding:** Window/door frame to be cleaned  
Window/door frame to be cleaned to ensure no damage.

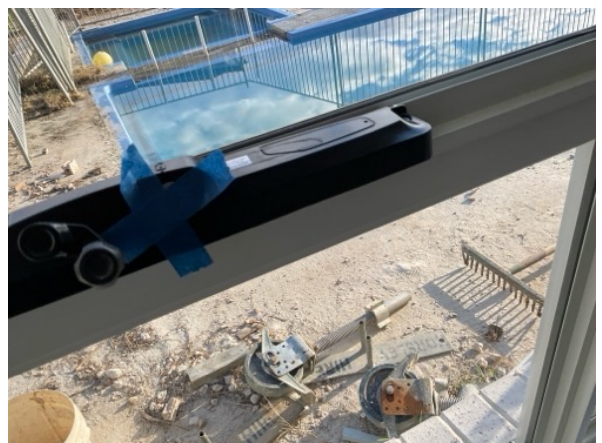
## Incomplete 1.65

**Finding:** Window lock is loose  
The window lock is loose and will need to be secured.

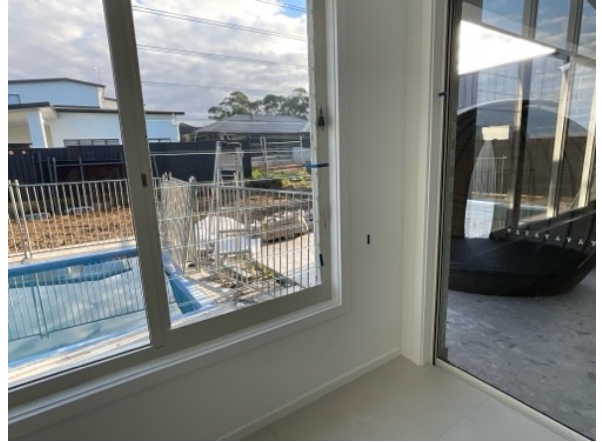
**Finding:** Window frame is missing silicon  
Missing silicon between the frame and the reveal

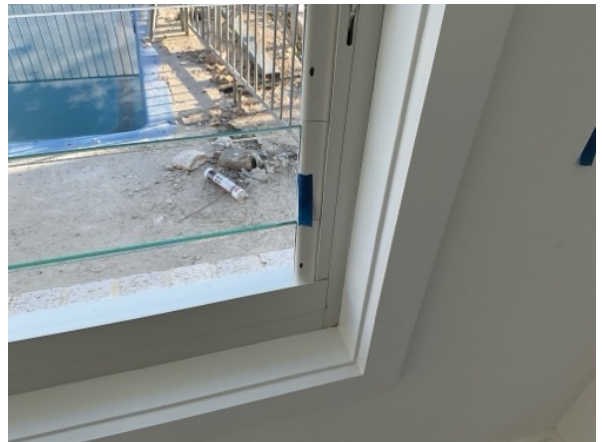
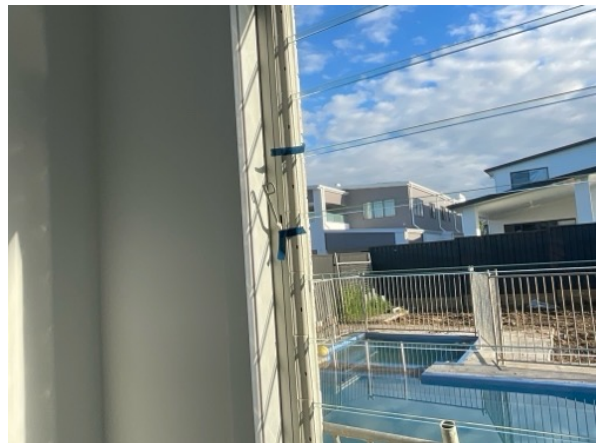
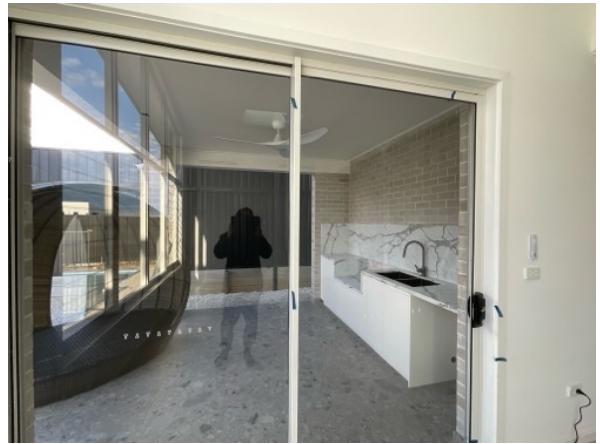
## Incomplete 1.69

**Finding:** Window/door frame to be cleaned  
Window/door frame to be cleaned to ensure no damage.

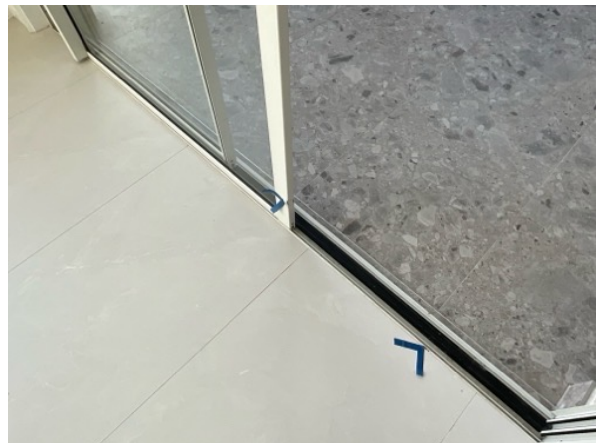
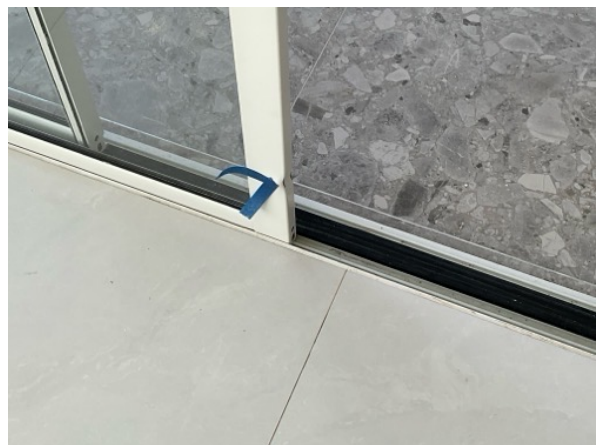
**Finding:** Damaged door frame

It was observed that the track and door frame have sustained noticeable damage, impacting the overall aesthetic and function.

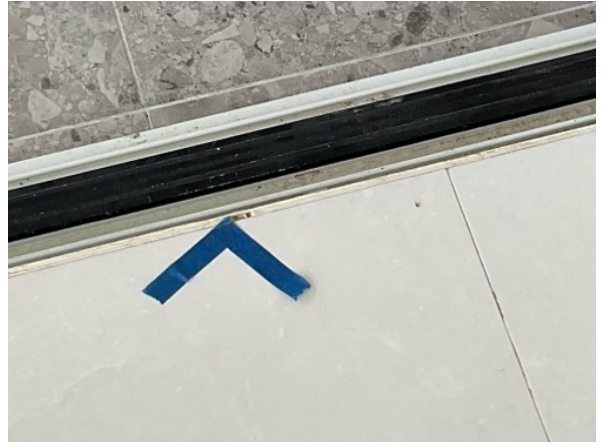
## Incomplete 1.73

**Finding:** Poorly finished silicone

Poorly finished silicone will need repair to restore appearance

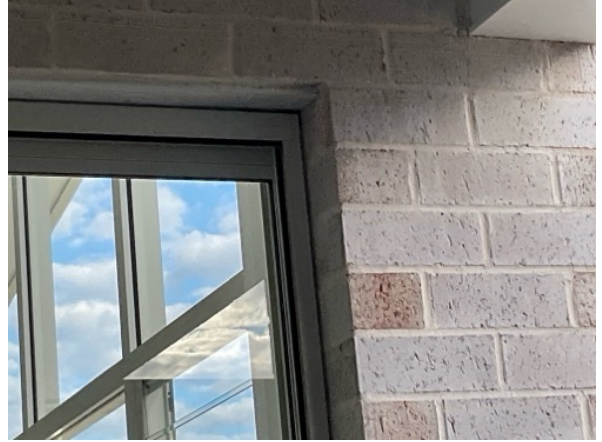
**Finding:** Missing or incomplete storm mould to the door/window frame

Missing or incomplete storm mould around the window/door frame will need repair to ensure adequate water tightness and appearance

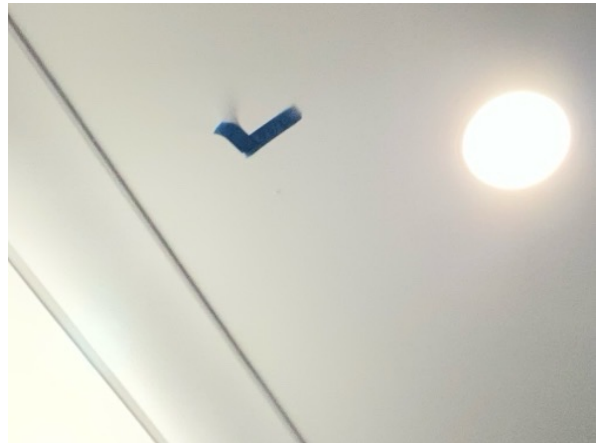
**Finding:** Popped nail to the wall/ceiling  
Popped nail heads to the wall/ceiling to be repaired to restore appearance

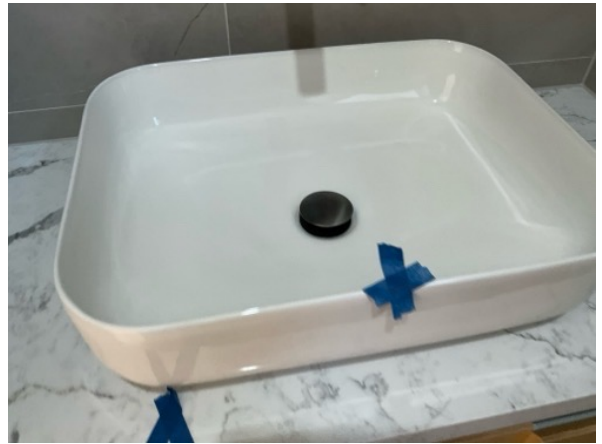
**Location:** Lower Powder Room  
**Finding:** Slow draining basin

It has been observed that the basin is experiencing slow drainage. This issue suggests a potential blockage or other underlying problem within the plumbing system that requires further investigation. It is important to address this defect promptly to prevent any possible escalation, which could lead to more significant plumbing issues or water damage. A qualified professional should be engaged to thoroughly assess the situation, identify the root cause, and recommend the necessary corrective measures to restore proper drainage functionality.

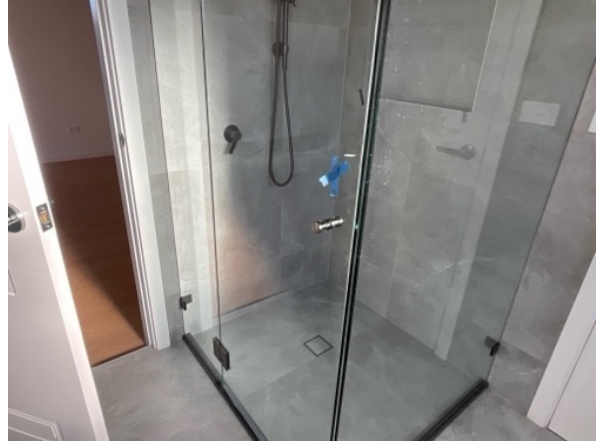
**Finding:** Shower screen door is not sitting tight  
Shower screen door is not sitting tight and will need to be repaired

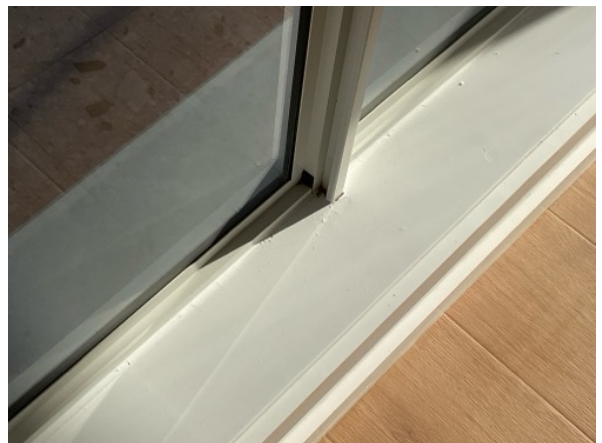
**Finding:** Damaged reveal  
Damaged reveal to be repaired

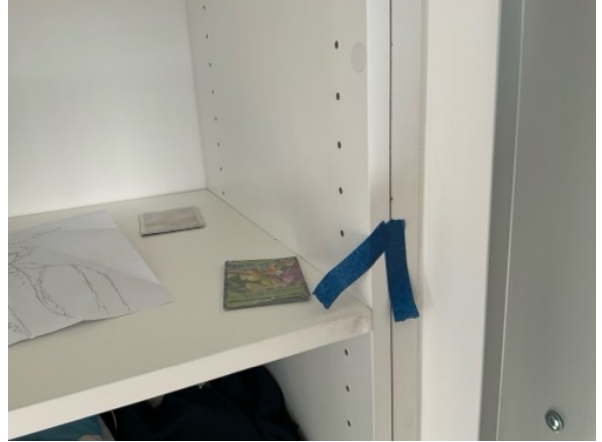
**Finding:** Damaged cabinet edge

Damaged cabinet edge will need repair to restore appearance

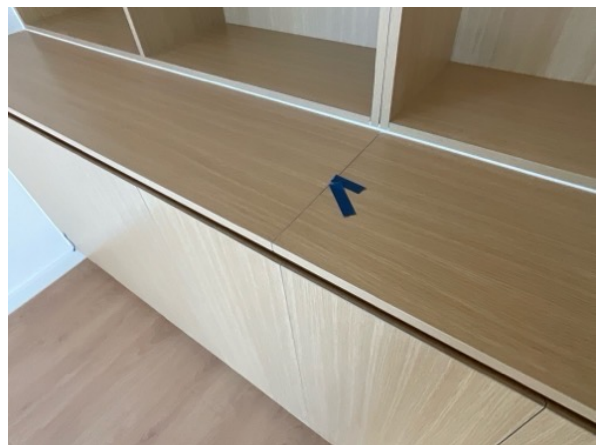
**Finding:** Benchtop has a damaged joint

Damaged benchtop joint will need repair, it is recommended that the benchtop surface be resurfaced/replaced to restore appearance

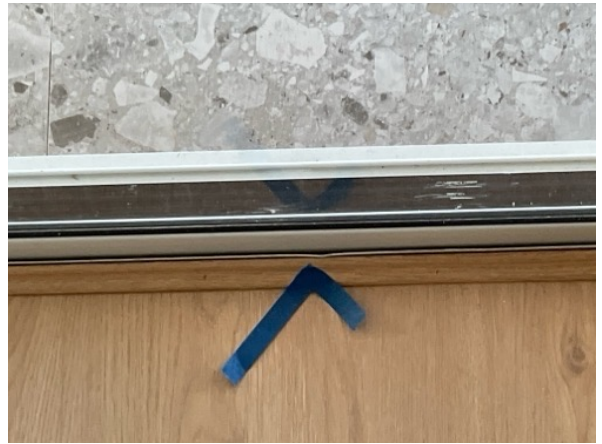
**Finding:** Damaged door frame

It was observed that the track have sustained noticeable damage, impacting the overall aesthetic and function.

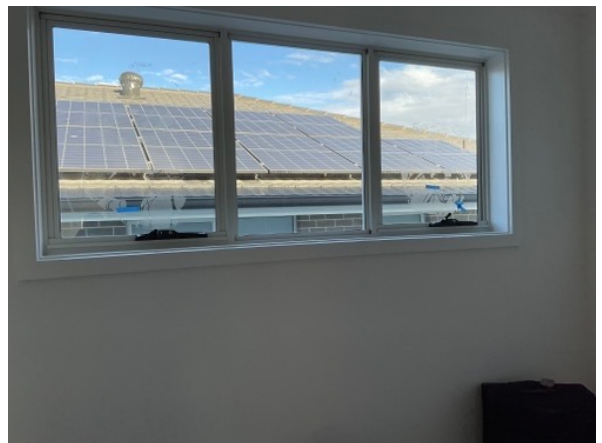
**Finding:** Window/door glass to be cleaned  
Glass to be cleaned to ensure there is no damage

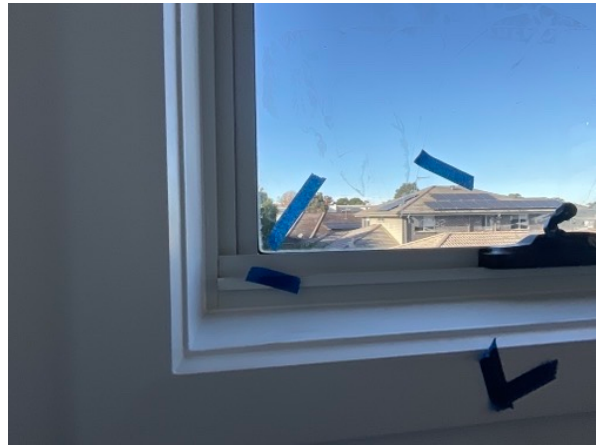
Loose rubber seal to window will need repair to ensure the window is water tight, To resolve this defect, it is recommended that a window servicing is carried out to restore the loose rubber.

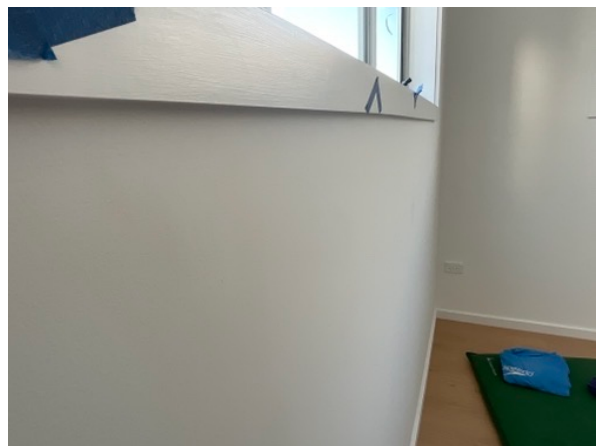
**Finding:** Architrave/moulding to the door/window is bowed  
Bottom of the architrave/moulding bowed and will need repair to restore appearance

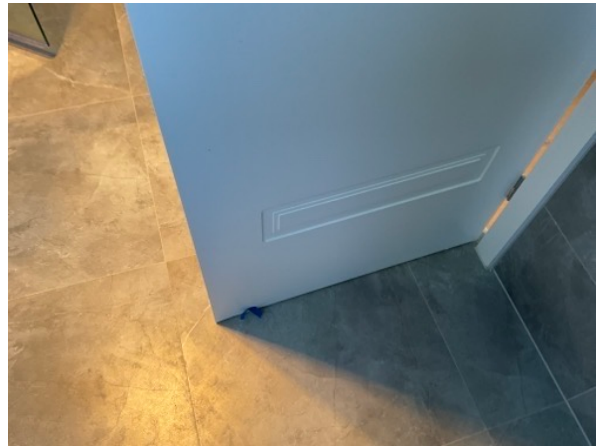
**Finding:** Damaged door  
Damaged surface needs repair to restore appearance

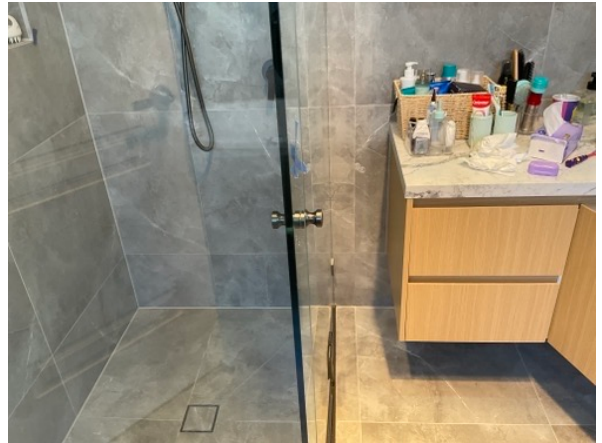
**Finding:** Shower screen door is not sitting tight  
Shower screen door is not sitting tight and will need to be repaired

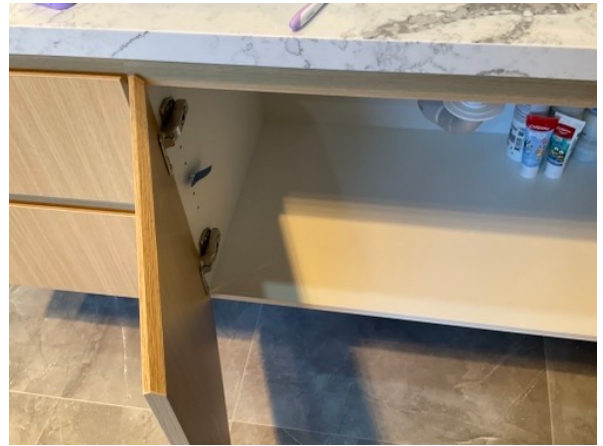
## Incomplete 2.31

**Finding:** Missing shelf  
Missing shelf to be installed

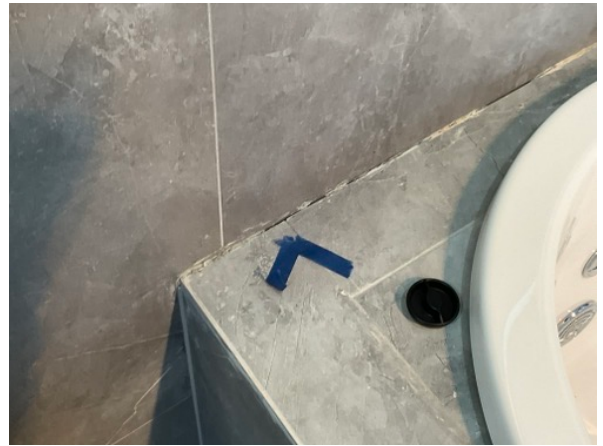
Bath tub exhibits stained and damaged grout/silicon, which may compromise the waterproofing integrity of the area.

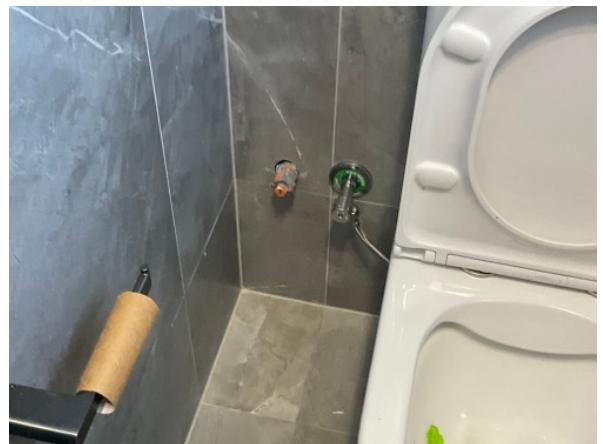
**Finding:** Missing flange to the tap  
Issuing flange to the tap to be installed

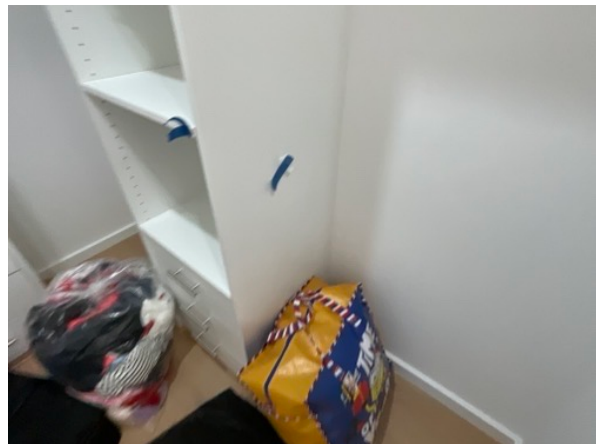
**Finding:** Hanging rod is missing  
Hanging rod to be installed

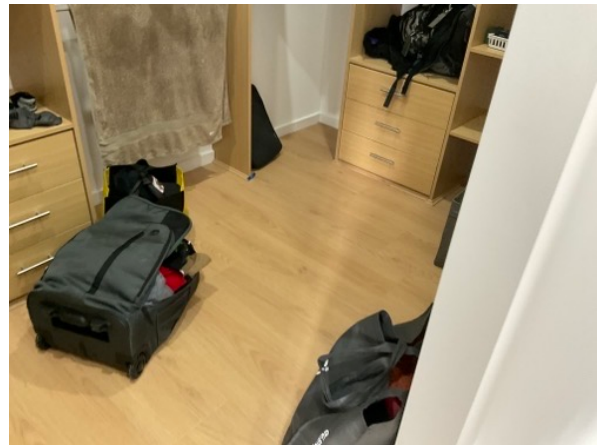
Poorly finished quad will need repair to restore appearance

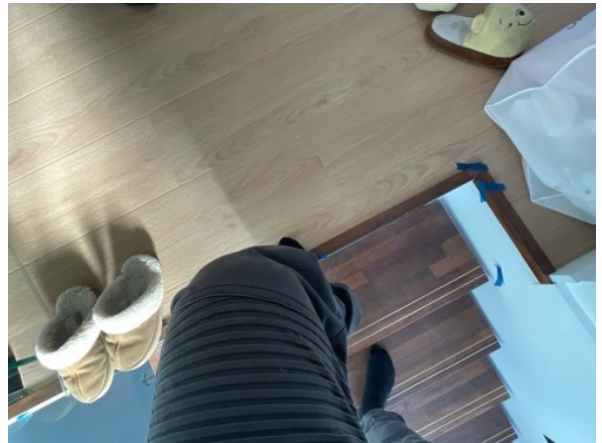
The flooring has a noticeable squeak, that will need repair

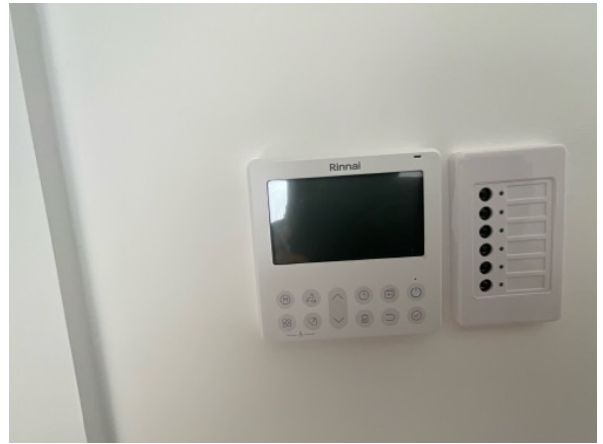
The air-conditioning requires a thorough testing period to assess its operational efficiency and functionality, as part of the evaluation process. To address this issue, it is recommended to engage a licensed technician to conduct a comprehensive assessment of the unit over an extended period to confirm its performance and rectify any identified deficiencies.

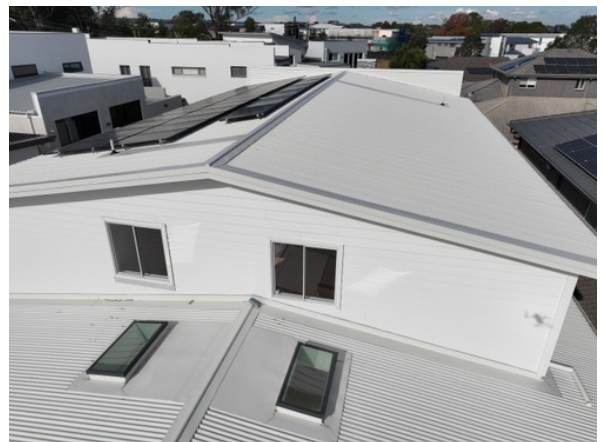
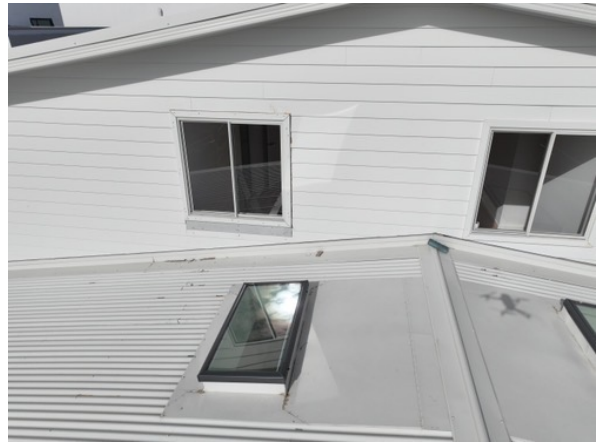
During the inspection of the roof exterior, it was observed that building waste, including remnants of construction materials, has accumulated across various sections of the roof surface. This buildup poses a potential obstruction to proper water drainage and could lead to long-term damage if not adequately addressed. It is important to have this waste promptly removed to ensure the integrity and functionality of the roofing system and to prevent any associated damages from occurring over time.

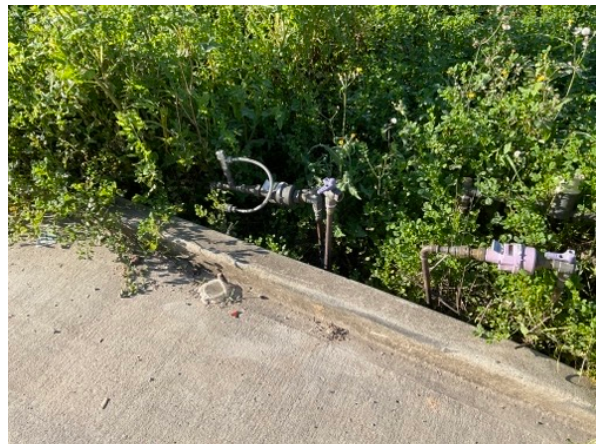
During the inspection, it was observed that a recycling water meter has not been installed in the external areas of the property. The absence of this meter means that there is currently no means to monitor or manage the usage of recycled water efficiently. This omission may lead to challenges in achieving sustainable water usage goals and could potentially result in increased water consumption costs. Installing a recycling water meter is recommended to facilitate effective monitoring and encourage the responsible use of recycled water resources.

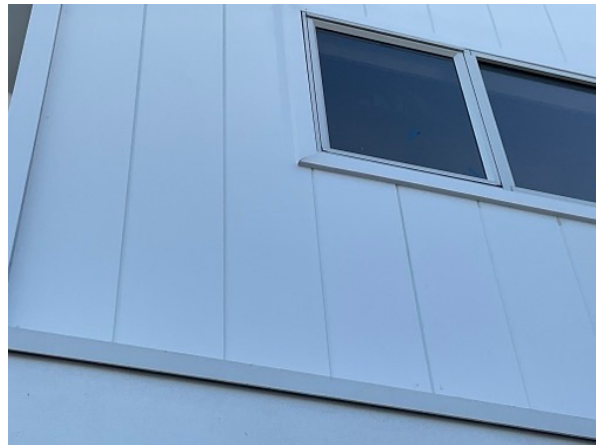
Moulding has become loose to the corner joint that has separated. This will need repair to restore appearance.

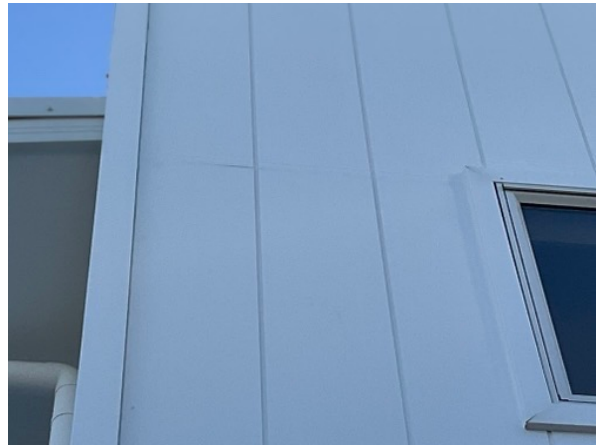
Loose cladding joint will need to be repaired to ensure water tightness

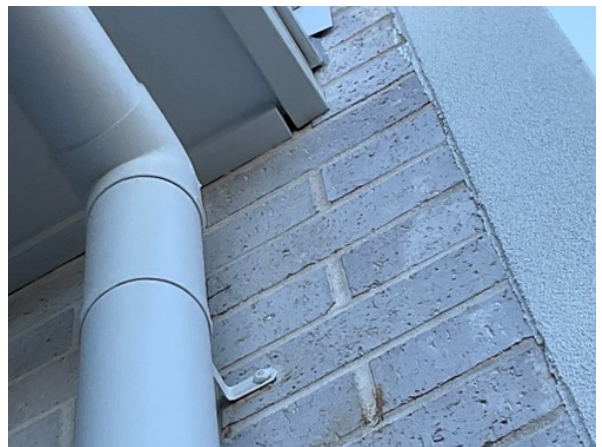
Missing or incomplete silicone to the moulding will need repair to reduce adequate water tightness and appearance

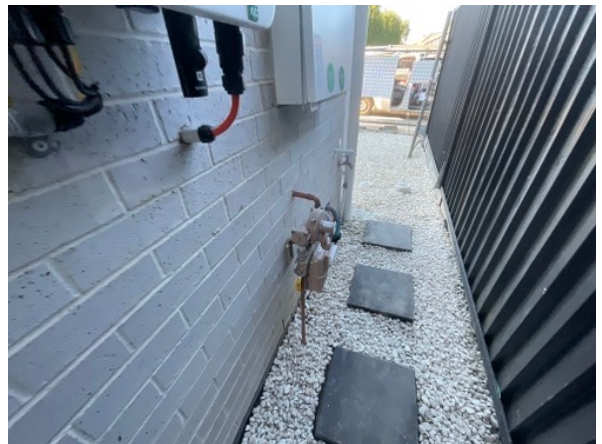
**Location:** All External Areas  
**Finding:** Gas meter  
Gas meter not tested

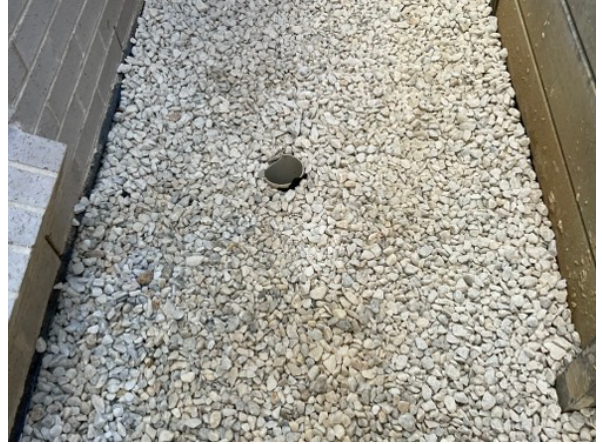
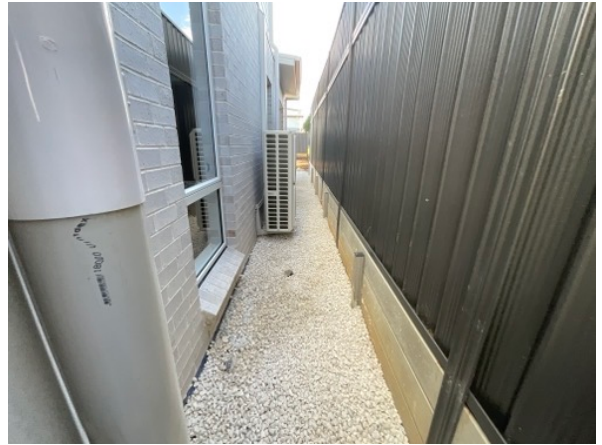
**Finding:** Pit/grate lid is missing  
Pit/grate lid is missing and will need to be installed.

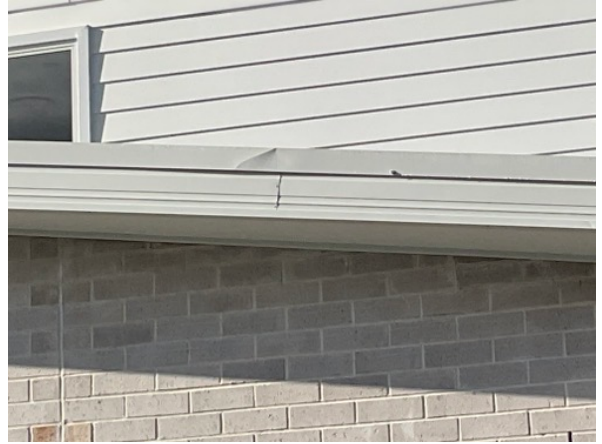
Damaged capping/flashing will need to be repaired to restore appearance.

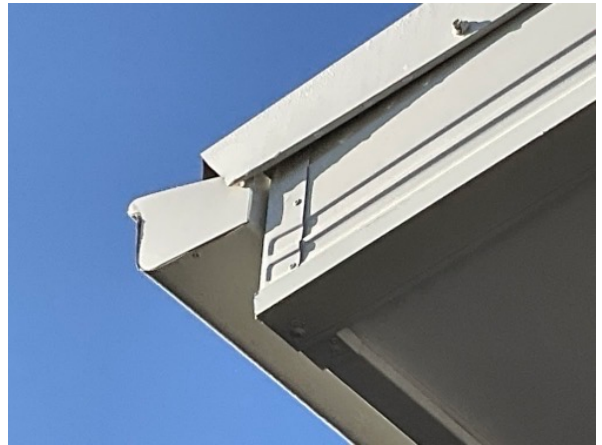
It has been observed that the capping is sitting off the wall and requires corrective action to ensure it is repositioned tightly against the structure. This detachment, if left unaddressed, could potentially lead to issues such as water ingress or pest entry, compromising the longevity and integrity of the building. To prevent any adverse effects on the property's condition, it is recommended that the capping be properly realigned and secured, ensuring it is firmly fixed to the wall.

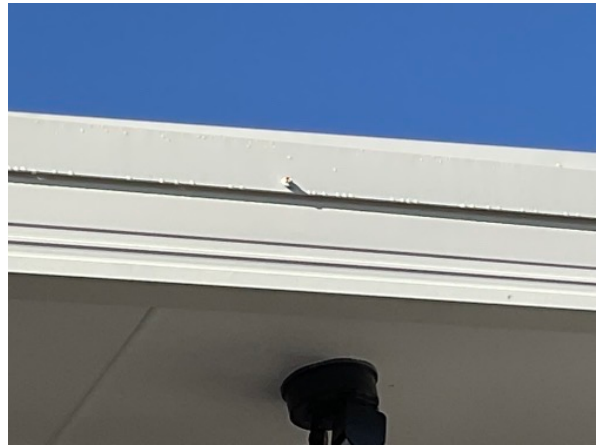
Screw heads exhibits notable rust stains, which should be addressed to prevent potential damage. Cleaning the stains is necessary to maintain the integrity and appearance of the fixture.

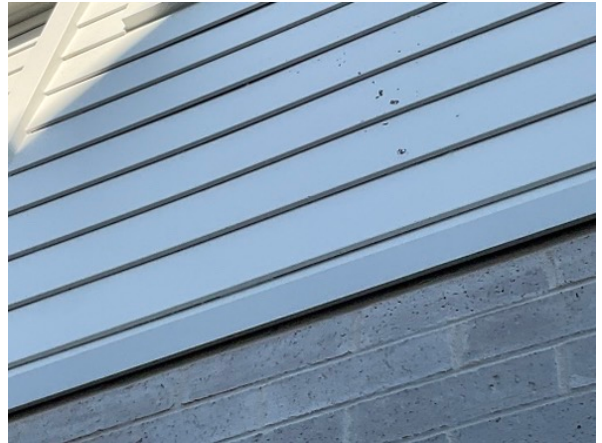
Loose cladding joint will need to be repaired to ensure water tightness

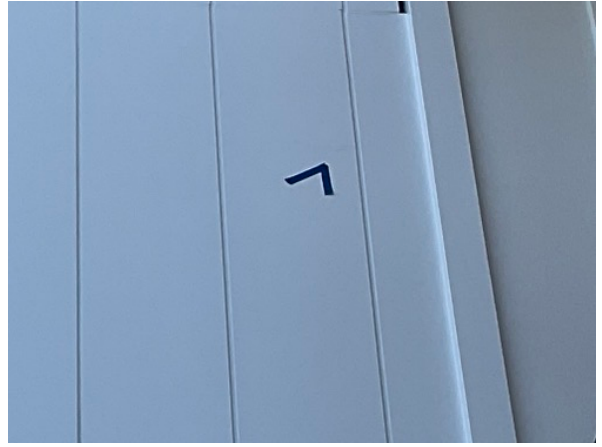
Damaged/incomplete cladding will need repair to prevent the ingress of moisture and the deterioration it can cause.

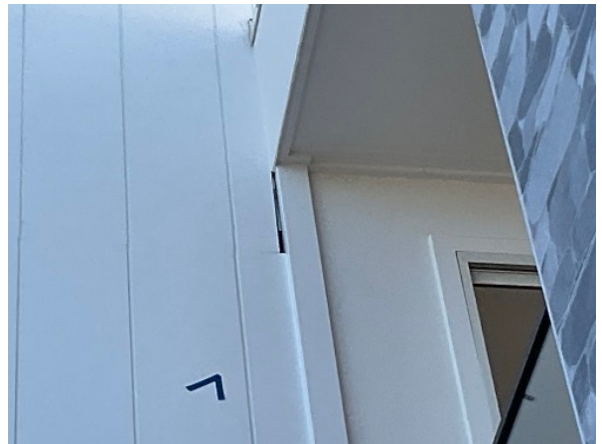
## Incomplete 2.90

**Finding:** Missing or incomplete silicon to the end of the cladding  
Missing or incomplete silicone to the end of the cladding will need repair to reduce adequate water tightness and appearance

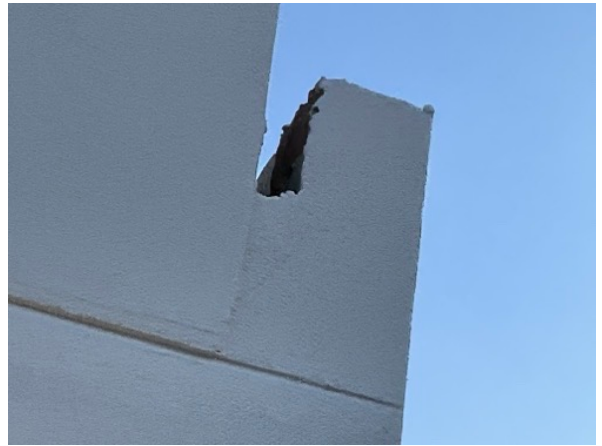
## Incomplete 2.91

**Finding:** Render is incomplete  
Incomplete render will need repair to restore appearance

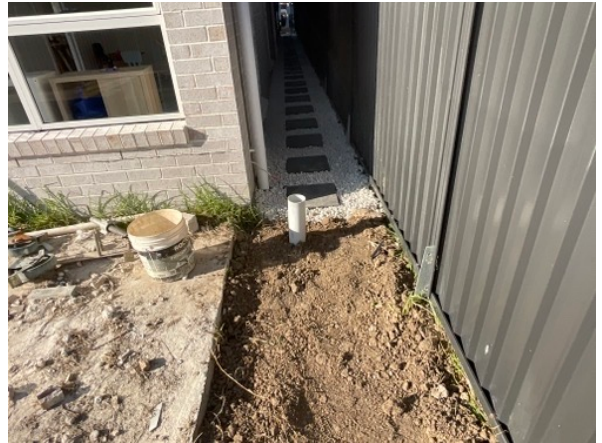
## Incomplete 2.92

**Finding:** Pit/grate lid is missing  
Pit/grate lid is missing and will need to be installed.

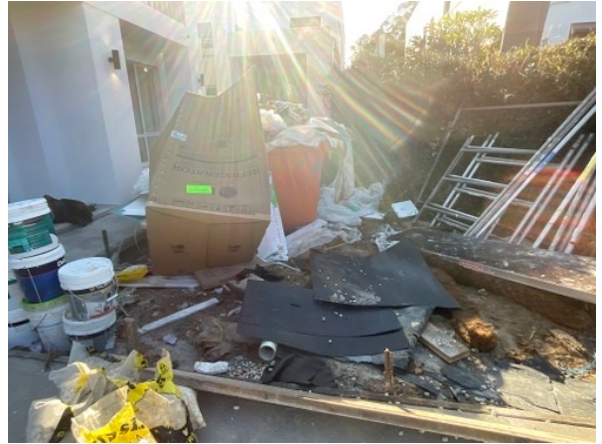
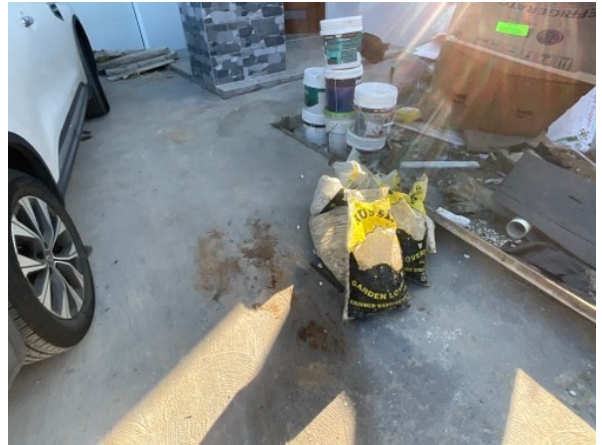
The landscaping in all external areas of the property remains incomplete, impacting the overall aesthetic and functionality of the space. Several areas lack the necessary turf, and there is an absence of designated garden beds, which were originally outlined in the project's landscaping plan. Additionally, the irrigation system installation is unfinished, leaving certain sections prone to inadequate watering and potential plant stress. Addressing these issues promptly is essential to ensure the landscape environment matures as intended and enhances the property's curb appeal.
