# Sample Report - Practical Completion Inspection

Inspection Date: 2 Jul 2026

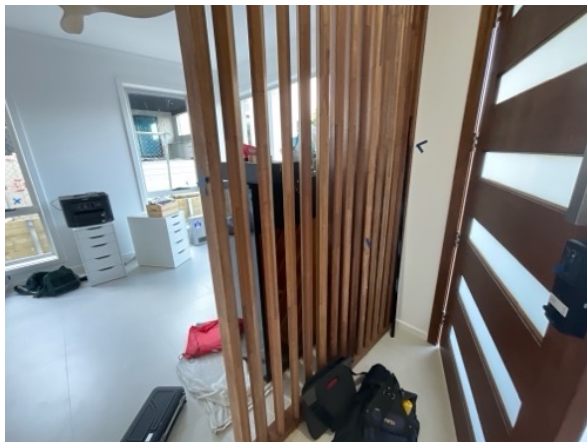
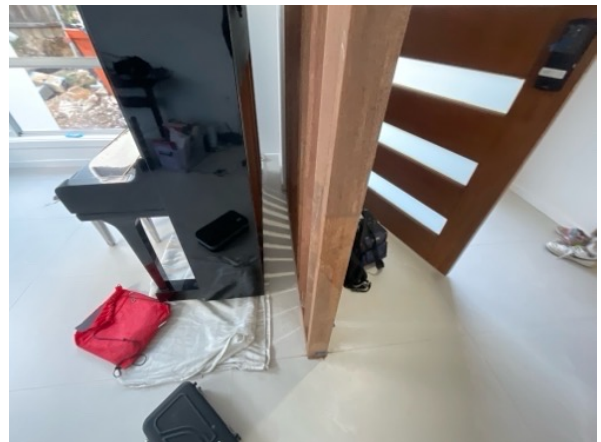
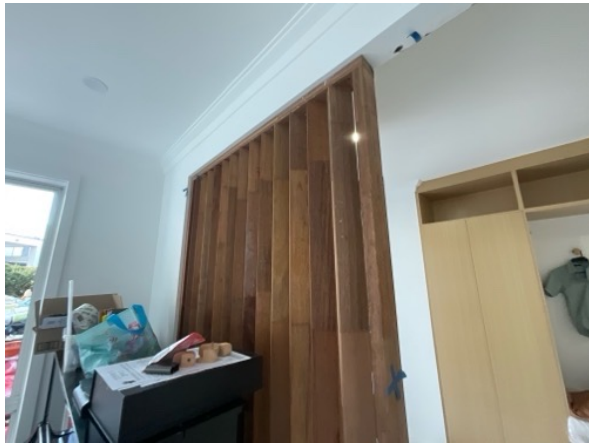
**Finding:** Incomplete painting

It was observed that the painting on the feature wall in the Piano Room and Entry is incomplete. Sections of the wall exhibit uneven paint coverage, with visible patches where the underlying surface is exposed, detracting from the intended aesthetic of these areas. This inconsistency in the finish not only affects the overall appearance but may also compromise the durability of the wall surface over time. It is recommended that the painting be completed to ensure a uniform and visually appealing finish consistent with the rest of the interior design.

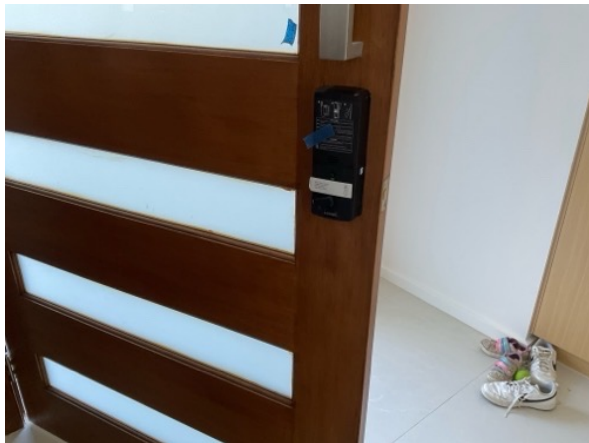
## Incomplete 1.02

**Location:** Piano Room And Entry

**Finding:** Electronic lock not working

It was observed that the electronic lock systems located to the entry is malfunctioning. The lock exhibit intermittent failures in responding to authorized access codes, causing undue inconvenience and potential security vulnerabilities. Moreover, the touchscreen interface occasionally freezes, requiring multiple attempts to regain functionality. This inconsistency not only compromises ease of access but also raises concerns regarding the reliability and effectiveness of the locking mechanism as a whole. Immediate attention and rectification are recommended to ensure secure and seamless operation.

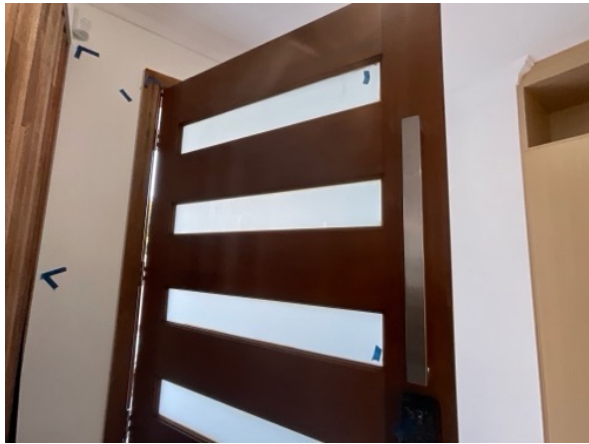
## Incomplete 1.03

**Location:** Piano Room And Entry

**Finding:** Window/door glass to be cleaned

Glass to be cleaned to ensure there is no damage

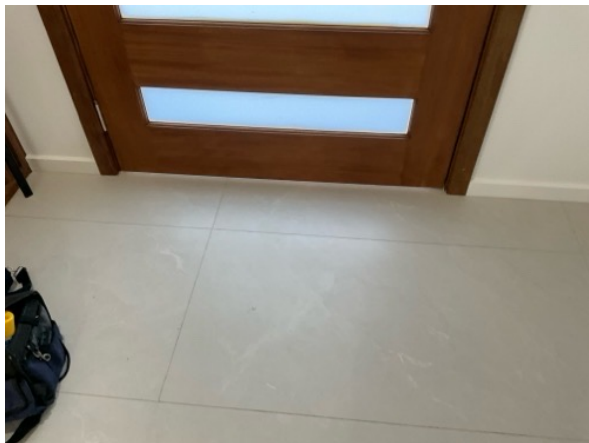
## Incomplete 1.04

**Location:** Piano Room And Entry

**Finding:** Weather/draft seal

Weather seal and/or draft seals are missing or inadequate and will need to be repaired or restored to ensure the integrity and water tightness of the door

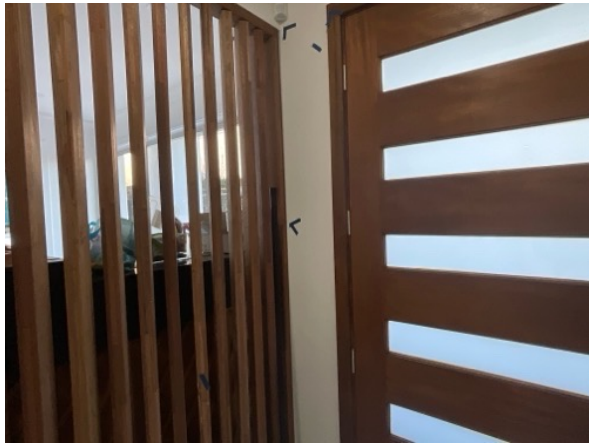
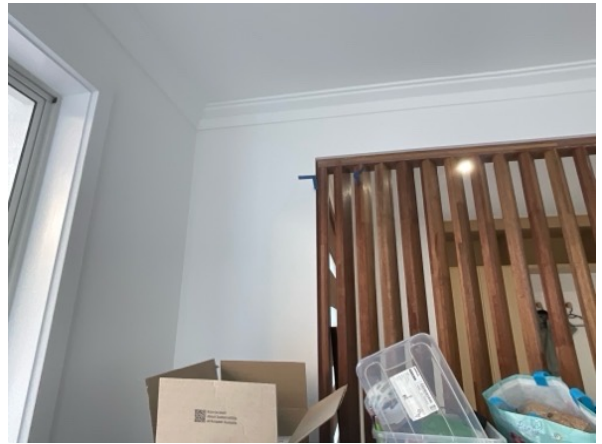
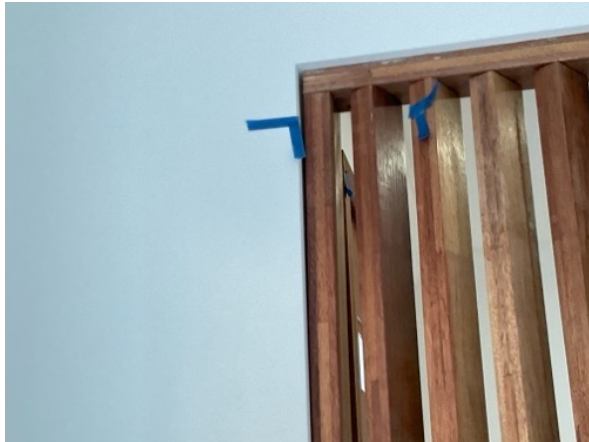
## Incomplete 1.05

**Location:** Piano Room And Entry

**Finding:** Excessive gap to the timber screen and wall junction

There is an excessive gap between the timber screen and the adjacent wall, which requires sealing.

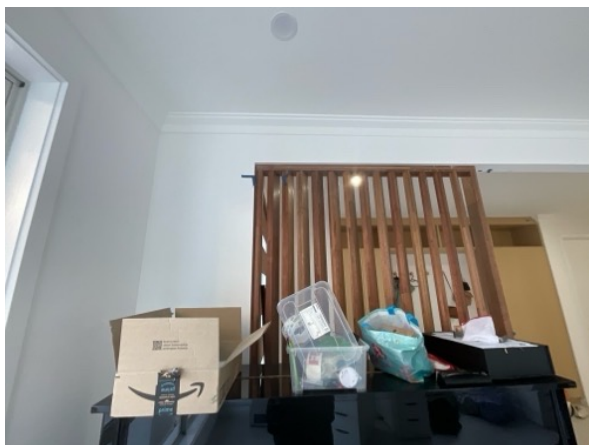
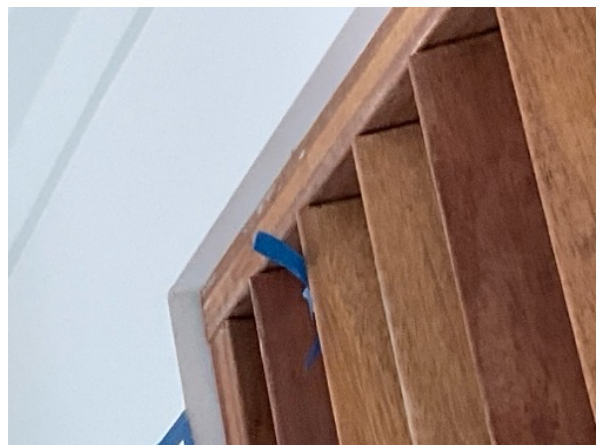
## Incomplete 1.06

**Location:** Piano Room And Entry

**Finding:** Timber screen alignment

The timber slats on the privacy screen do not align properly with the top of the slats and the top plate, resulting in a misalignment that affects the overall aesthetic.

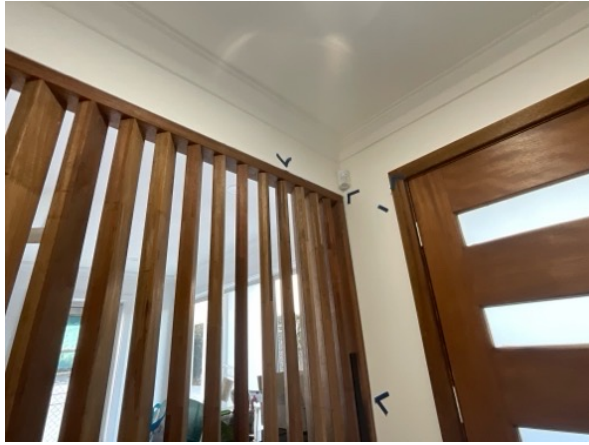
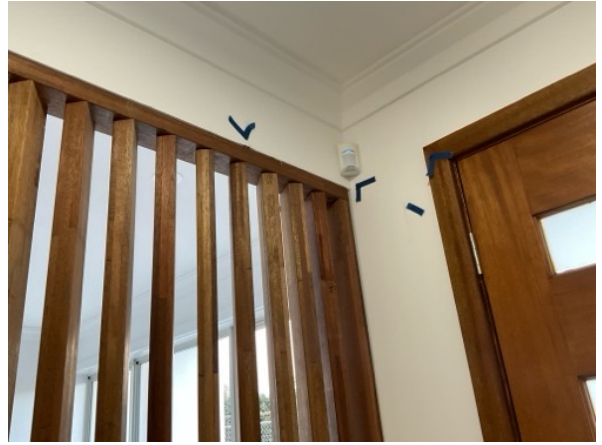
## Incomplete 1.07

**Location:** Piano Room And Entry

**Finding:** Wall patching is required

Patches are incomplete and will need finishing to a good standard

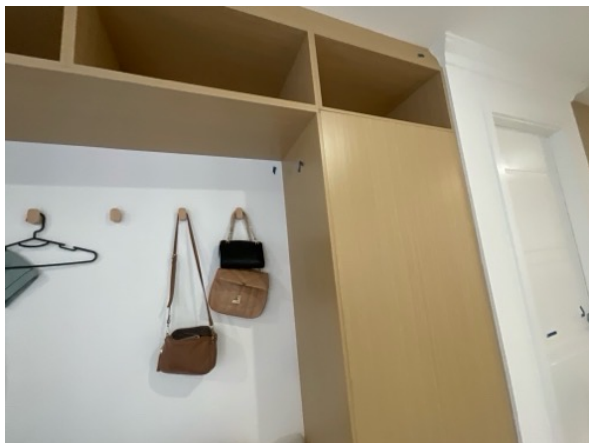
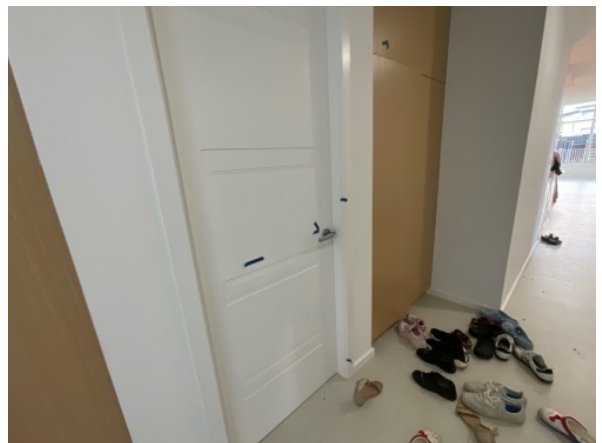
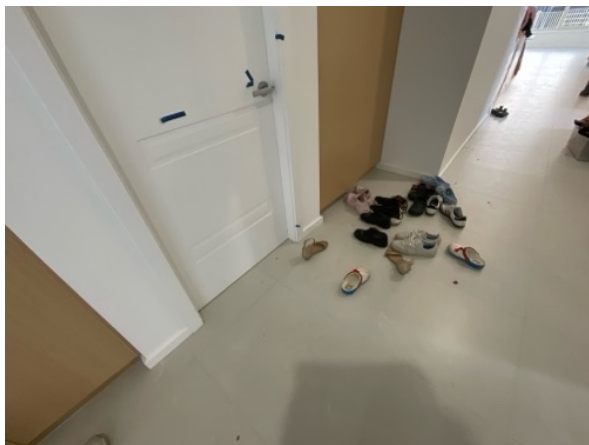
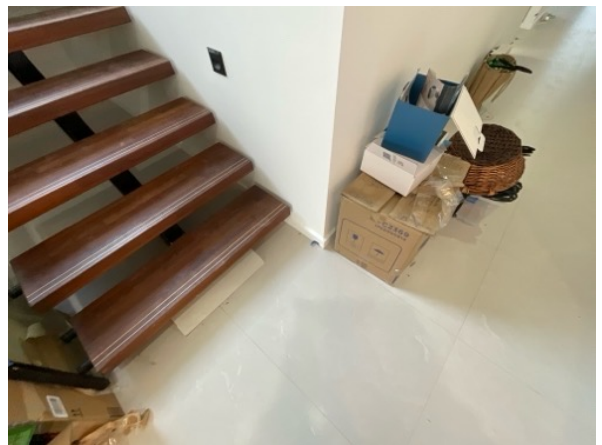
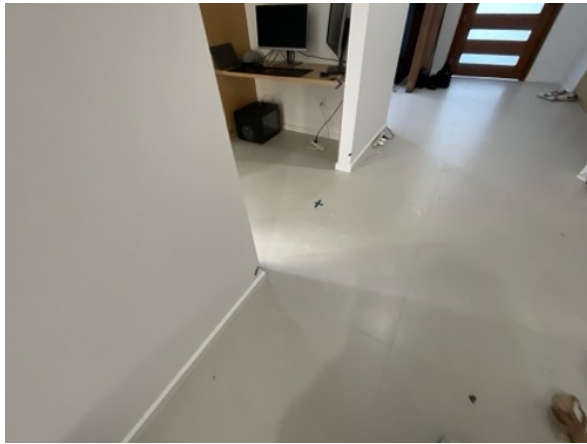
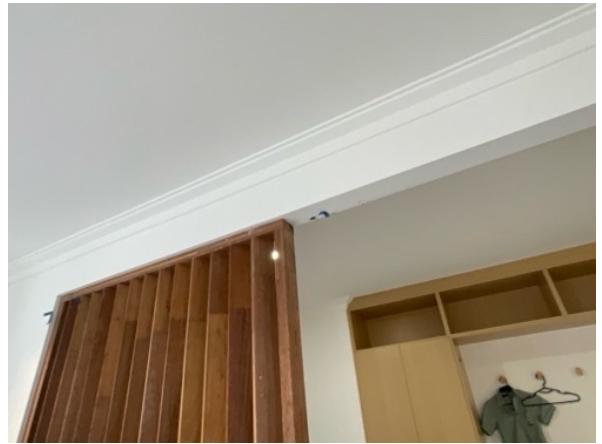
## Incomplete 1.08

**Location:** Piano Room And Entry

**Finding:** Paint touchups required

Minor paint touchups required as tagged on site to restore appearance

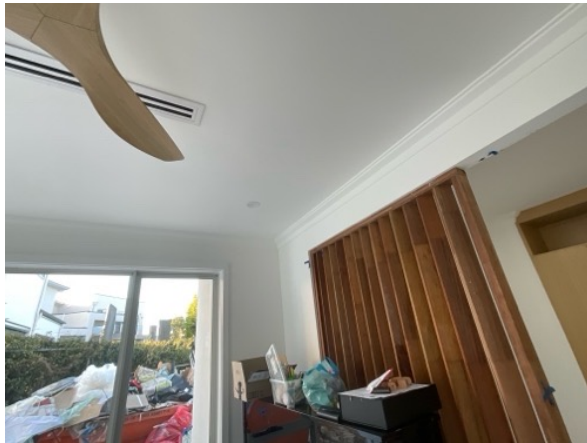
## Incomplete 1.09

**Location:** Piano Room And Entry

**Finding:** Popped nail to the wall/ceiling

Popped nail heads to the wall/ceiling to be repaired to restore appearance

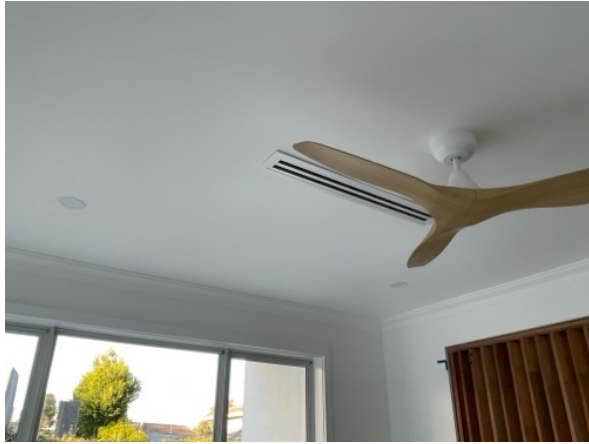
## Incomplete 1.10

| Piano Room And Entry | Air-conditioner vent is not sitting tight to the plaster board |

**Location:** Piano Room And Entry

**Finding:** Air-conditioner vent is not sitting tight to the plaster board

The air-conditioner vent is observed to not sit flush against the plasterboard, leading to potential inefficiencies and aesthetic concerns. It is recommended to refit or realign the vent to

ensure a secure and tight installation.

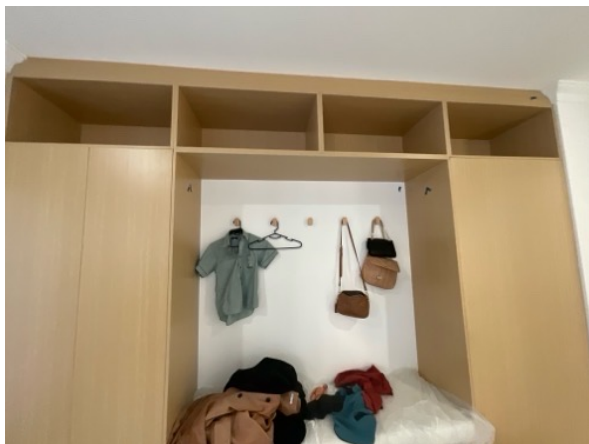
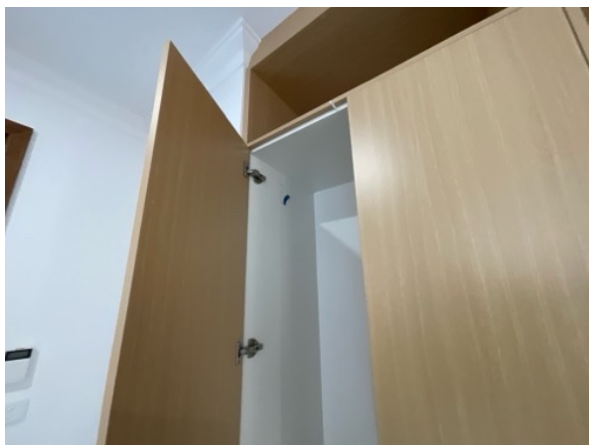
## Incomplete 1.11

| Piano Room And Entry | Hanging rod is missing |

**Location:** Piano Room And Entry  
**Finding:** Hanging rod is missing  
Hanging rod to be installed

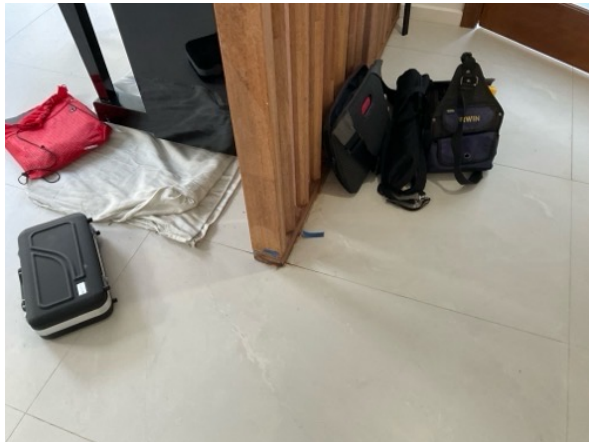
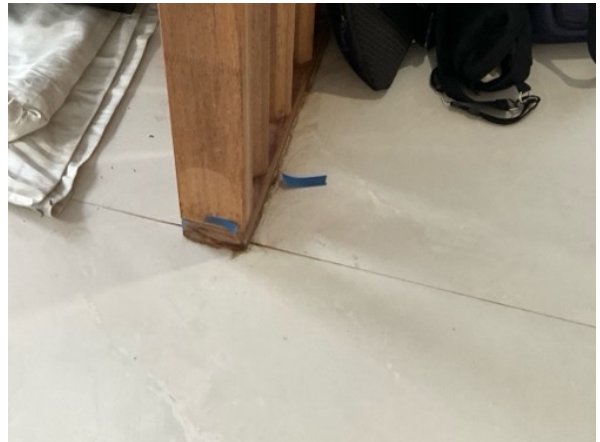
## Incomplete 1.12

**Location:** Piano Room And Entry

**Finding:** Flooring to be cleaned  
Flooring to be cleaned to ensure no damaged has occurred.

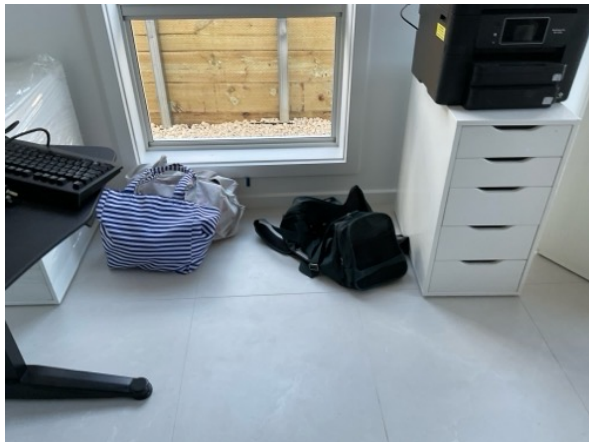
## Incomplete 1.13

**Location:** Piano Room And Entry  
**Finding:** Underside of the architrave to be sealed  
Underside of the window architraves to be sealed

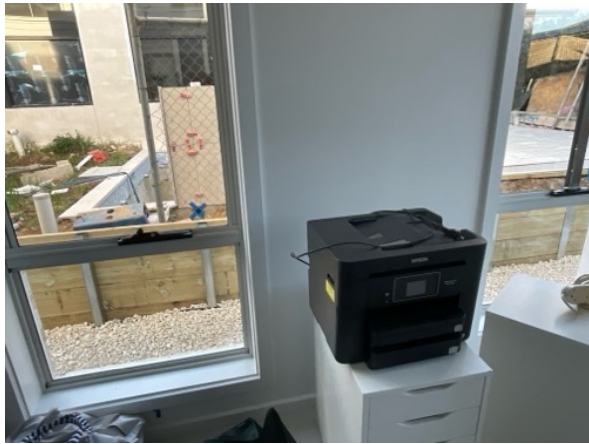
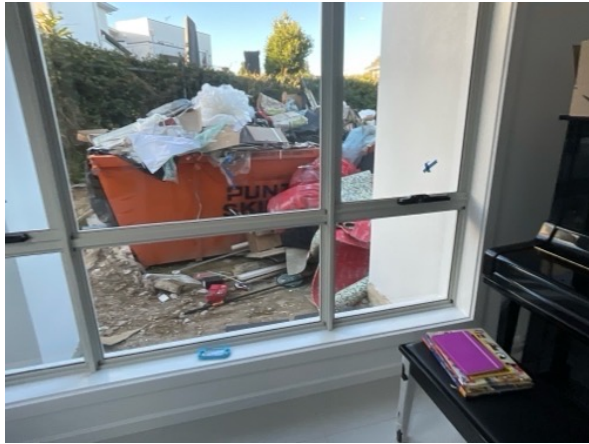
## Incomplete 1.14

**Location:** Piano Room And Entry  
**Finding:** Window is binding  
The window is currently binding and will need adjustment and servicing. To resolve this defect, it is recommended that a window servicing is carried out to restore smooth operation of the openable portion of the window.

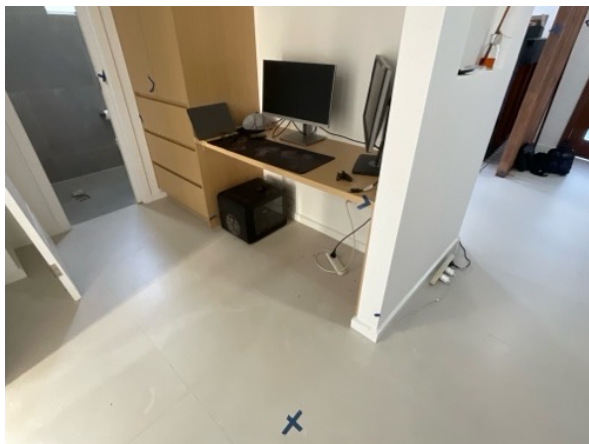
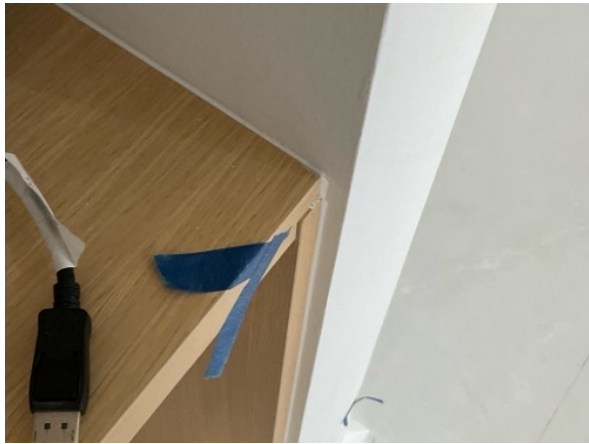
## Incomplete 1.15

**Location:** Piano Room And Entry

**Finding:** Cabinet edge not aligned

Missing cabinet edge not aligned and will need to be repositioned to restore appearance

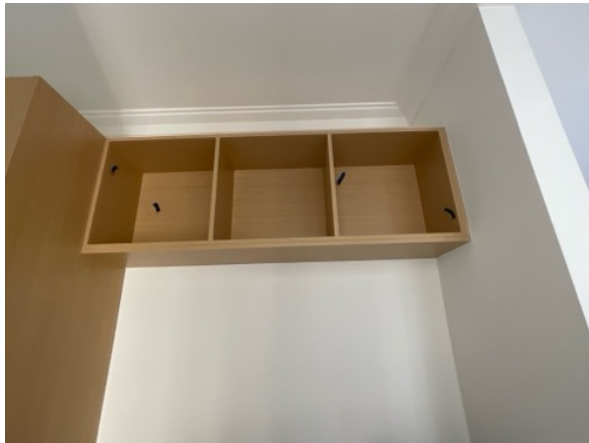
## Incomplete 1.16

| Piano Room And Entry | Missing screw head sticker |

**Location:** Piano Room And Entry  
**Finding:** Missing screw head sticker  
Missing screw head sticker cover to be installed

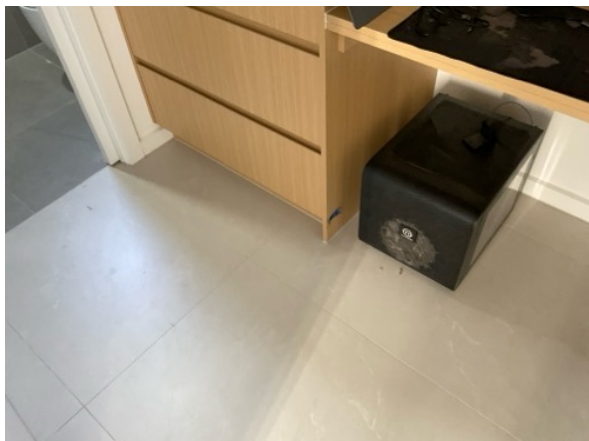
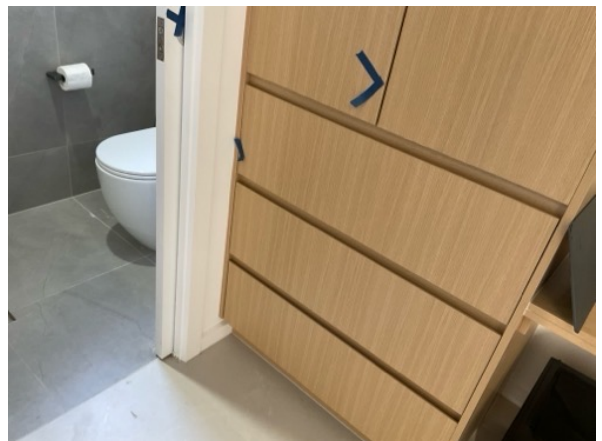
## Incomplete 1.17

**Location:** Piano Room And Entry  
**Finding:** Cabinet surfaces to be cleaned  
Surfaces to be cleaned to ensure no damage

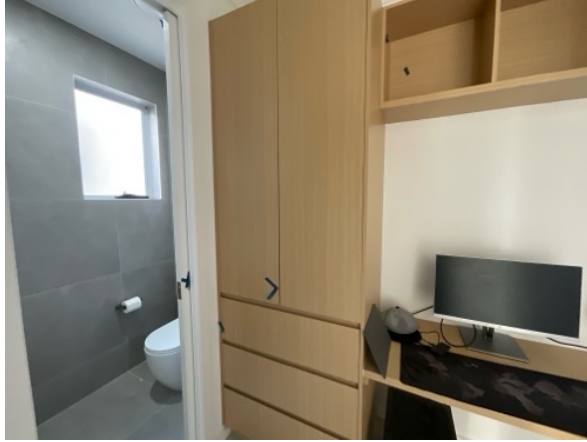
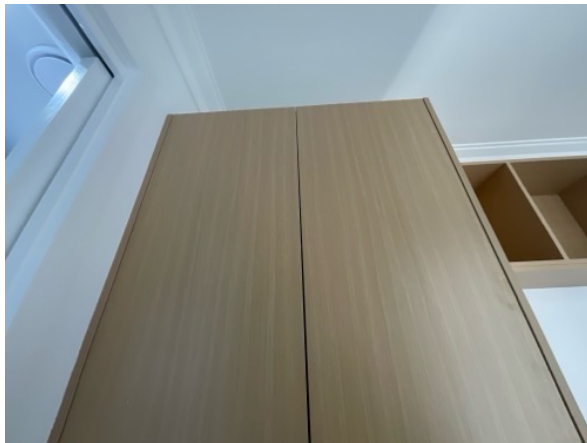
## Incomplete 1.18

**Location:** Piano Room And Entry

**Finding:** Cabinet doors need adjusting

Cabinet doors require adjustment, as they are not functioning correctly. It is recommended that the cabinet doors be realigned and adjusted to ensure smooth operation.

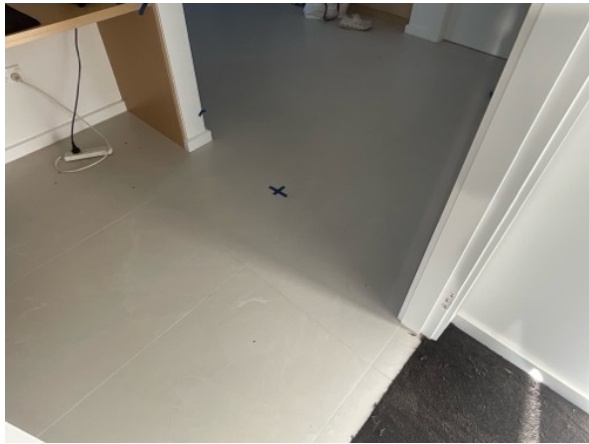
## Incomplete 1.19

**Location:** Piano Room And Entry

**Finding:** Drummy tile

Drummy tiles in several locations, which indicate insufficient adhesion to the substrate. This defect can lead to potential cracking or dislodgement over time and affects the overall structural integrity of the flooring. Immediate assessment and rectification by a qualified professional are recommended to prevent further deterioration and ensure the safety and longevity of the tiled surface.

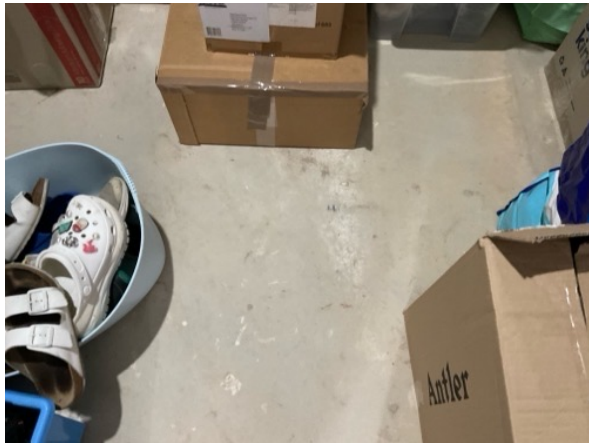
## Incomplete 1.20

**Location:** Garage

**Finding:** Chipped concrete

Damaged concrete to be repaired to restore appearance

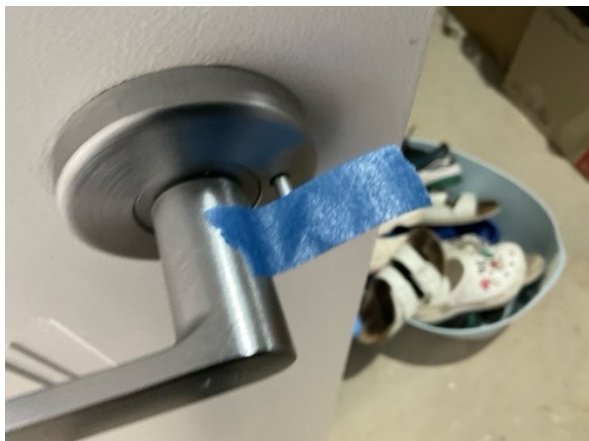
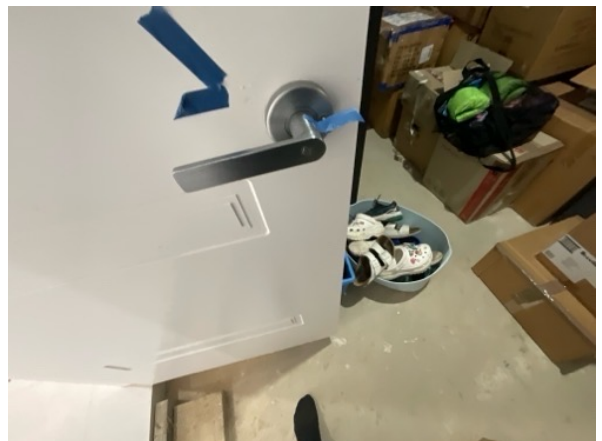
**Finding:** Door lock

Door lock will need to be repaired

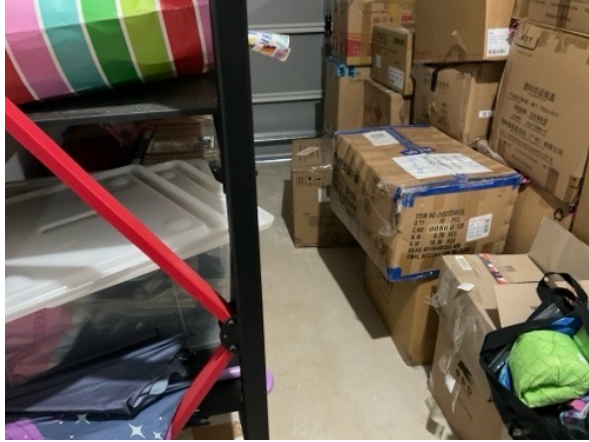
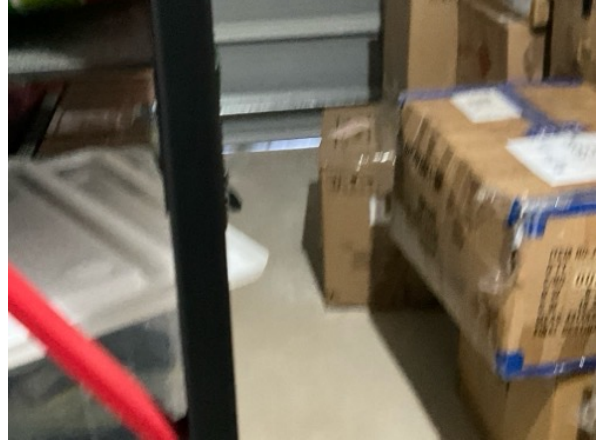
## Incomplete 1.22

**Location:** Garage

**Finding:** Garage door to be adjusted

Garage door to be adjusted to ensure the seal to the concrete is tight and not allow any water into the garage

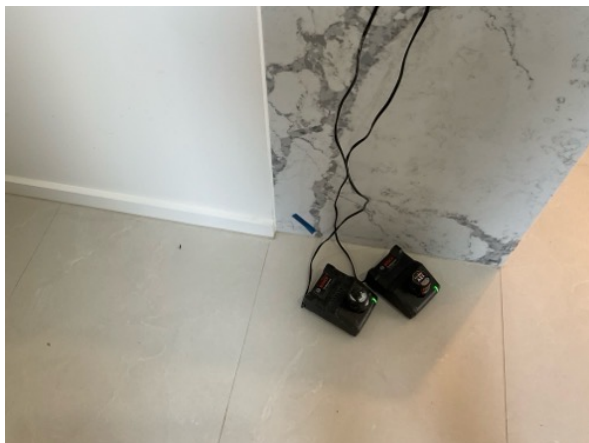
## Incomplete 1.23

**Location:** Kitchen

**Finding:** Benchtop surface and edge to be cleaned

The benchtop surface and edges are required to be cleaned to ensure there is no damage or imperfections to the surface, If necessary, minor repairs should be conducted to restore appearance.

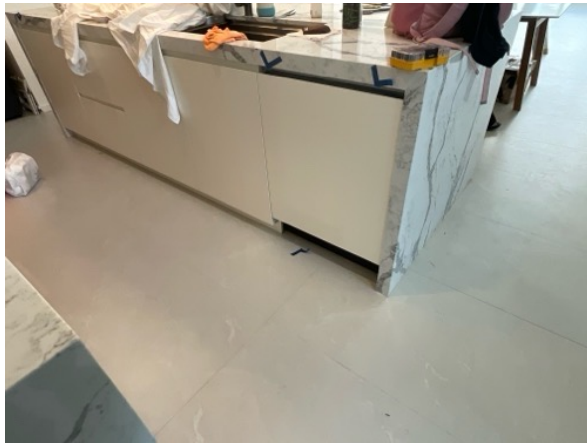
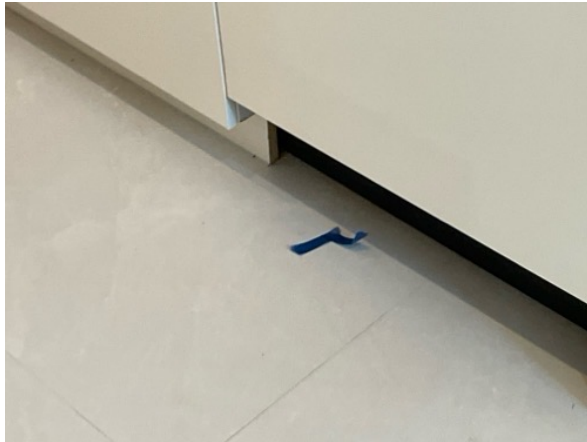
## Incomplete 1.24

**Location:** Kitchen

**Finding:** Missing kicker and filler piece to the dishwasher

It was noted that the dishwasher in the kitchen is missing its kicker panel filler piece to both the top and bottom sections. This absence detracts from the overall appearance and finish of the appliance, leaving the installation looking incomplete.

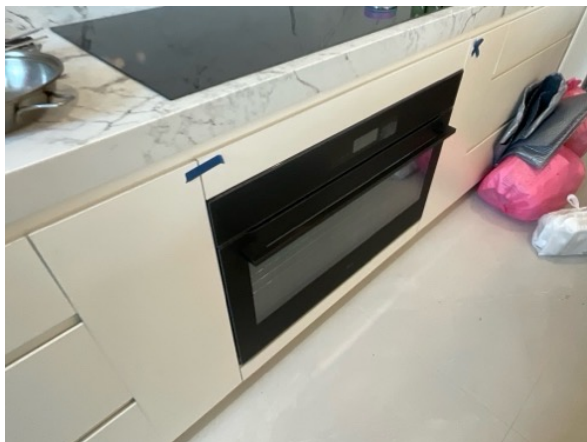
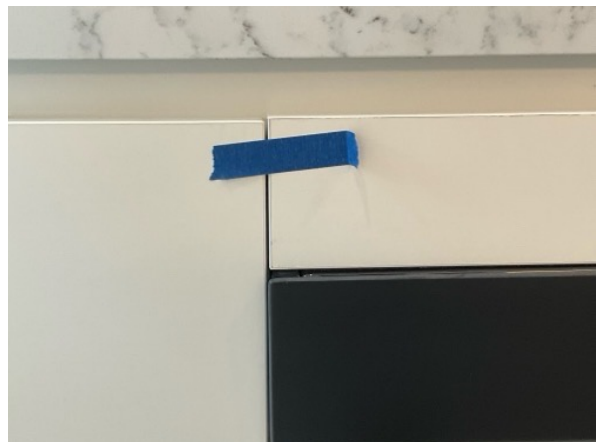
## Incomplete 1.25

**Location:** Kitchen

**Finding:** Cabinet alignment is required  
Cabinets are not sitting even with each other and will need to be repositioned

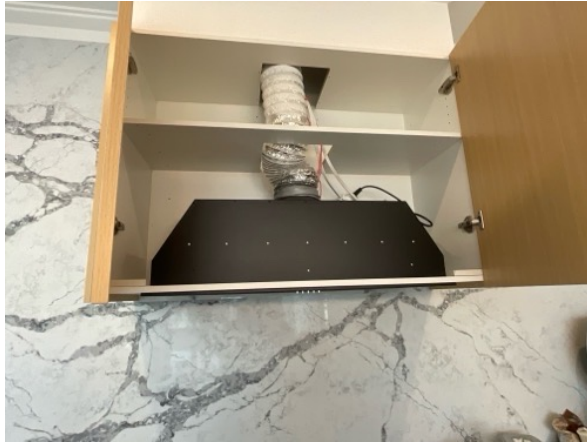
## Incomplete 1.26

**Location:** Kitchen

**Finding:** Missing cover to the range hood ducting  
The kitchen is missing a cover to the range hood ducting, impacting the overall aesthetic of the cabinetry. This defect should be rectified by installing the appropriate covering to restore the

intended appearance.

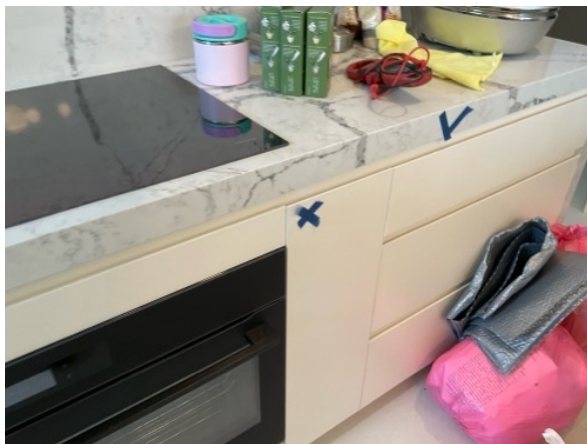
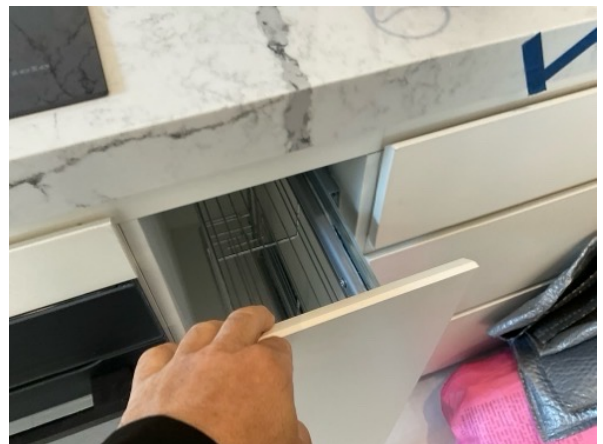
## Incomplete 1.27

**Location:** Kitchen

**Finding:** Binding/rubbing doors/drawers

Binding/rubbing doors/drawers to be eased to restore functionality.

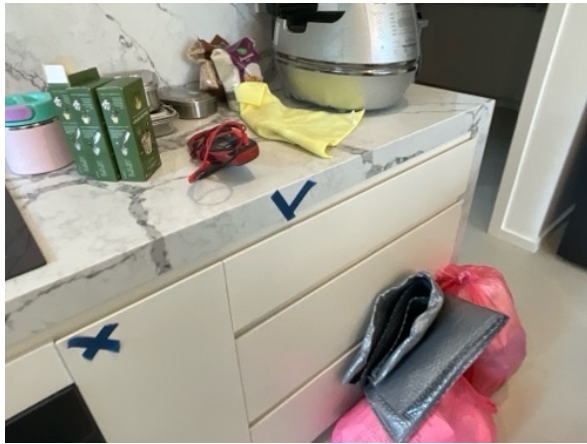
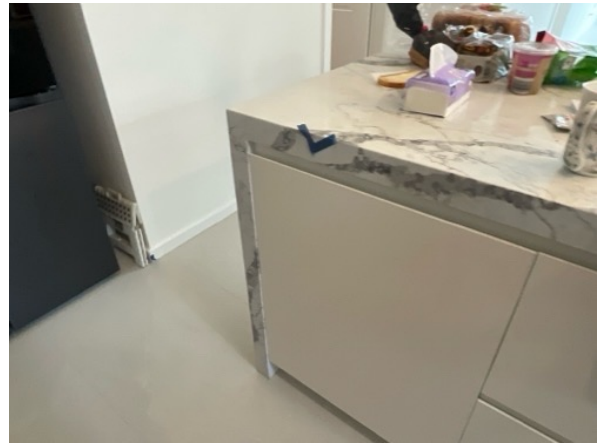
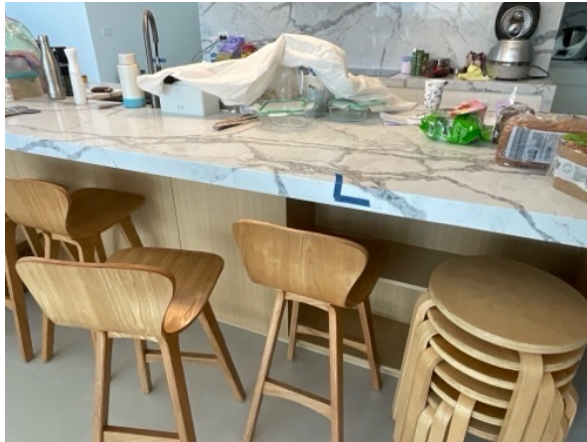
## Incomplete 1.28

**Location:** Kitchen

**Finding:** Incomplete silicone to the underside of the bench

Incomplete silicone to the under side of the bench

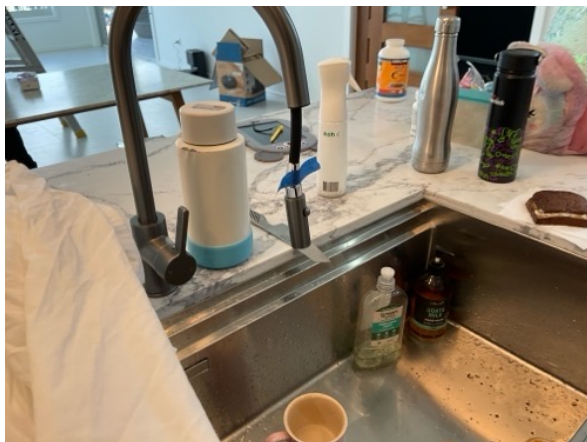
## Incomplete 1.29

**Location:** Kitchen

**Finding:** Binding hose to the tap  
Binding hose to the tap to be repaired to restore use

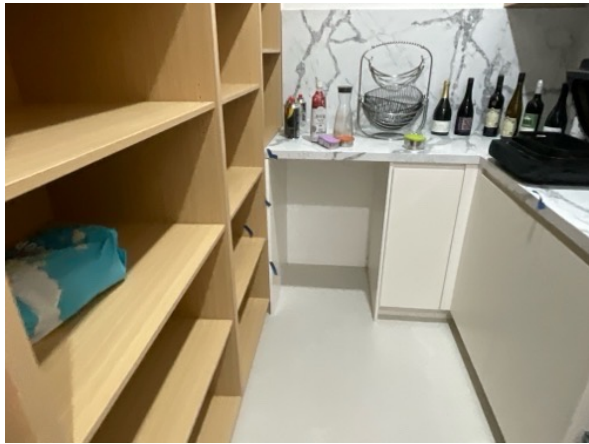
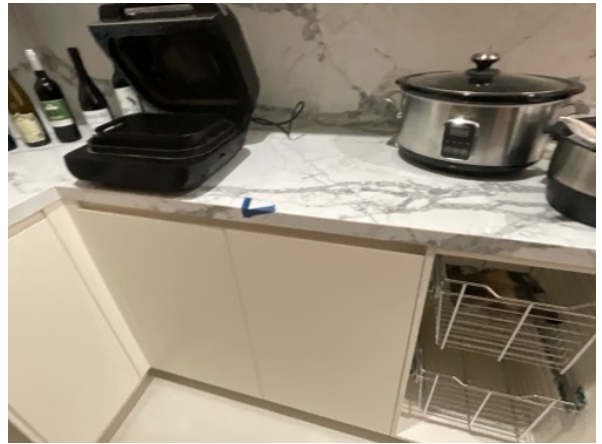
## Incomplete 1.30

**Location:** Kitchen

**Finding:** Incomplete silicone to the underside of the bench  
Incomplete silicone to the under side of the bench

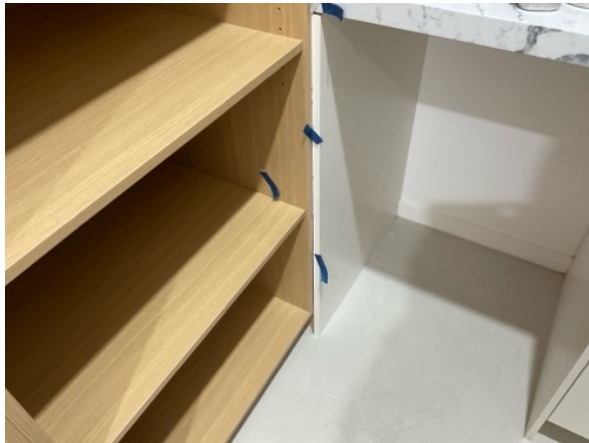
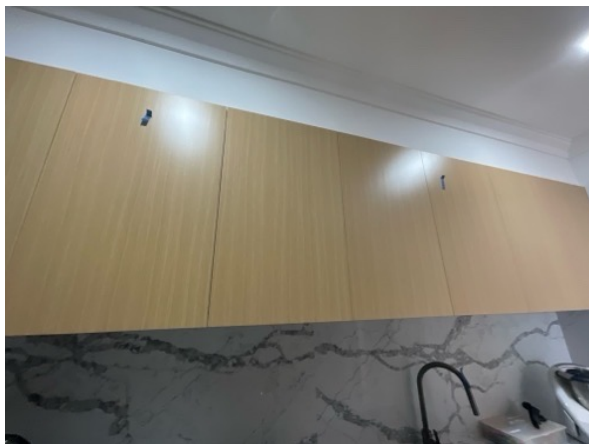
## Incomplete 1.31

**Location:** Kitchen

**Finding:** Cabinet surfaces to be cleaned  
Surfaces to be cleaned to ensure no damage

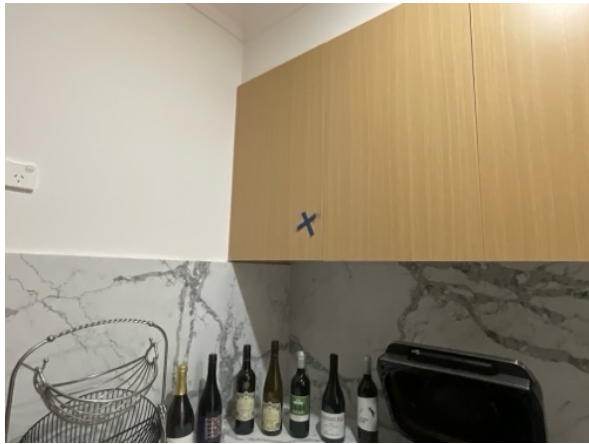
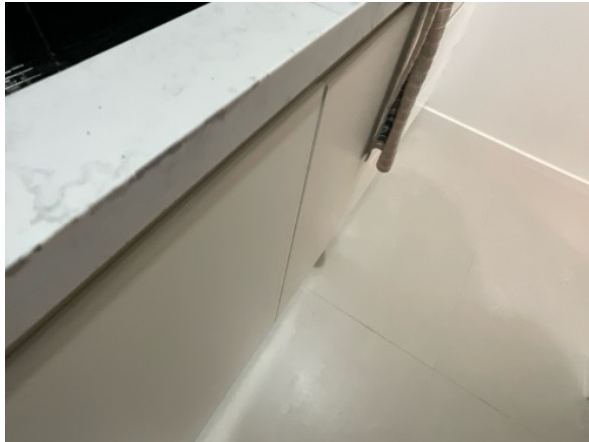
## Incomplete 1.32

**Location:** Kitchen

**Finding:** Cabinet alignment is required  
Cabinets are not sitting even with each other and will need to be repositioned

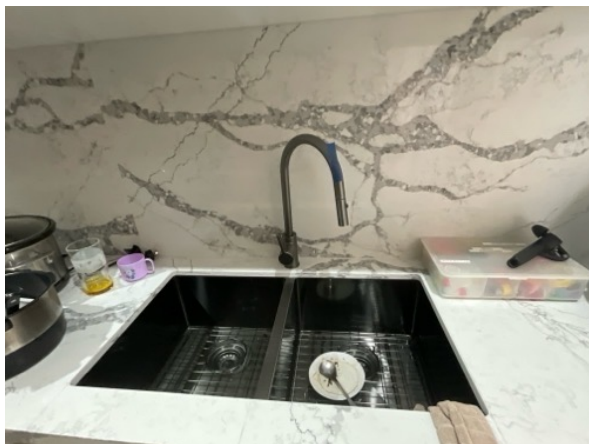
### Incomplete 1.33

**Location:** Kitchen  
**Finding:** Loose tap  
Loose tap to be secured

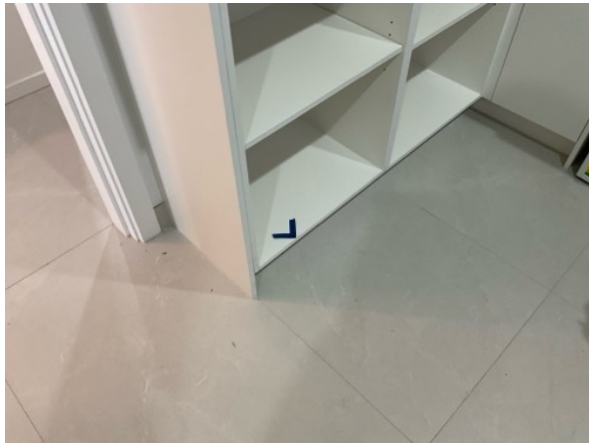
### Incomplete 1.34

**Location:** Laundry  
**Finding:** Missing screw head sticker  
Missing screw head sticker cover to be installed

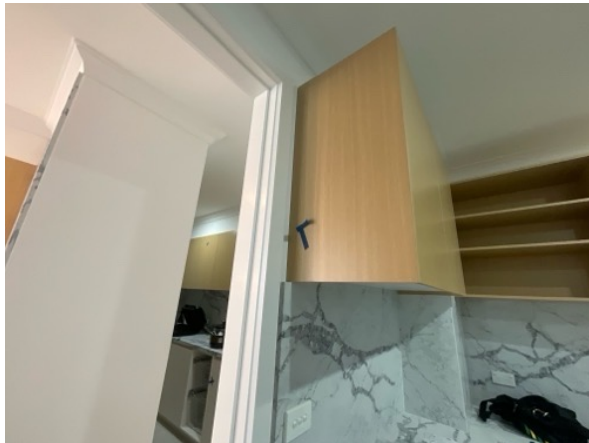
## Incomplete 1.35

**Location:** Laundry

**Finding:** Incomplete silicon to the cabinet  
Incomplete silicon to the cabinet and wall junction

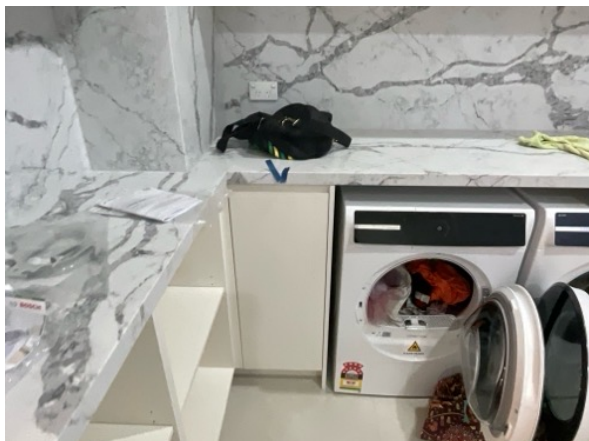
## Incomplete 1.36

**Location:** Laundry

**Finding:** Incomplete silicone to the underside of the bench  
Incomplete silicone to the under side of the bench

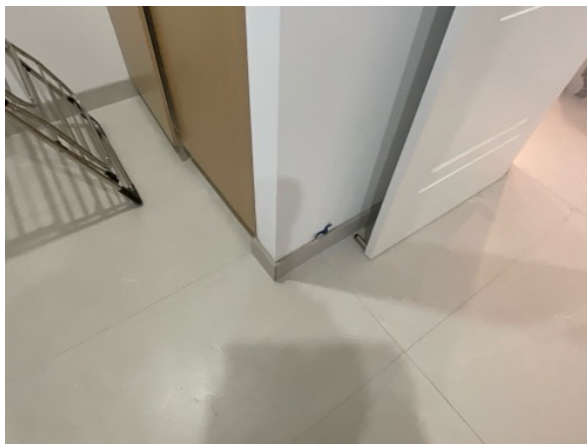
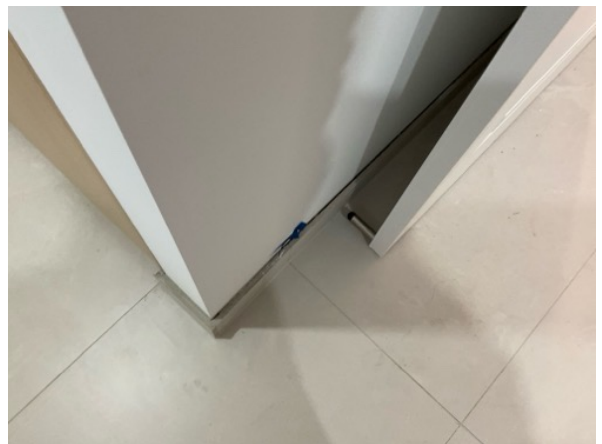
**Finding:** Incomplete silicone to the top of the skirting

Incomplete silicone to the top of the skirting will need completion to restore appearance.

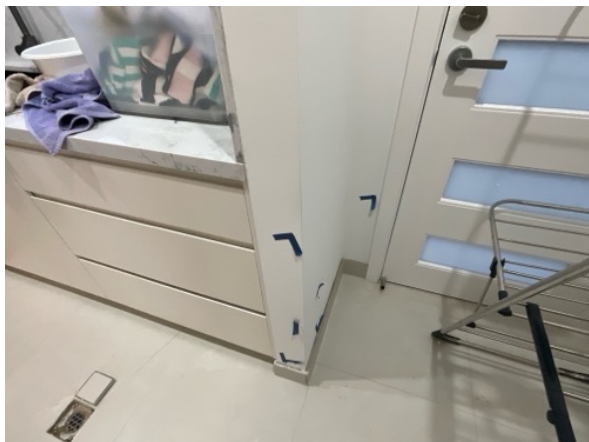
## Incomplete 1.40

**Location:** Laundry

**Finding:** Wall patching is required

Patches are incomplete and will need finishing to a good standard

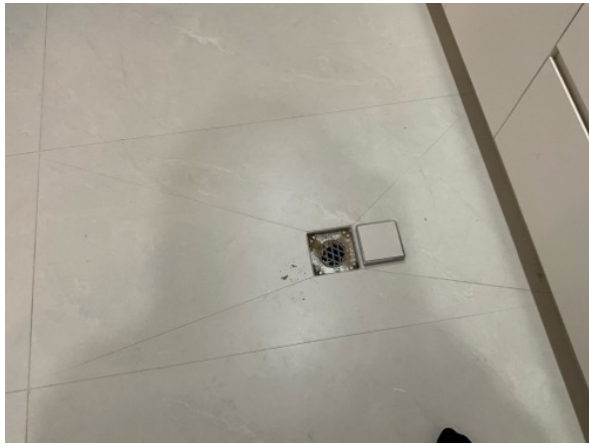
## Incomplete 1.41

**Location:** Laundry

**Finding:** Floor waste

Floor waste to be cleaned

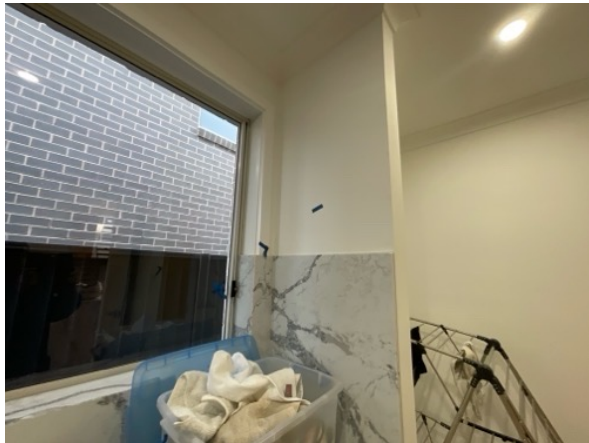
## Incomplete 1.42

**Location:** Laundry

**Finding:** Paint touchups required

Minor paint touchups required as tagged on site to restore appearance

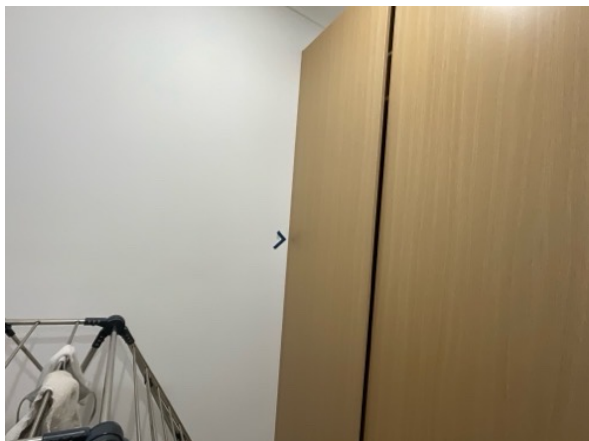
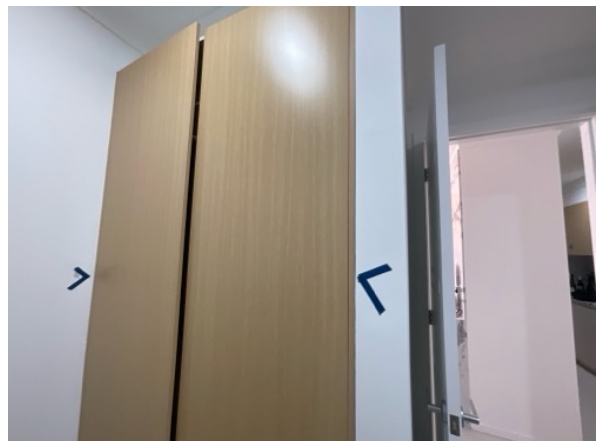
## Incomplete 1.43

**Location:** Laundry

**Finding:** Incomplete silicon to the cupboard

Incomplete silicon to the cupboard and wall junction

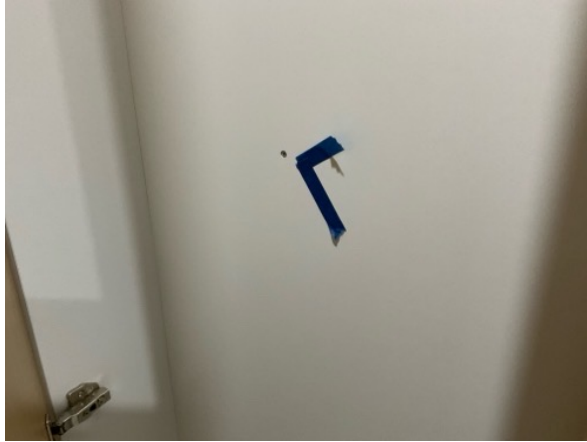
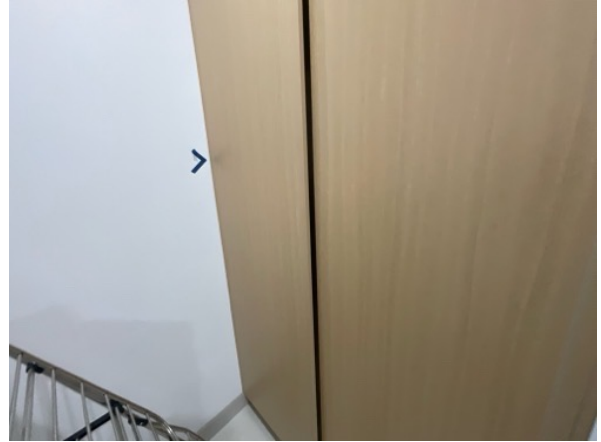
## Incomplete 1.44

**Location:** Laundry

**Finding:** Missing screw head sticker  
Missing screw head sticker cover to be installed

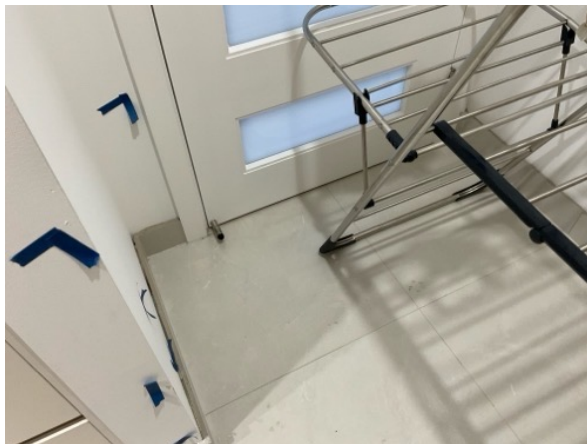
## Incomplete 1.45

**Location:** Laundry

**Finding:** Weather/draft seal  
Weather seal and/or draft seals are missing or inadequate and will need to be repaired or restored to ensure the integrity and water tightness of the door

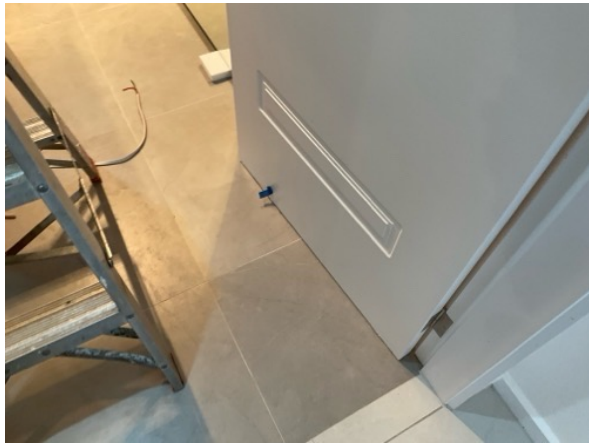
**Location:** WC Lower

**Finding:** Damaged door  
Damaged edge needs repair to restore appearance

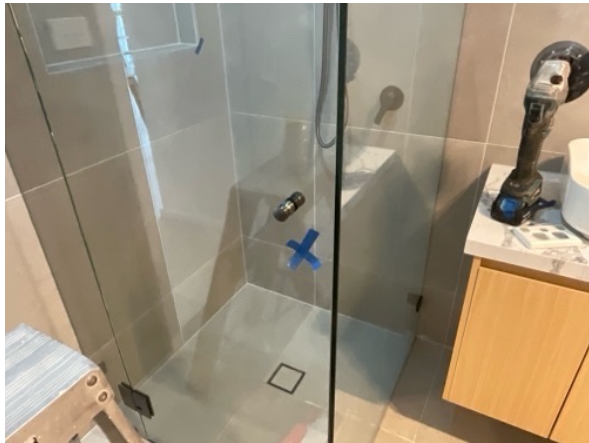
## Incomplete 1.47

**Finding:** Shower screen door is not sitting tight  
Shower screen door is not sitting tight and will need to be repaired

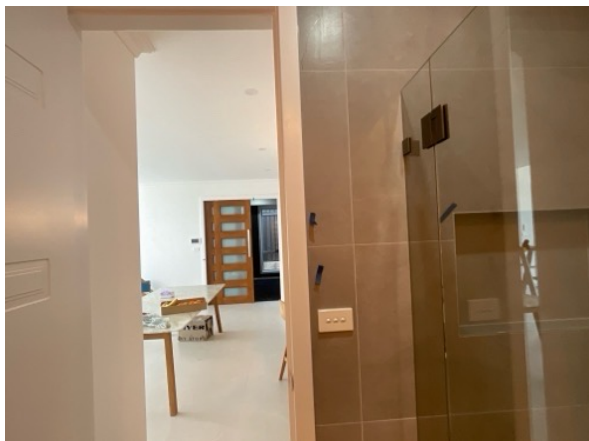
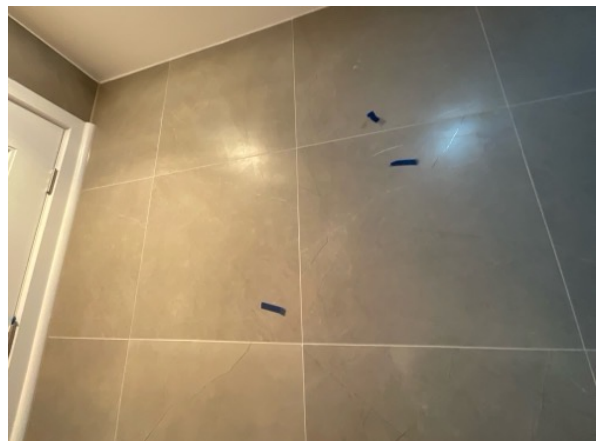
## Incomplete 1.48

**Finding:** Tile surface to be cleaned  
Tile surface to be cleaned to ensure there is no damage
