# Sample Report - Practical Completion Inspection

Inspection Date: 2 Jul 2026

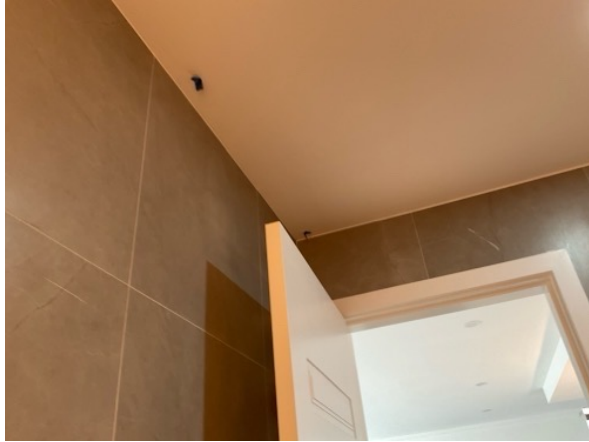
## Incomplete 1.49

**Finding:** Paint touchups required

Minor paint touchups required as tagged on site to restore appearance

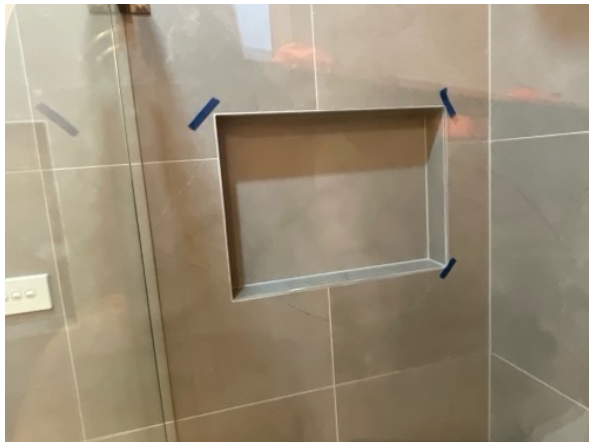
## Incomplete 1.50

**Finding:** Sharp corners to the niche

Sharp corners to the niche will need to be repaired to restore appearance and safety

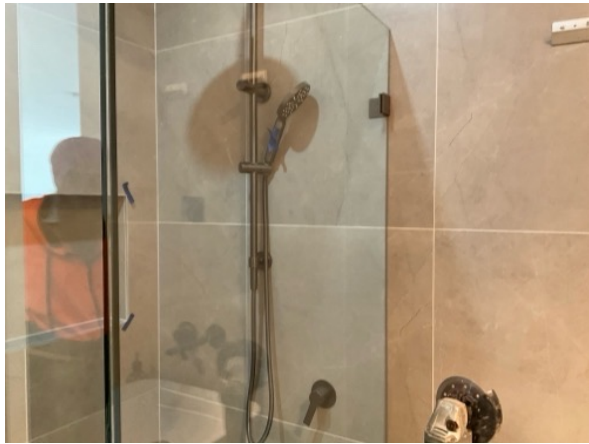
## Incomplete 1.51

**Finding:** Shower rose is loose

Shower rose is loose and will need repair

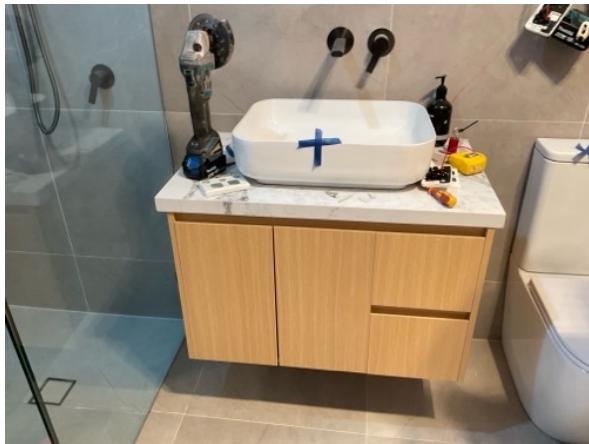
## Incomplete 1.52

**Finding:** Loose basin

The basin was not securely fixed, presenting looseness which may lead to further displacement or damage. Immediate corrective action is recommended to ensure compliance and to maintain the integrity of the installation.

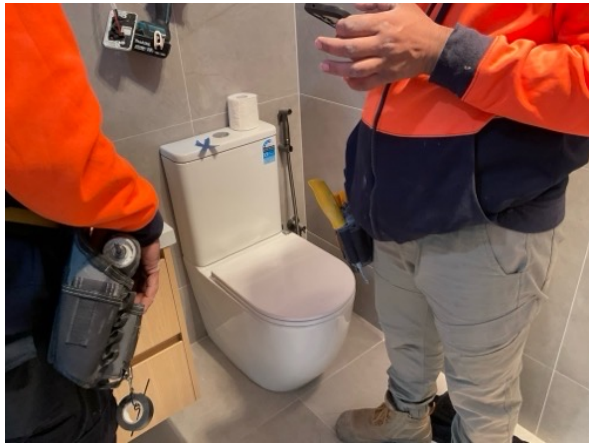
## Incomplete 1.53

**Finding:** Loose toilet system

Loose toilet system to be secured

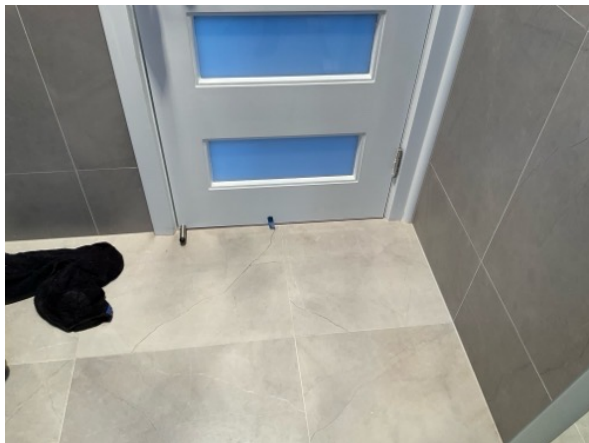
## Incomplete 1.54

**Finding:** Weather/draft seal

Weather seal and/or draft seals are missing or inadequate and will need to be repaired or restored to ensure the integrity and water tightness of the door

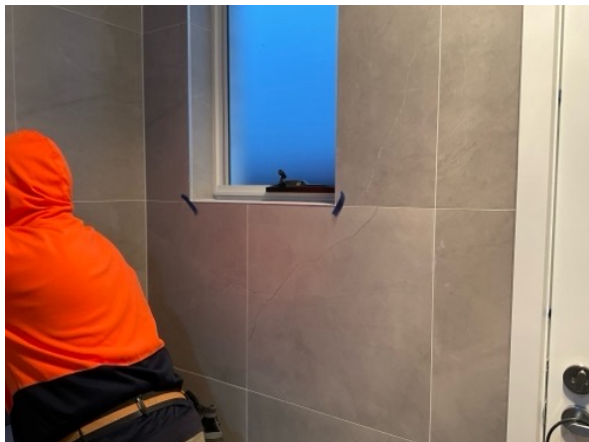
## Incomplete 1.55

**Finding:** Sharp corner to the metal angle

Sharp corner to the metal angle will need to be repaired to restore appearance and safety

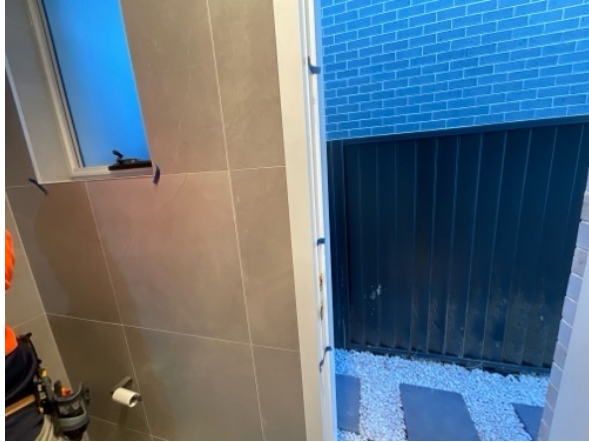
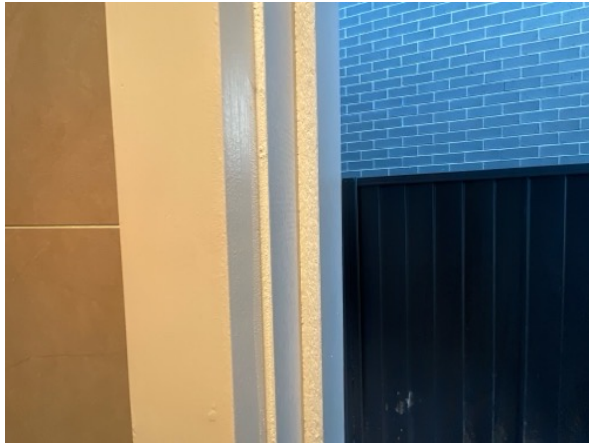
## Incomplete 1.56

**Finding:** Damaged door jam

Damaged door jam will need repair to restore appearance

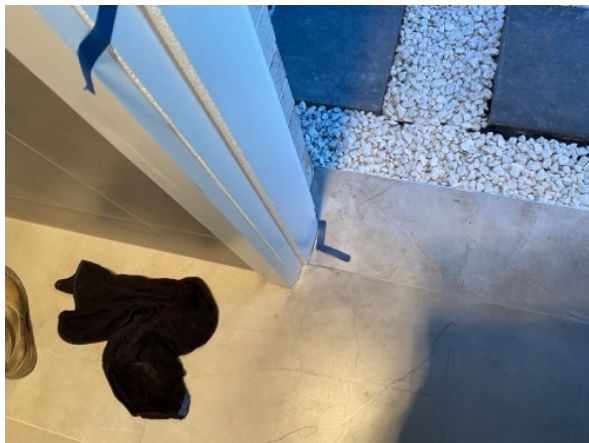
## Incomplete 1.57

**Finding:** Incomplete silicon/grout to the floor

Incomplete silicon to the to floor to be completed to restore appearance

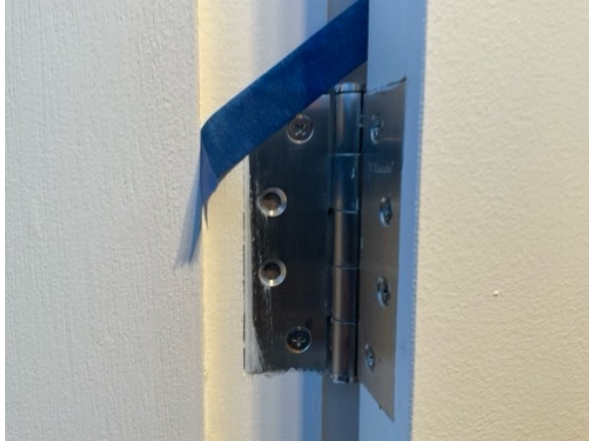
## Incomplete 1.58

**Location:** WC Lower  
**Finding:** Door hinge  
Missing screws to the hinges

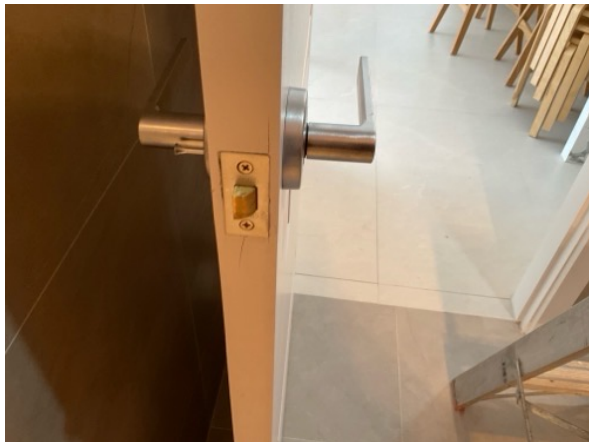
## Incomplete 1.59

**Location:** WC Lower  
**Finding:** Damaged door  
Damaged edge needs repair to restore appearance

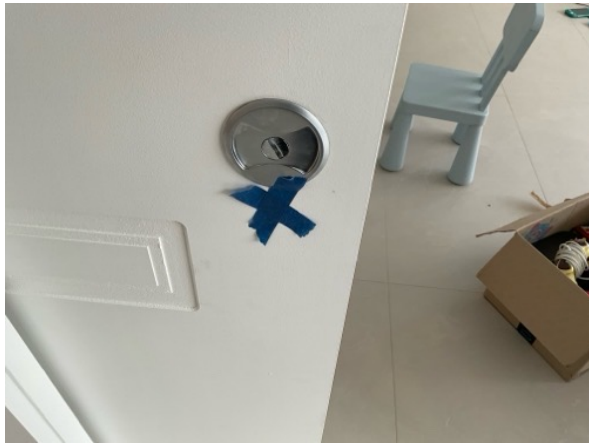
## Incomplete 1.60

**Location:** Rumpus  
**Finding:** Door handle will need replacing as it is unable to be easily opened  
Door handle will need replacing as it is unable to be easily opened

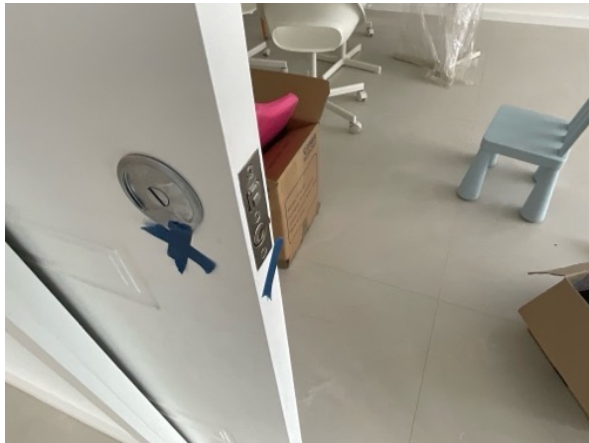
## Incomplete 1.61

**Finding:** Damaged door

Damaged edge needs repair to restore appearance

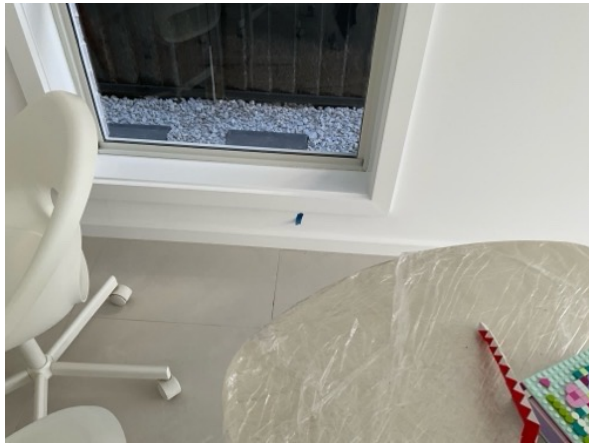
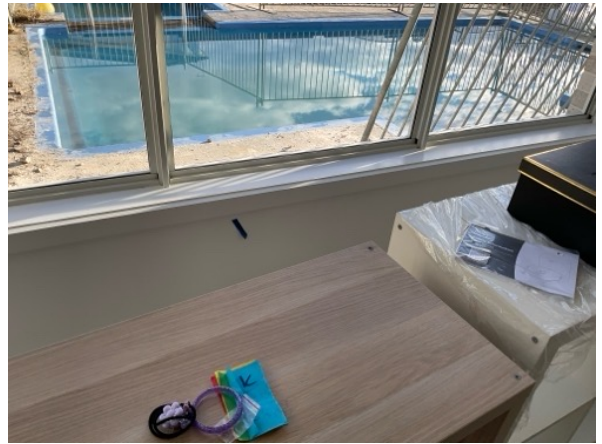
**Finding:** Underside of the architrave to be sealed

Underside of the window architraves to be sealed

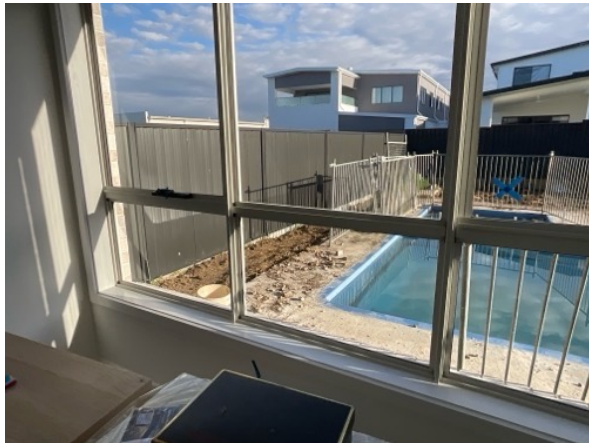
## Incomplete 1.64

**Finding:** Window/door frame to be cleaned  
Window/door frame to be cleaned to ensure no damage.

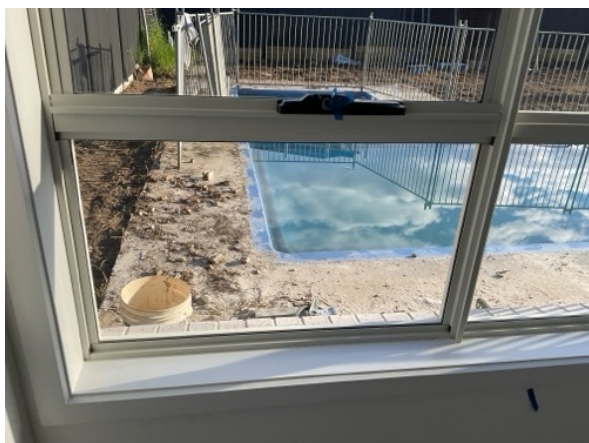
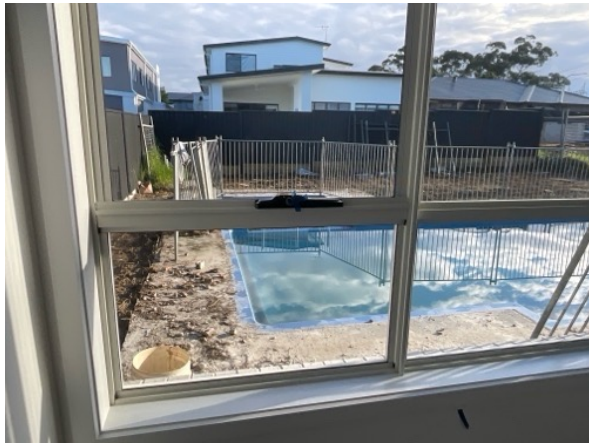
## Incomplete 1.65

**Finding:** Window lock is loose  
The window lock is loose and will need to be secured.

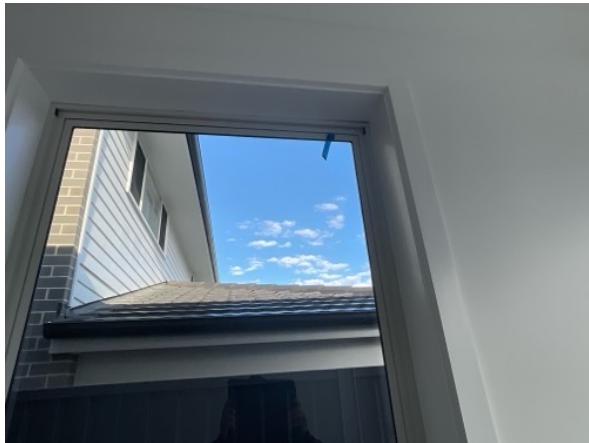
## Incomplete 1.66

**Finding:** Window frame is missing silicon  
Missing silicon between the frame and the reveal

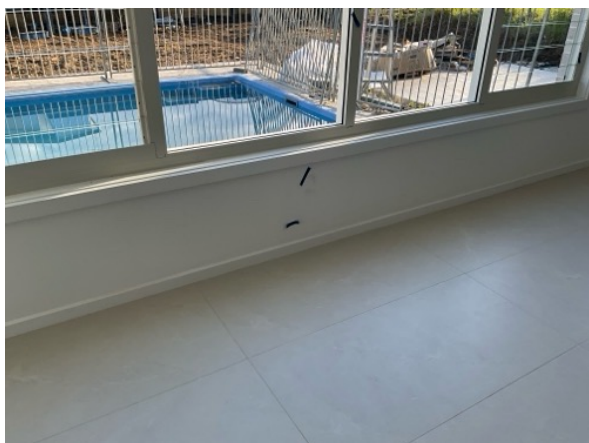
## Incomplete 1.67

**Finding:** Underside of the architrave to be sealed  
Underside of the window architraves to be sealed

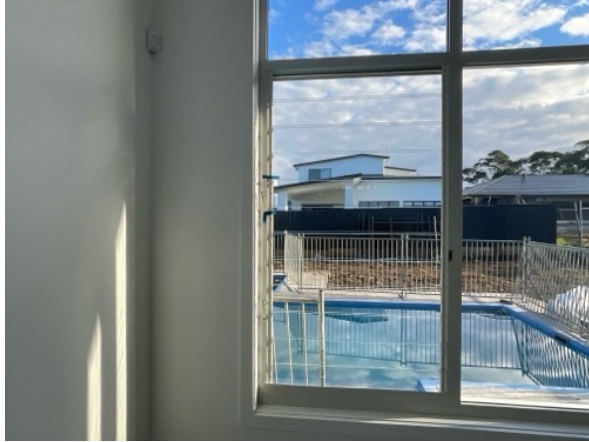
## Incomplete 1.68

**Finding:** Window frame is missing silicon  
Missing silicon between the frame and the reveal

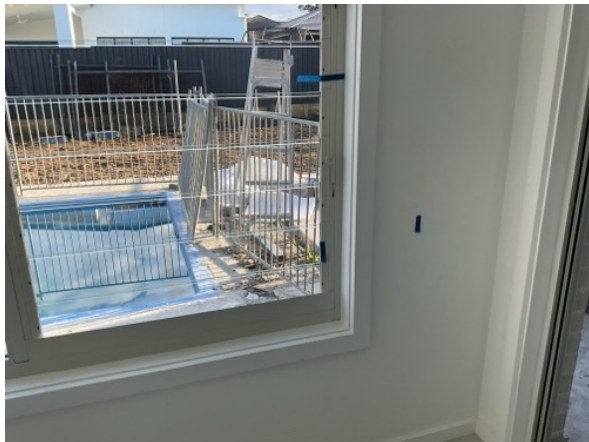
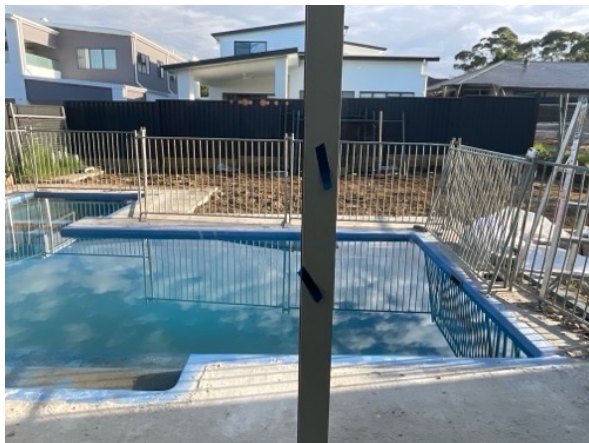
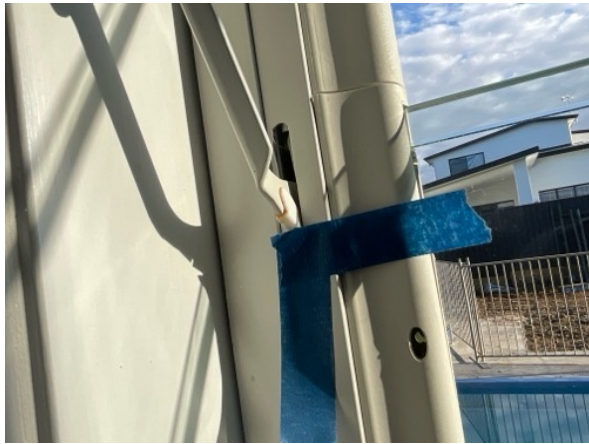
## Incomplete 1.69

**Finding:** Window/door frame to be cleaned  
Window/door frame to be cleaned to ensure no damage.

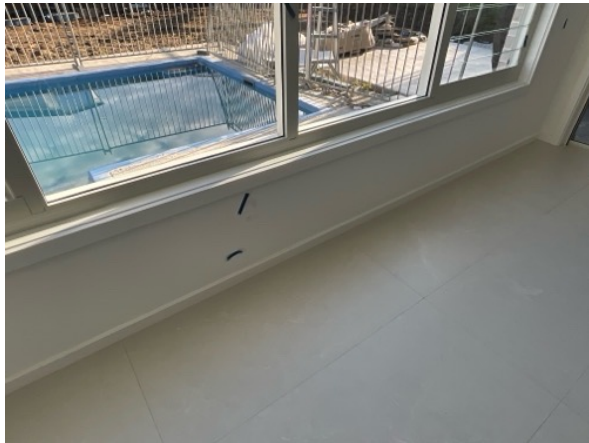
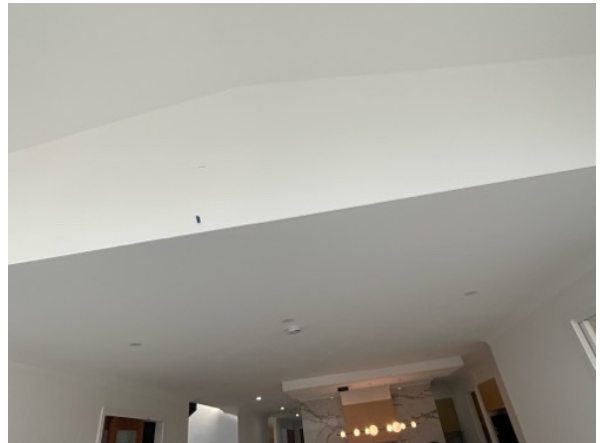
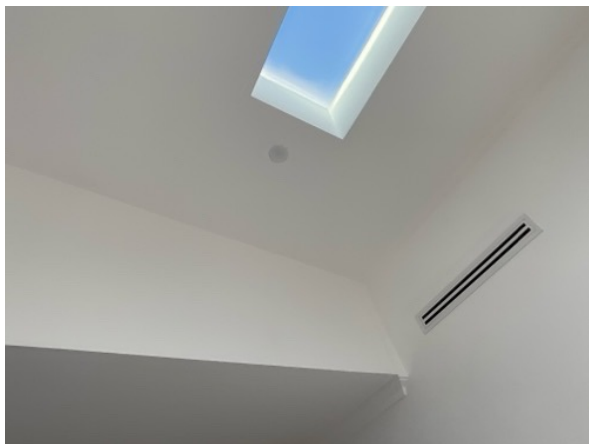
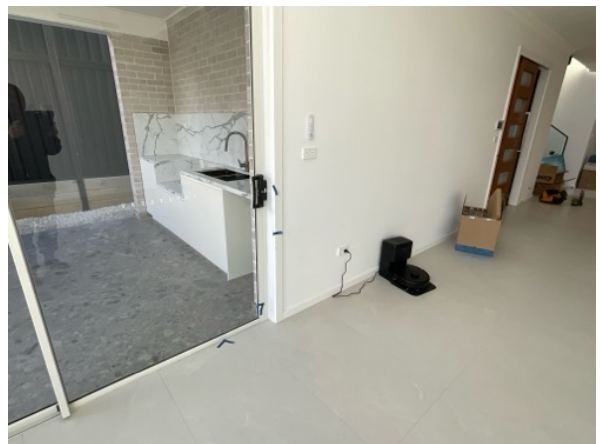
## Incomplete 1.70

**Finding:** Paint touchups required

Minor paint touchups required as tagged on site to restore appearance

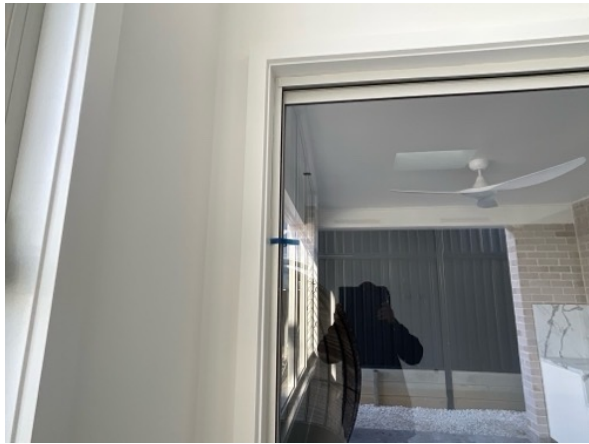
## Incomplete 1.71

**Finding:** Door frame is missing silicon

Missing silicon between the frame and the jam

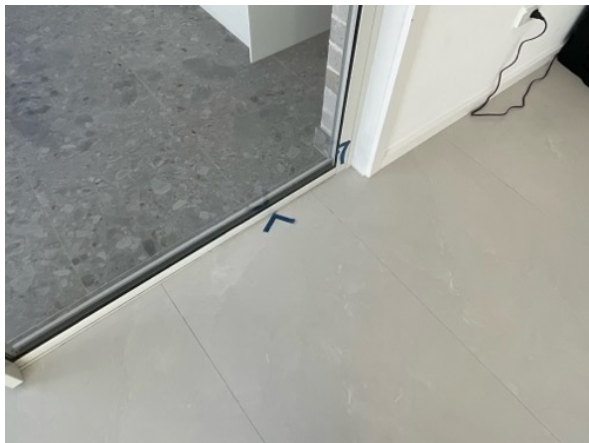
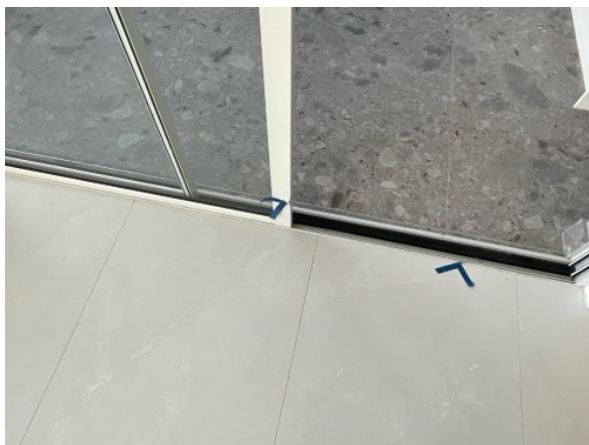
## Incomplete 1.72

**Finding:** Damaged door frame

It was observed that the track and door frame have sustained noticeable damage, impacting the overall aesthetic and function.

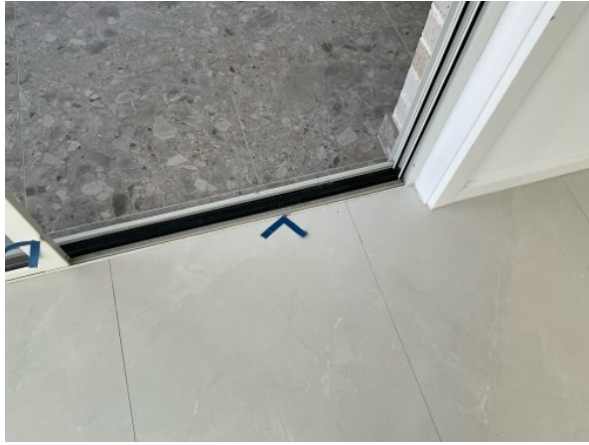
## Incomplete 1.73

**Finding:** Poorly finished silicone

Poorly finished silicone will need repair to restore appearance

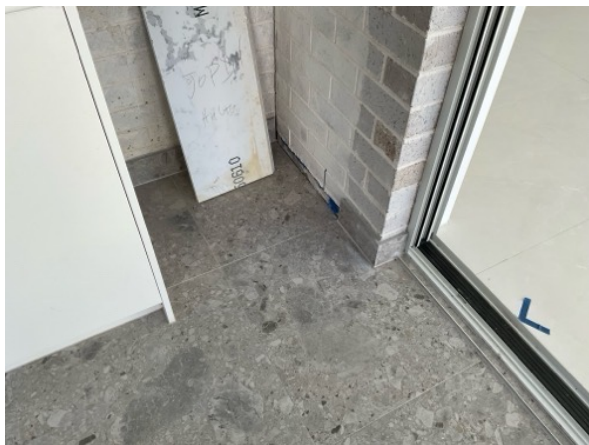
## Incomplete 1.74

**Location:** Alfresco  
**Finding:** Skirting tile  
Incomplete skirting tiles

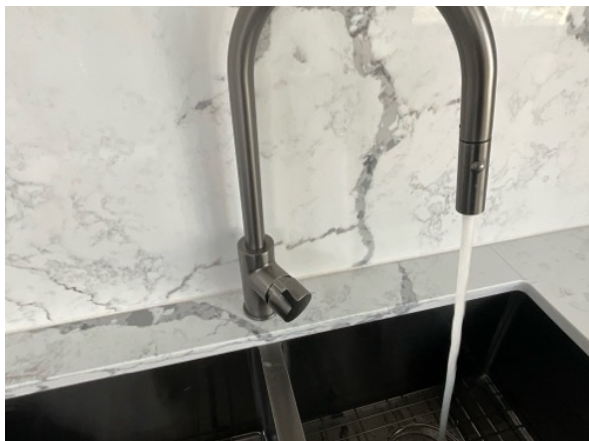
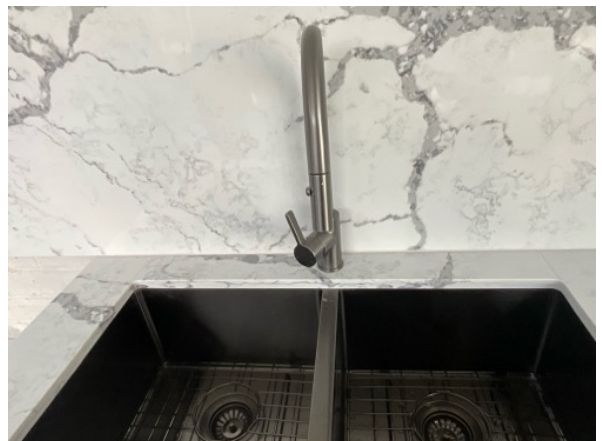
## Incomplete 1.75

**Location:** Alfresco  
**Finding:** Loose tap  
Loose tap to be secured

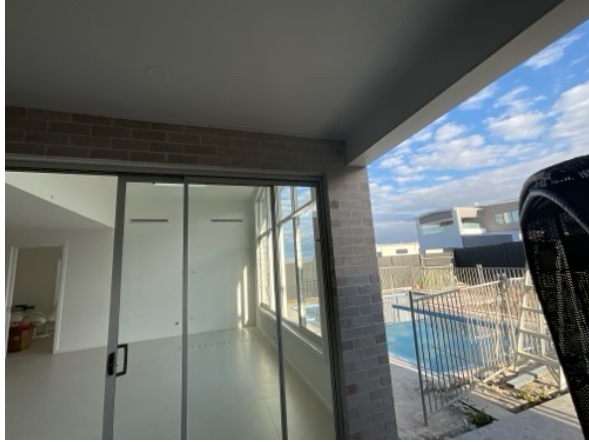
**Finding:** Missing or incomplete storm mould to the door/window frame

Missing or incomplete storm mould around the window/door frame will need repair to ensure adequate water tightness and appearance

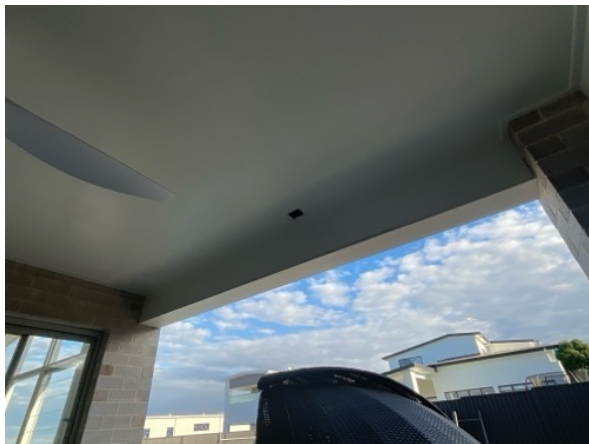
## Incomplete 1.77

**Location:** Alfresco

**Finding:** Ceiling patches required

Patches to the ceiling are required to restore appearance

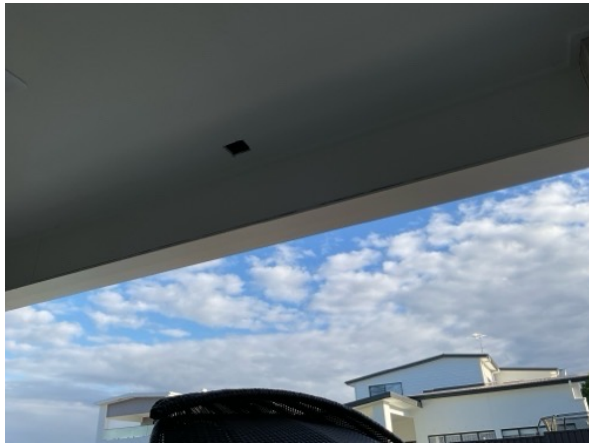
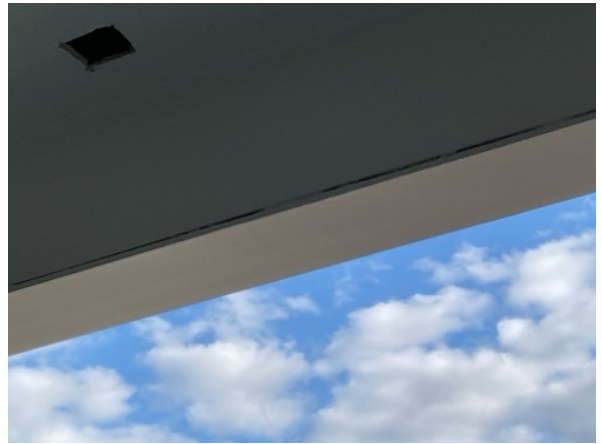
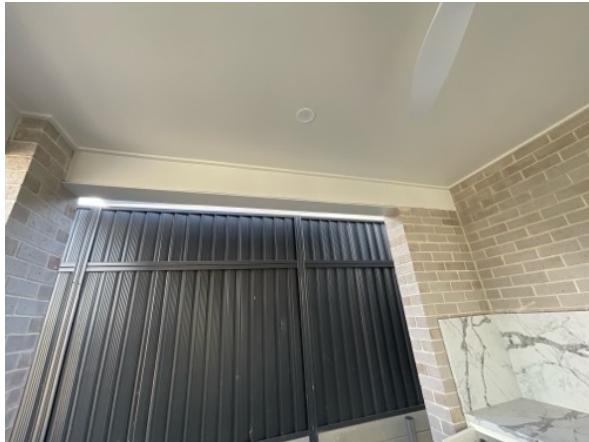
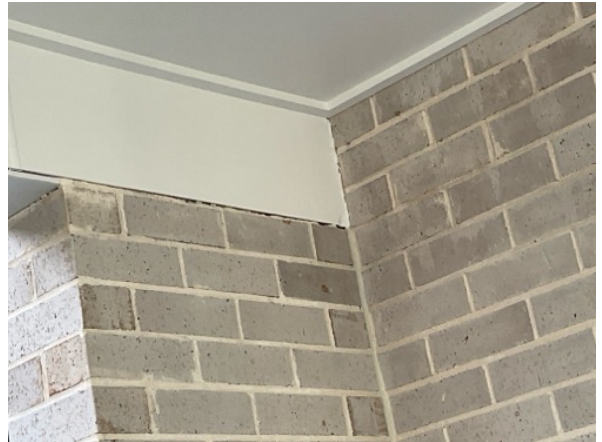
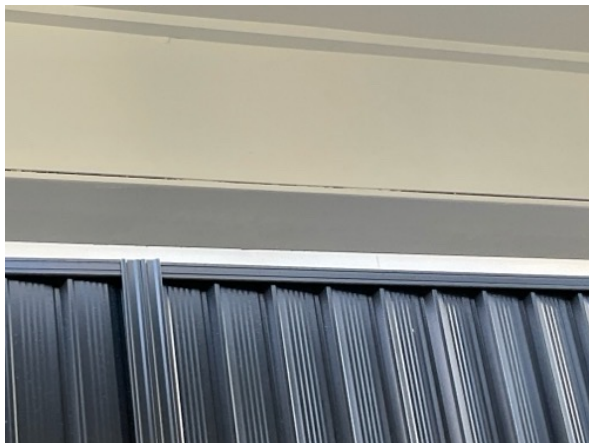
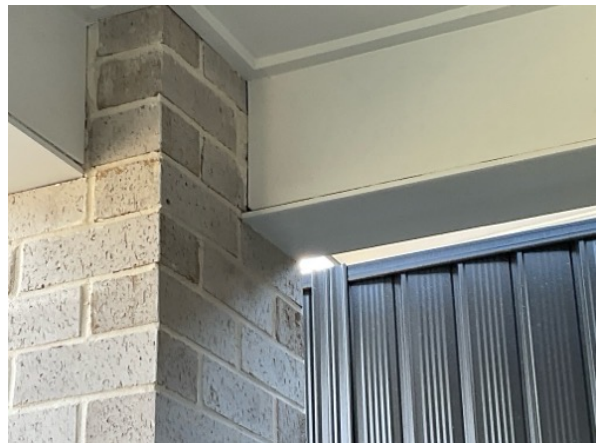
## Incomplete 1.78

**Location:** Alfresco

**Finding:** Joint patching to the wall/ceiling is required

Joint patches are incomplete and will need finishing to a good standard

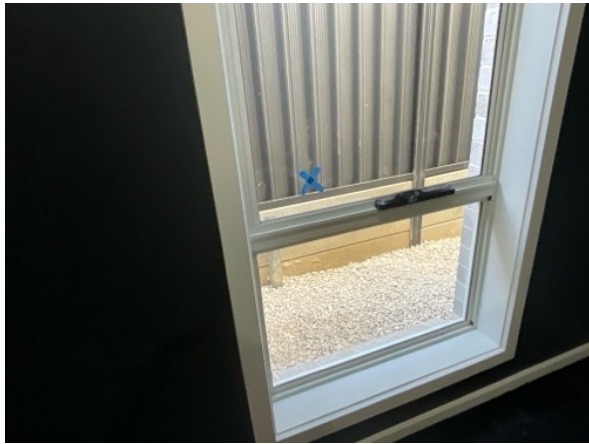
## Incomplete 1.79

**Location:** Media

**Finding:** Window is binding

The window is currently binding and will need adjustment and servicing. To resolve this defect, it is recommended that a window servicing is carried out to restore smooth operation of the openable portion of the window.

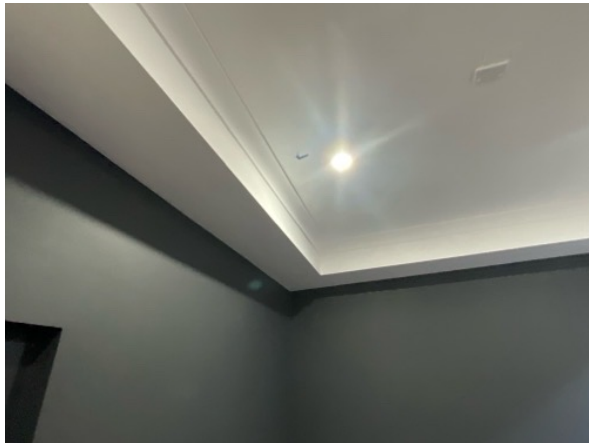
## Incomplete 1.80

**Location:** Media

**Finding:** Popped nail to the wall/ceiling  
Popped nail heads to the wall/ceiling to be repaired to restore appearance

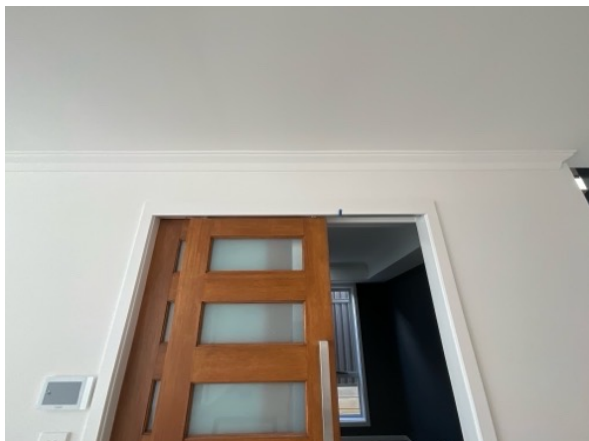
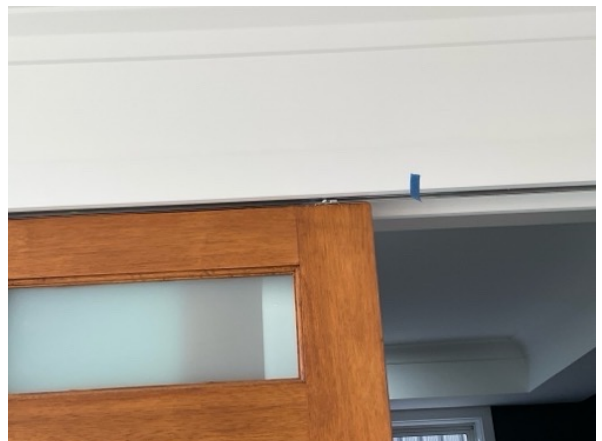
## Incomplete 1.81

**Location:** Media

**Finding:** Pelmet to doors  
Missing pelmet to the doors

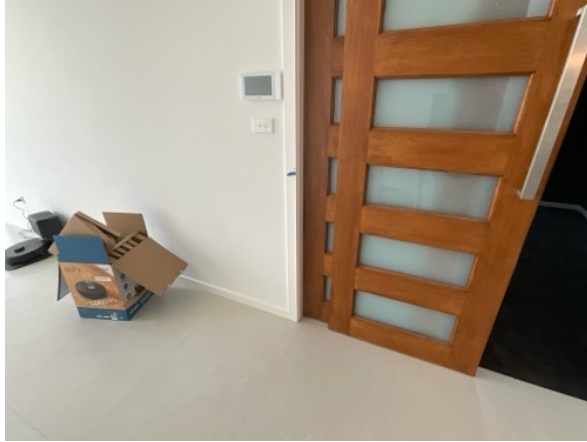
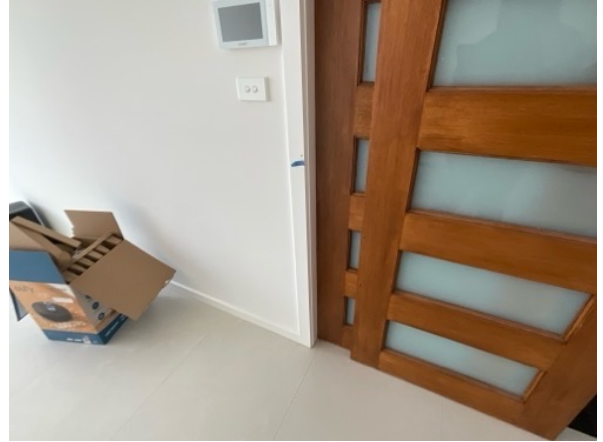
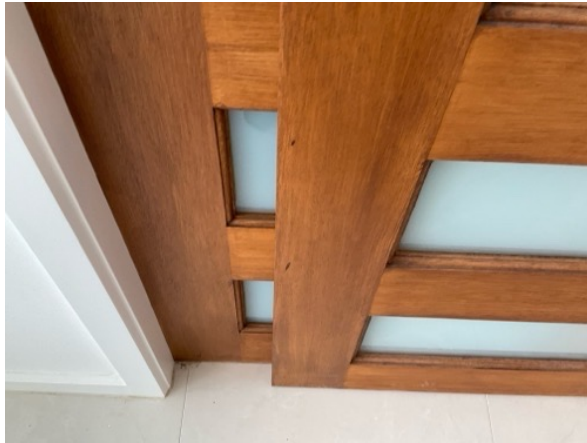
## Incomplete 1.82

**Location:** Media

**Finding:** Paint touchups required

Minor paint touchups required to restore appearance

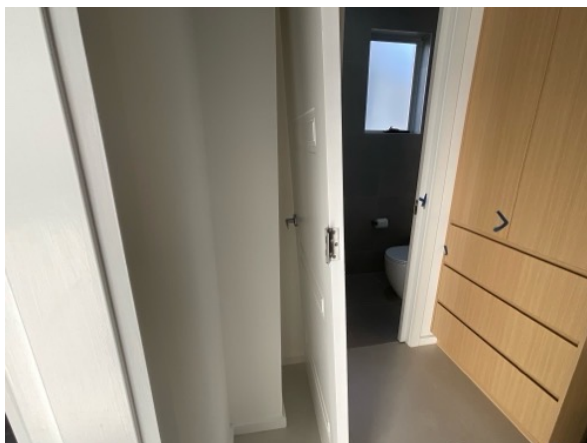
## Incomplete 1.83

**Location:** Bedroom 1

**Finding:** Door to be installed

Door to be installed

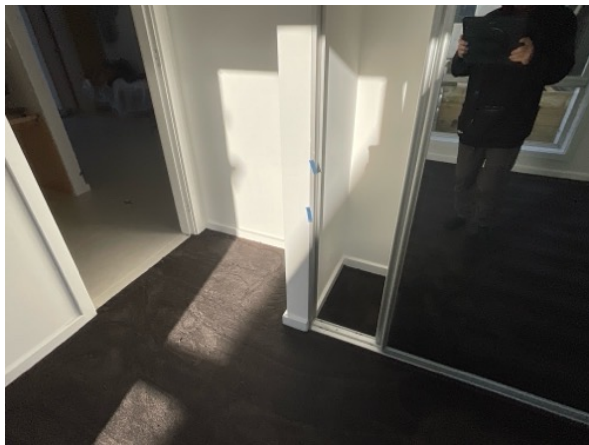
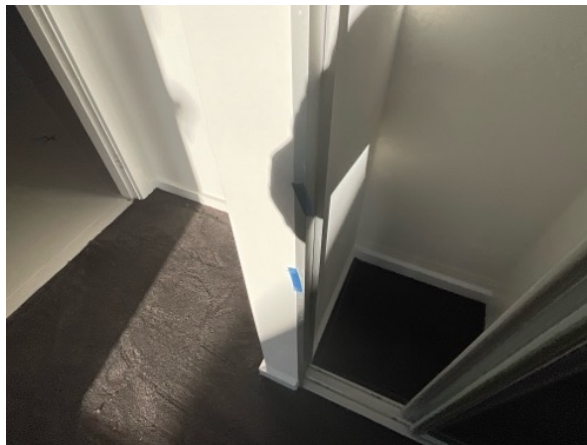
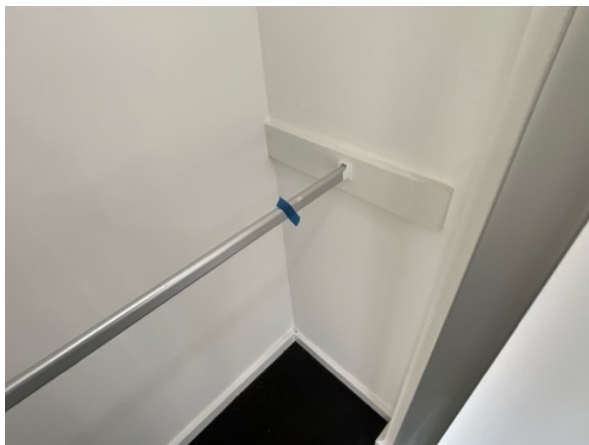
## Incomplete 1.84

**Location:** Bedroom 1

**Finding:** Robe surfaces to be cleaned  
Paint to be cleaned off the robe surfaces

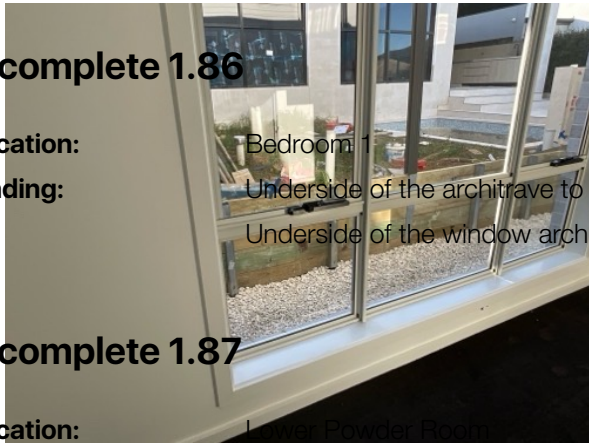
Underside of the architrave to be sealed

Underside of the window architraves to be sealed

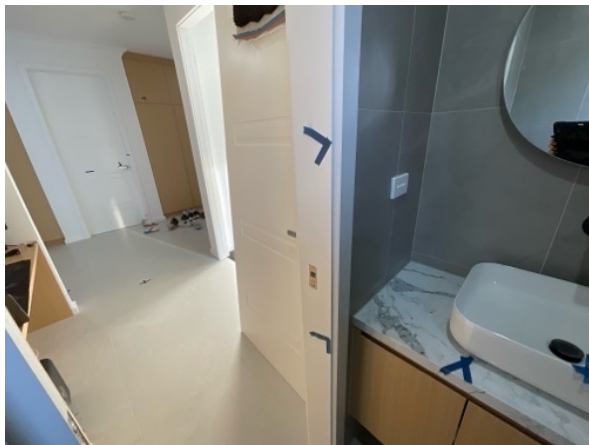
## Incomplete 1.87

Damaged door jam

Damaged door jam will need repair to restore appearance

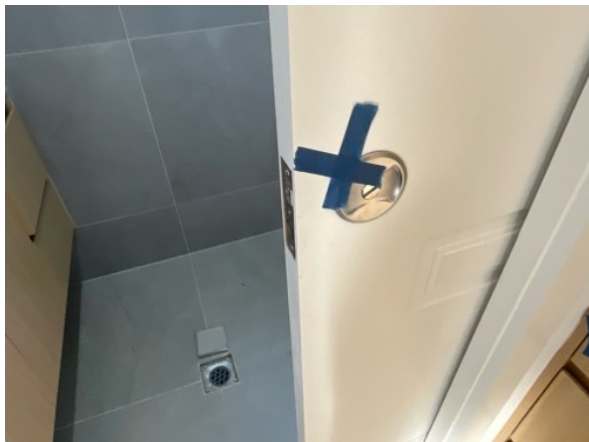
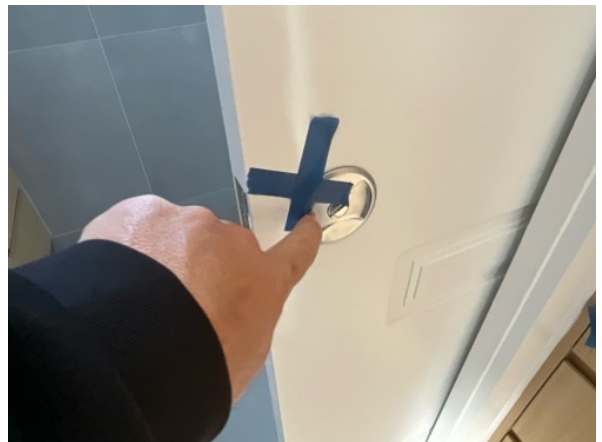
## Incomplete 1.88

Door handle will need replacing as it is unable to be easily opened

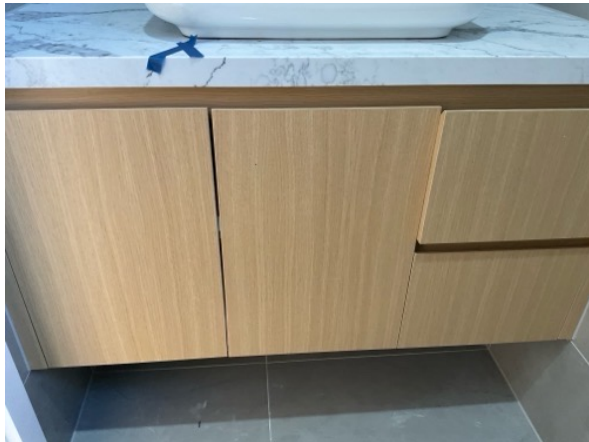
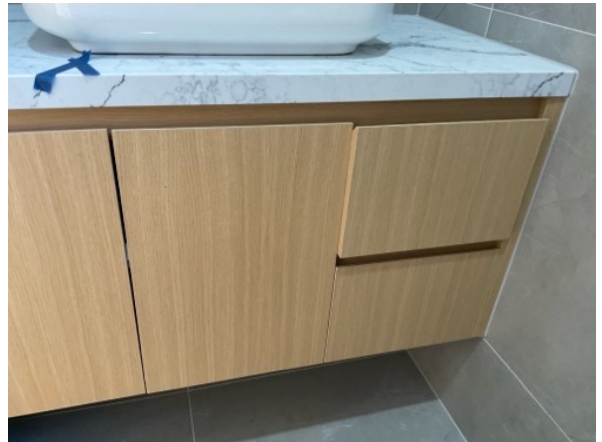
## Incomplete 1.89

Lower Powder Room

**Finding:** Cabinet doors are binding  
Cabinet door are binding and will need adjusting

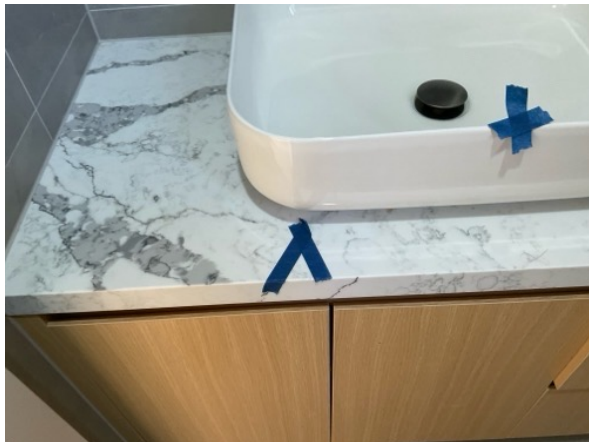
## Incomplete 1.90

**Location:** Lower Powder Room  
**Finding:** Basin  
Incomplete silicon to the base of the basin

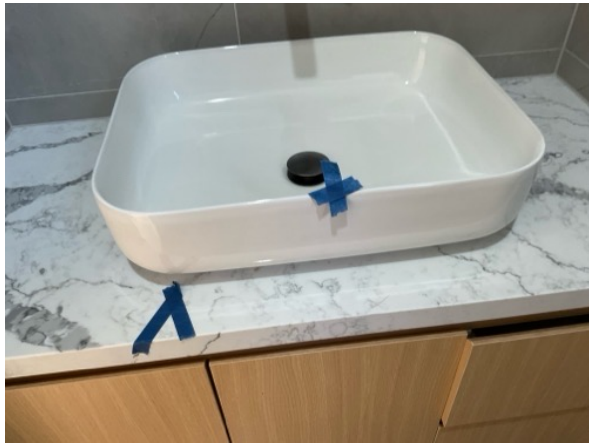
## Incomplete 1.91

**Location:** Lower Powder Room  
**Finding:** Slow draining basin

It has been observed that the basin is experiencing slow drainage. This issue suggests a potential blockage or other underlying problem within the plumbing system that requires further investigation. It is important to address this defect promptly to prevent any possible escalation, which could lead to more significant plumbing issues or water damage. A qualified professional should be engaged to thoroughly assess the situation, identify the root cause, and recommend the necessary corrective measures to restore proper drainage functionality.

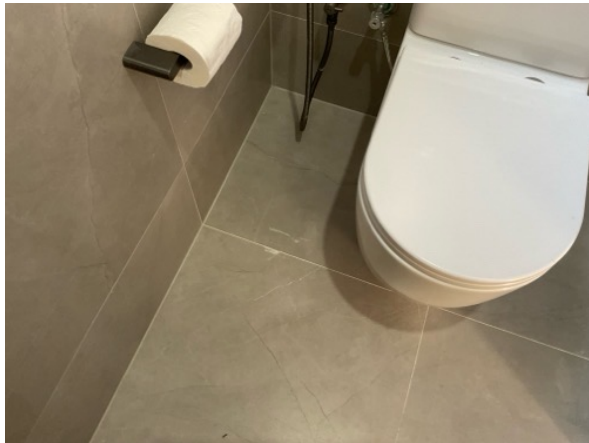
## Incomplete 1.92

**Location:** Lower Powder Room

**Finding:** Tile surface to be cleaned  
Tile surface to be cleaned to ensure there is no damage

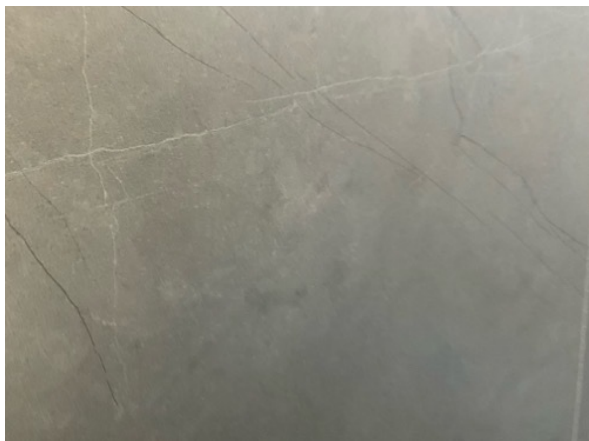
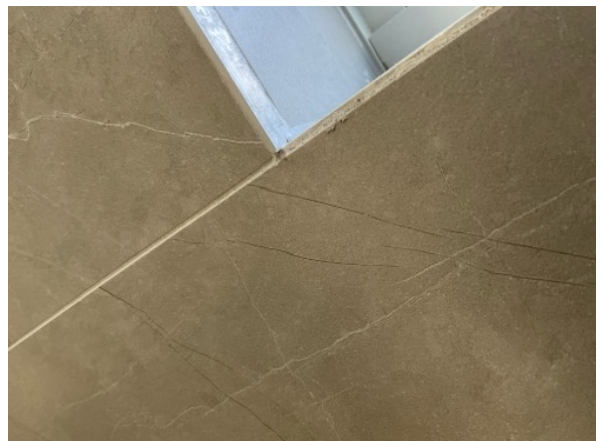
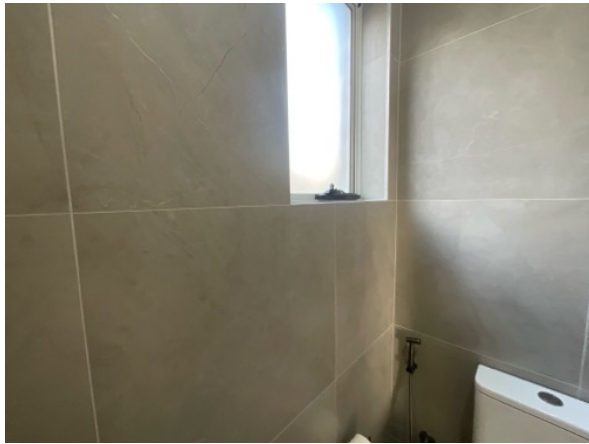
## Incomplete 1.93

**Location:** Lower Powder Room

**Finding:** Sharp corner to the metal angle  
Sharp corner to the metal angle will need to be repaired to restore appearance and safety

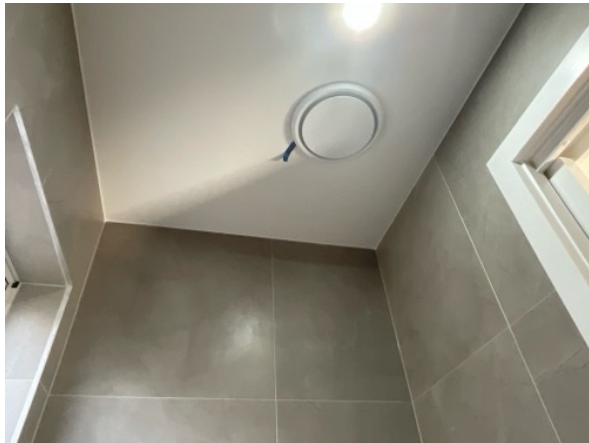
## Incomplete 1.94

**Location:** Lower Powder Room

**Finding:** Exhaust fan  
Exhaust fan is not sitting tight to the ceiling

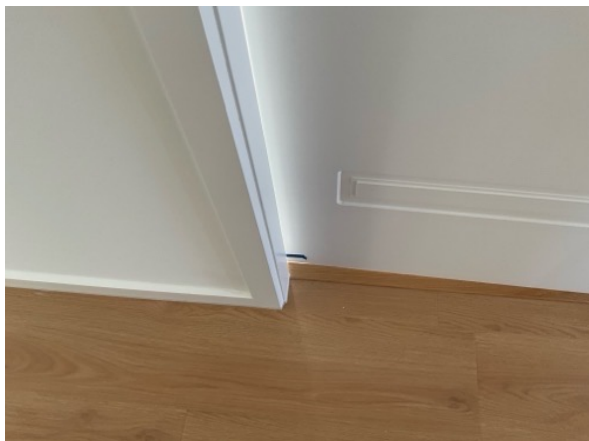
## Incomplete 1.95

**Location:** Bedroom 5

**Finding:** Damaged door  
Damaged edge needs repair to restore appearance

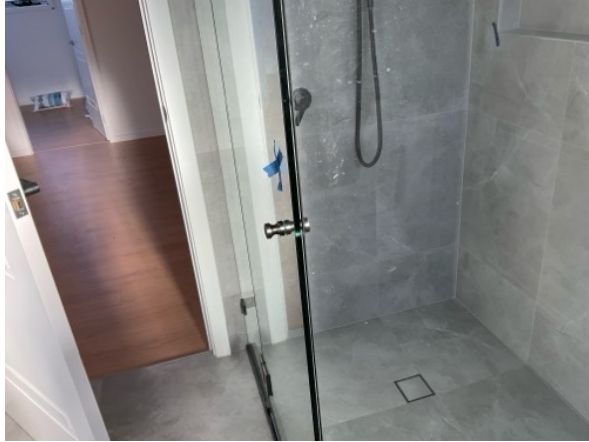
## Incomplete 1.96

**Location:** Bathroom

**Finding:** Shower screen door is not sitting tight  
Shower screen door is not sitting tight and will need to be repaired

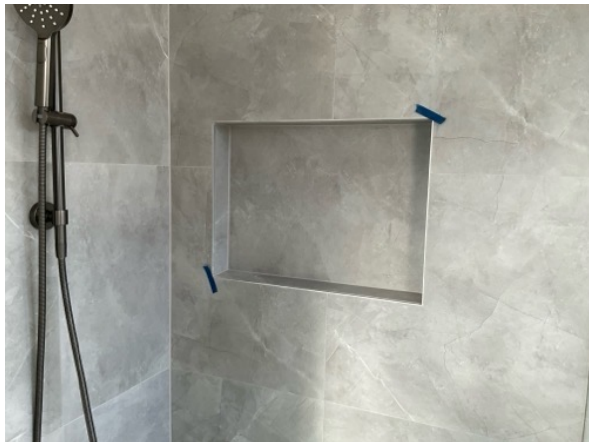
## Incomplete 1.97

**Location:** Bathroom

**Finding:** Sharp corners to the niche  
Sharp corners to the niche will need to be repaired to restore appearance and safety

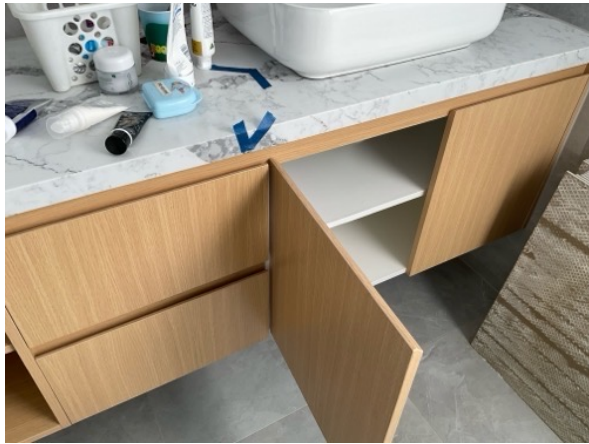
## Incomplete 1.98

**Location:** Bathroom

**Finding:** Underside of the vanity benchtop to be sealed  
Missing or incomplete silicone to the underside of the vanity benchtop

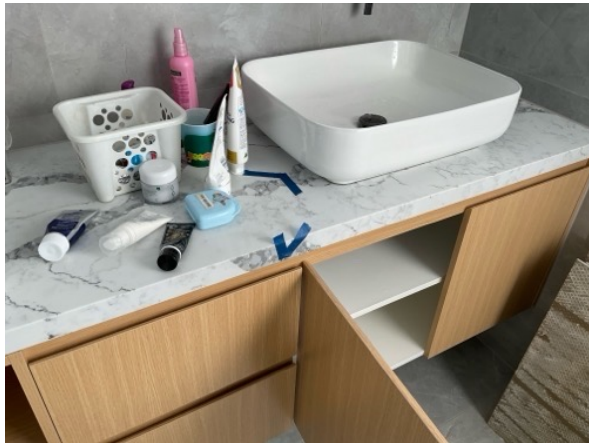
## Incomplete 1.99

**Location:** Bathroom

**Finding:** Basin  
Incomplete silicon to the base of the basin

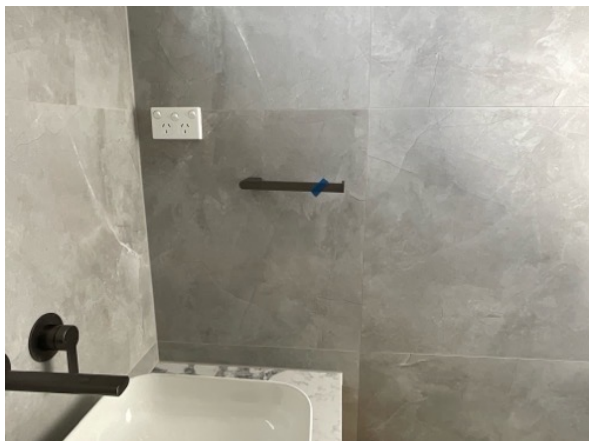
## Incomplete 2.00

**Location:** Bathroom

**Finding:** Towel rail is loose  
Towel rail will need to be secured

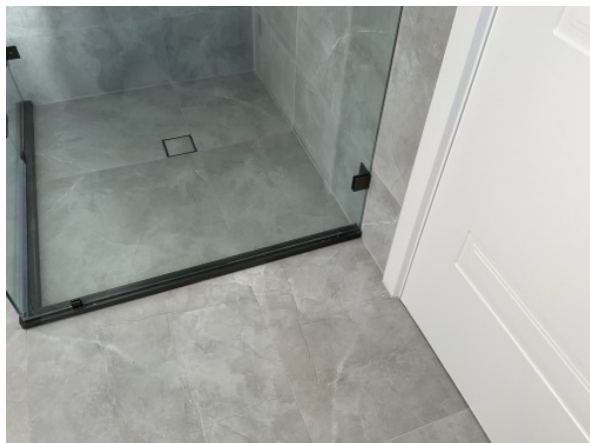
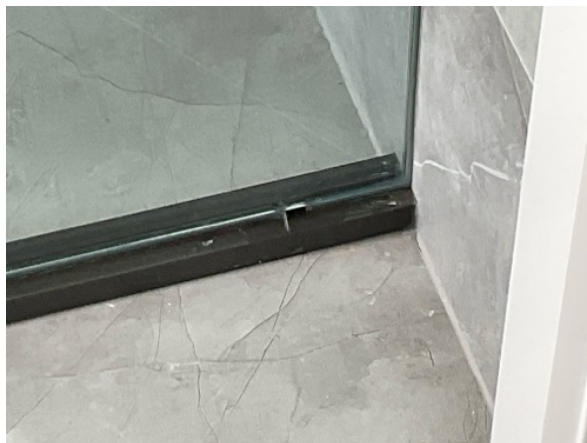
## Incomplete 2.01

**Location:** Bathroom

**Finding:** Leaking screen

The shower screen exhibits leakage at the base. Water seepage may cause potential damage to surrounding structures and finishes, leading to further deterioration if not addressed promptly. The deficiency indicates inadequate sealing or deterioration of existing seals.

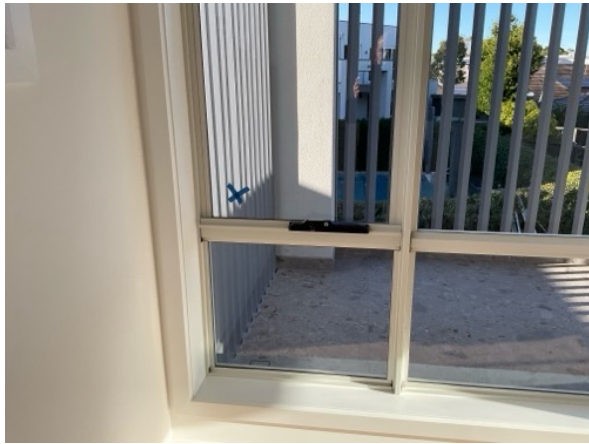
## Incomplete 2.04

**Location:** Bedroom 4

**Finding:** Underside of the architrave to be sealed  
Underside of the window architraves to be sealed

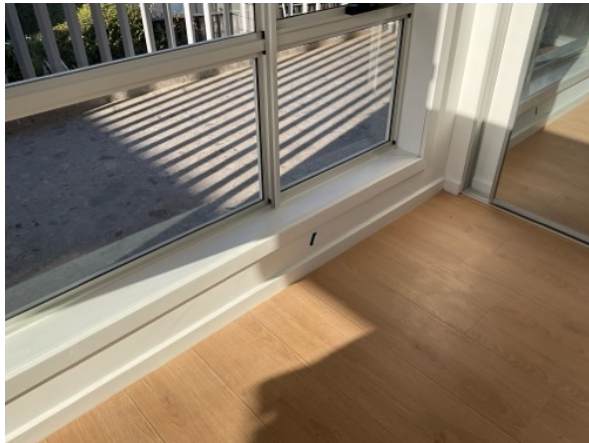
## Incomplete 2.05

**Location:** Bedroom 4

**Finding:** Damaged reveal  
Damaged reveal to be repaired

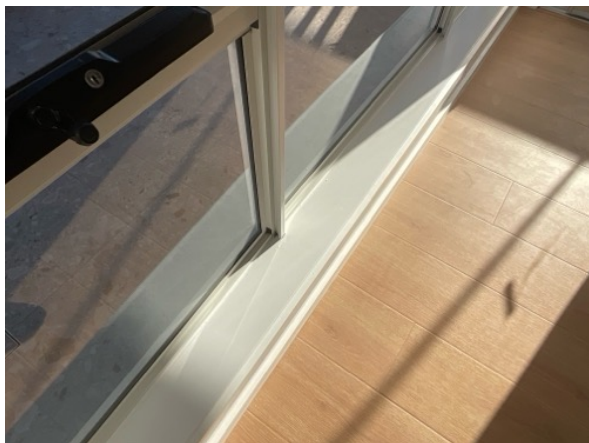
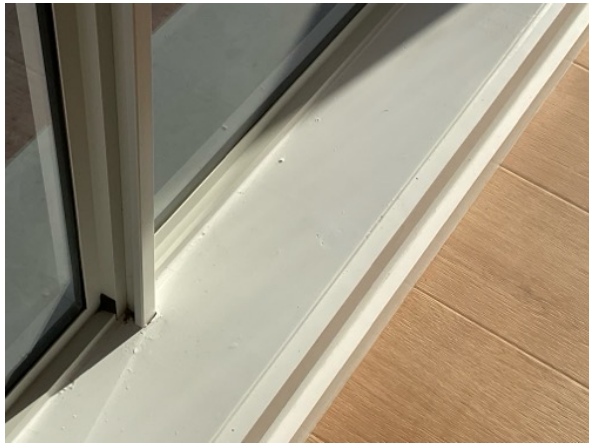
## Incomplete 2.06

**Location:** Bedroom 4

**Finding:** Incomplete silicone to the end of the skirting  
Incomplete silicone to the end of the skirting
