# Sample Report - Practical Completion Inspection

Inspection Date: 2 Jul 2026

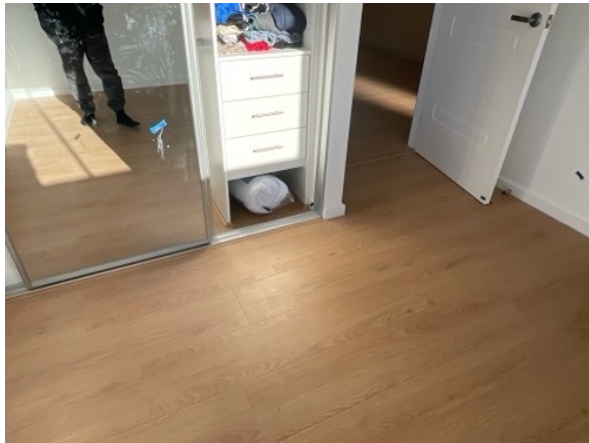
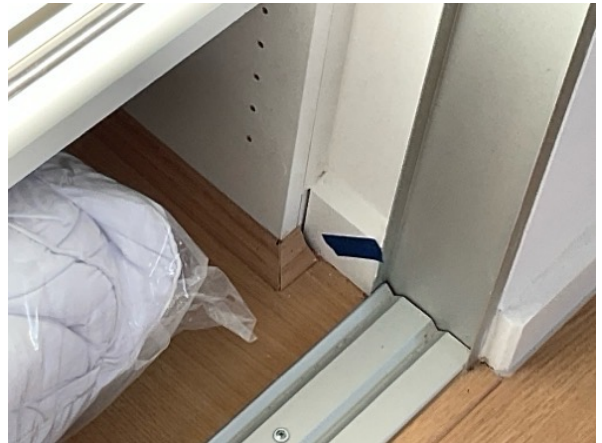
## Incomplete 2.07

**Location:** Bedroom 4

**Finding:** Mirror surface to be cleaned  
Mirror surface to be cleaned to ensure no damage

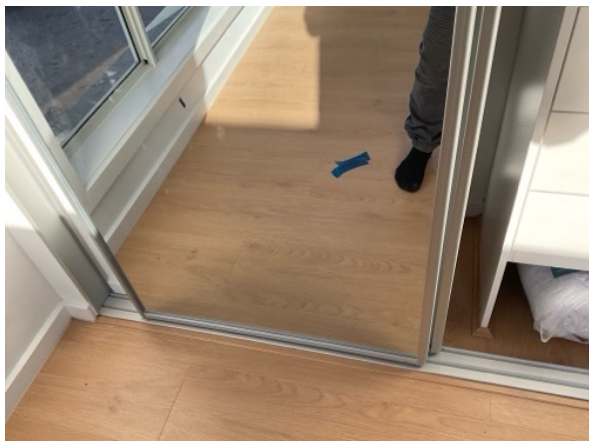
## Incomplete 2.08

**Location:** Bedroom 4

**Finding:** Damaged cabinet edge

Damaged cabinet edge will need repair to restore appearance

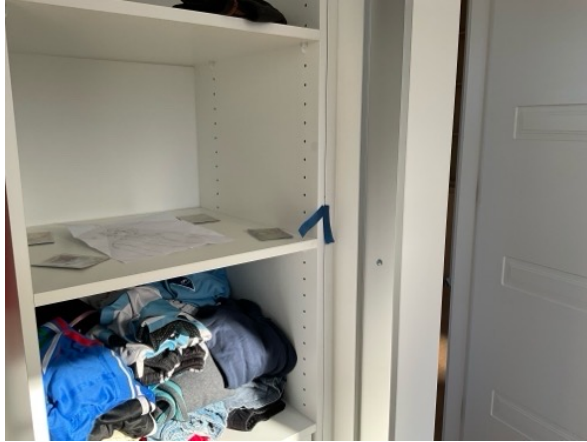
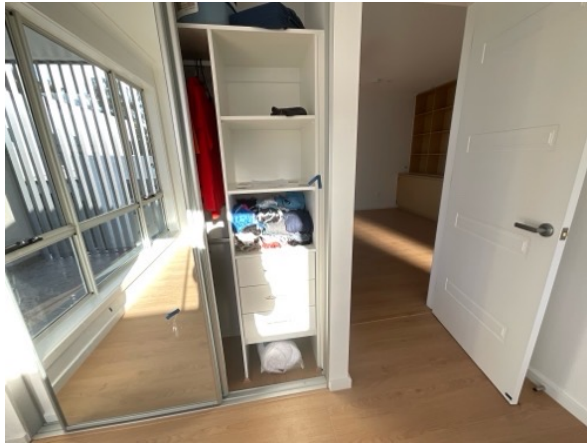
## Incomplete 2.09

**Location:** Bedroom 4

**Finding:** Paint touchups required

Minor paint touchups required as tagged on site to restore appearance

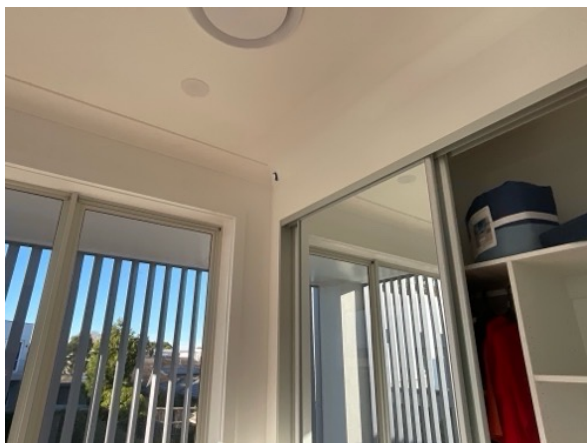
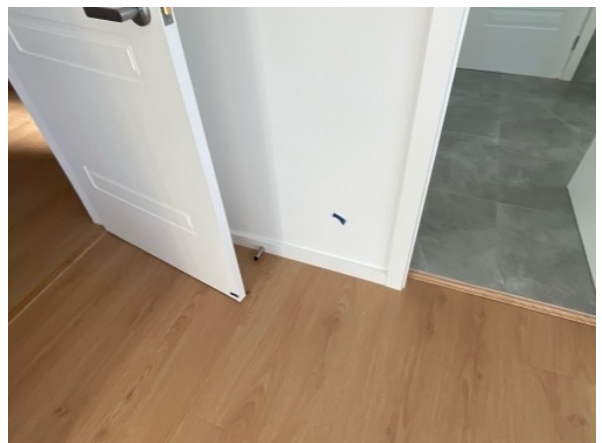
## Incomplete 2.10

**Location:** Leisure

**Finding:** Paint touchups required

Minor paint touchups required as tagged on site to restore appearance

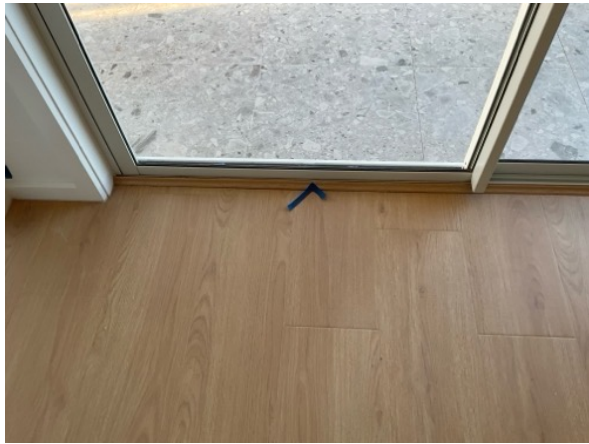
## Incomplete 2.16

**Location:** Leisure

**Finding:** Window/door frame to be cleaned  
Window/door frame to be cleaned to ensure no damage.

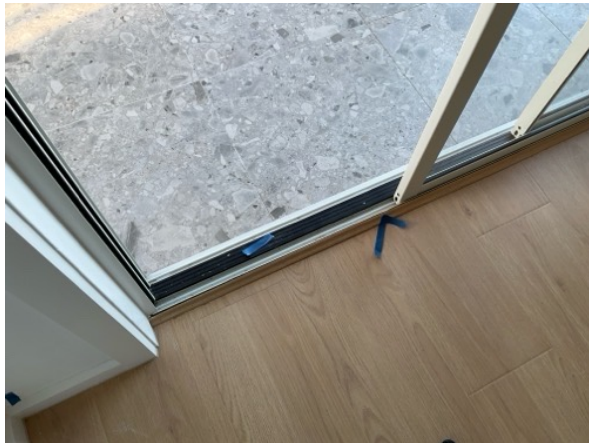
## Incomplete 2.17

**Location:** Leisure

**Finding:** Missing or incomplete silicon to the door/window frame  
Missing or incomplete silicone around the window/door frame will need repair to ensure adequate water tightness and appearance

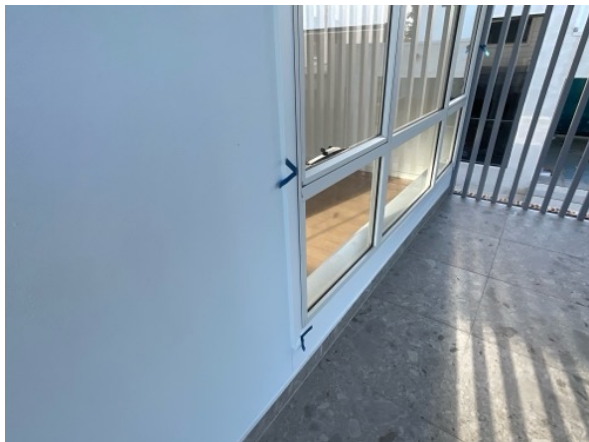
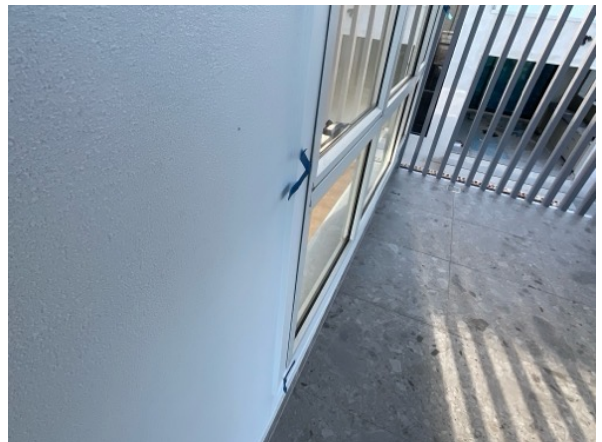
## Incomplete 2.18

**Location:** Leisure

**Finding:** Architrave joint is poorly finished

Architrave around the window frame is poorly finished and will need repair to restore appearance.

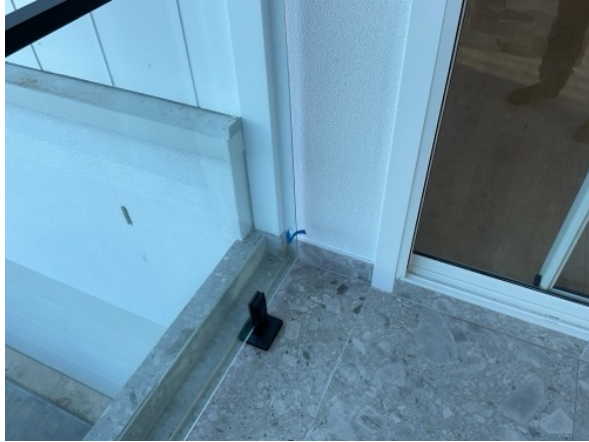
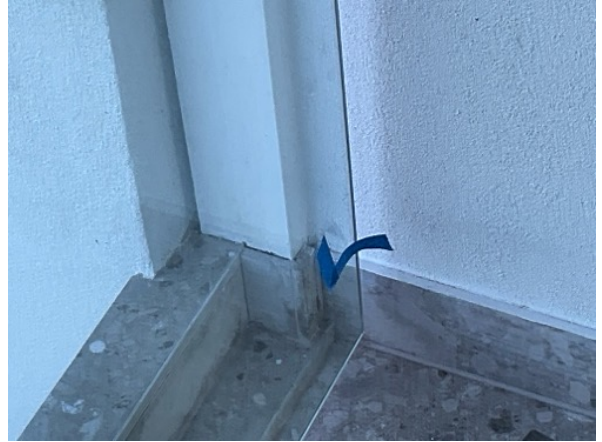
## Incomplete 2.21

**Location:** Bedroom 2

**Finding:** Window/door glass to be cleaned  
Glass to be cleaned to ensure there is no damage

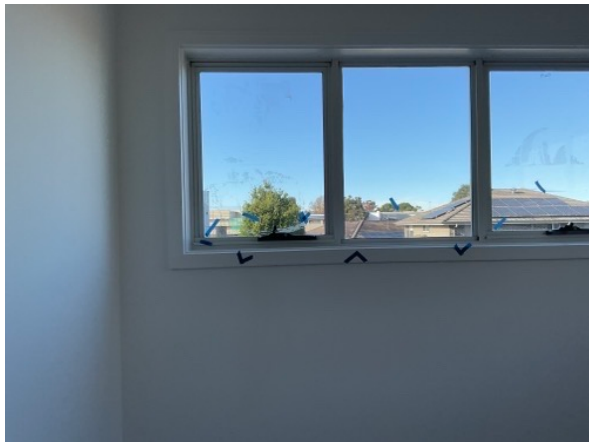
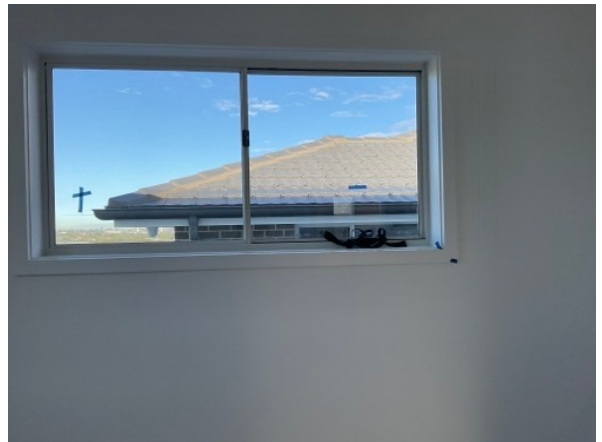
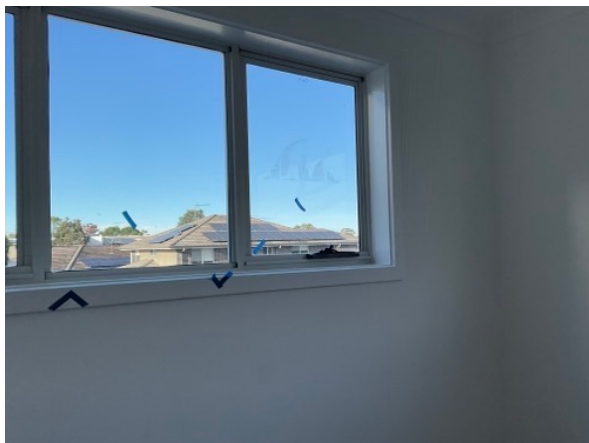
## Incomplete 2.22

**Location:** Bedroom 2

The window is currently binding and will need adjustment and servicing. To resolve this defect, it is recommended that a window servicing is carried out to restore smooth operation of the openable portion of the window.

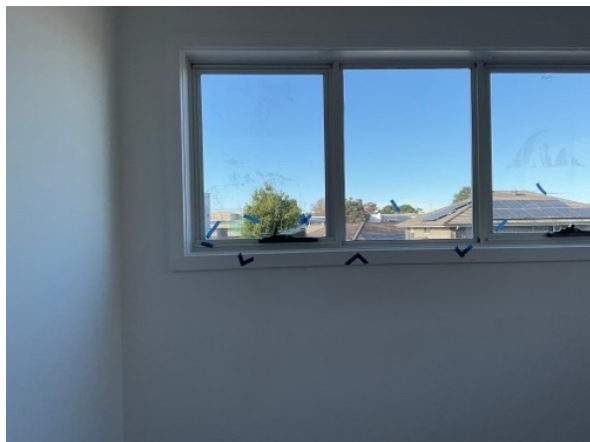
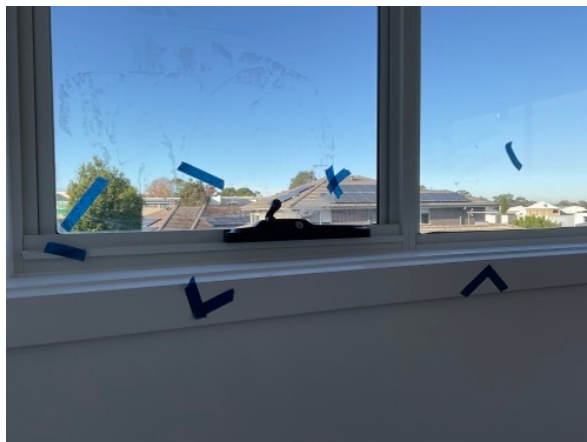
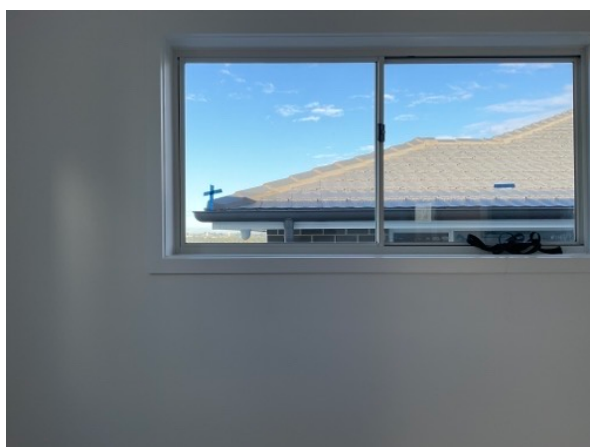
**Finding:** Window is binding

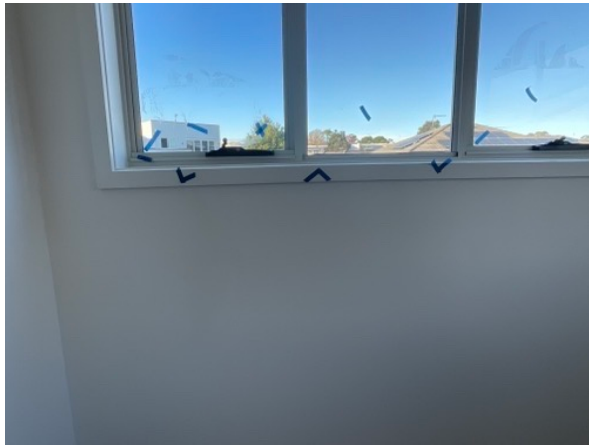
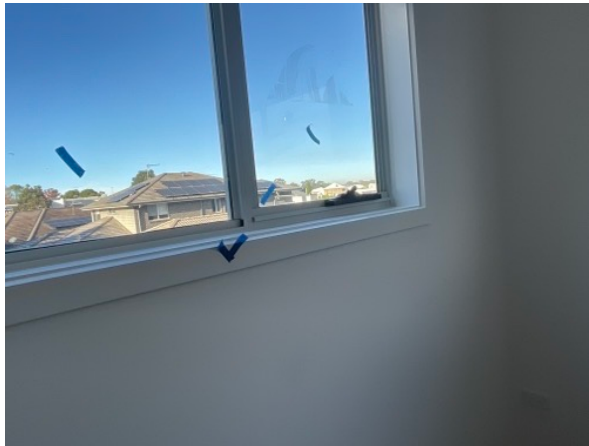
## Incomplete 2.23

**Location:** Bedroom 2

**Finding:** Rubber seal to window

Loose rubber seal to window will need repair to ensure the window is water tight, To resolve this defect, it is recommended that a window servicing is carried out to restore the loose rubber.

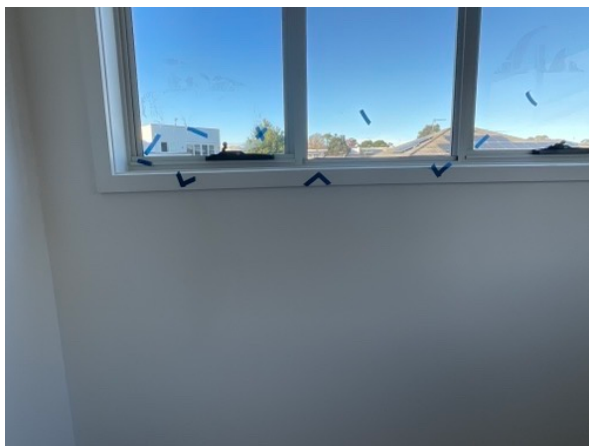
## Incomplete 2.24

**Location:** Bedroom 2

**Finding:** Architrave/moulding to the door/window is bowed  
Bottom of the architrave/moulding bowed and will need repair to restore appearance

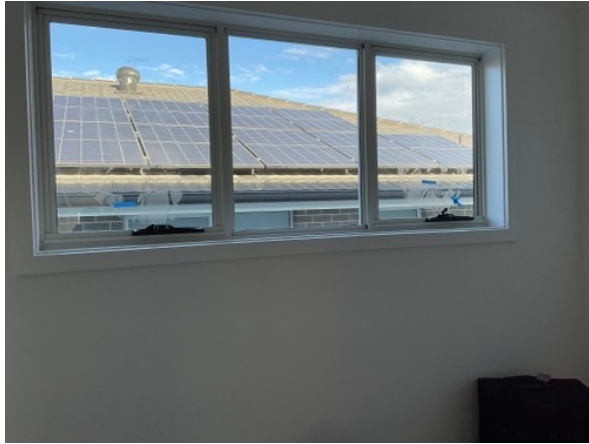
## Incomplete 2.25

**Location:** Bedroom 3 Including Bathroom

The window is currently binding and will need adjustment and servicing. To resolve this defect, it is recommended that a window servicing is carried out to restore smooth operation of the

openable portion of the window.

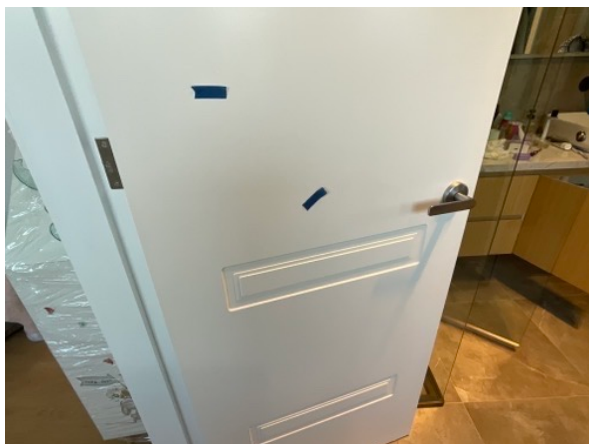
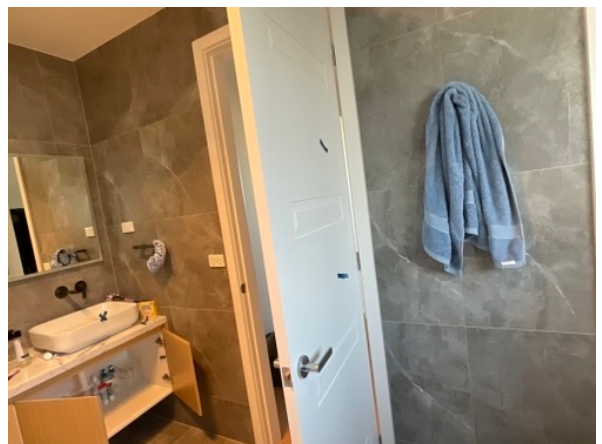
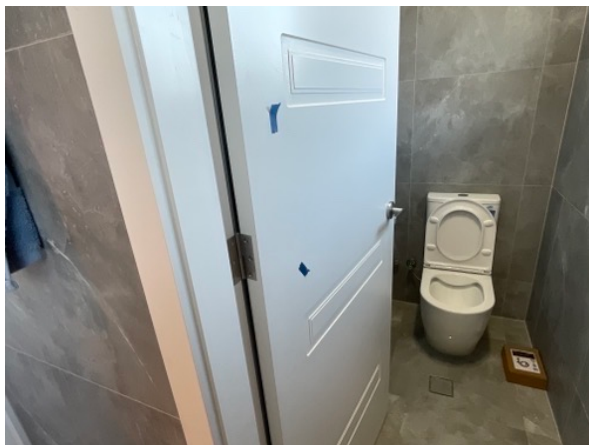
## Incomplete 2.26

**Location:** Bedroom 3 Including Bathroom

**Finding:** Paint touchups required

Minor paint touchups required as tagged on site to restore appearance

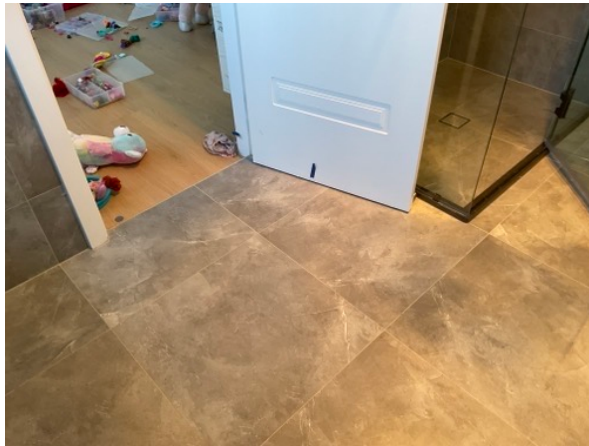
## Incomplete 2.27

**Location:** Bedroom 3 Including Bathroom

**Finding:** Damaged door  
Damaged surface needs repair to restore appearance

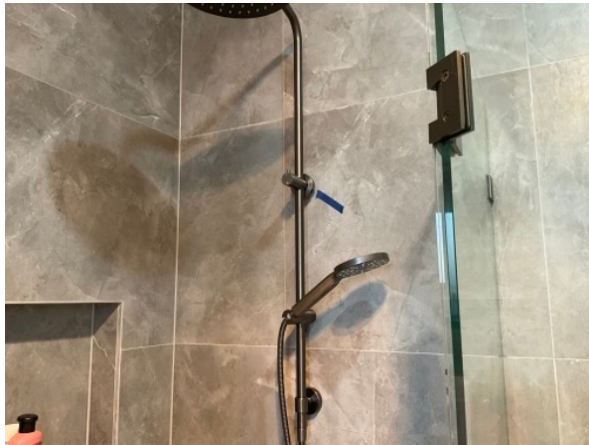
## Incomplete 2.28

**Location:** Bedroom 3 Including Bathroom  
**Finding:** Loose flange to the shower rose  
Loose flange to the shower rose to be sealed

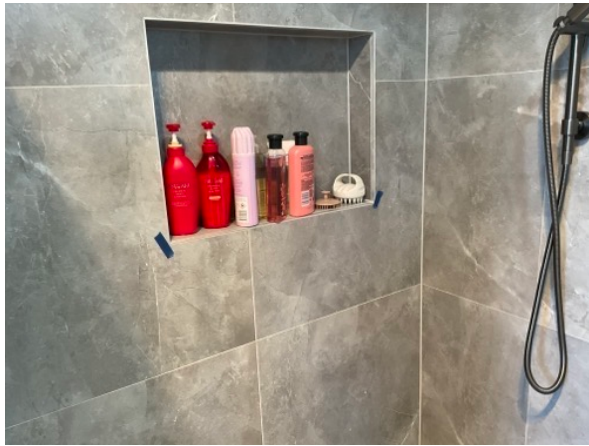
## Incomplete 2.29

**Location:** Bedroom 3 Including Bathroom  
**Finding:** Sharp corners to the niche  
Sharp corners to the niche will need to be repaired to restore appearance and safety

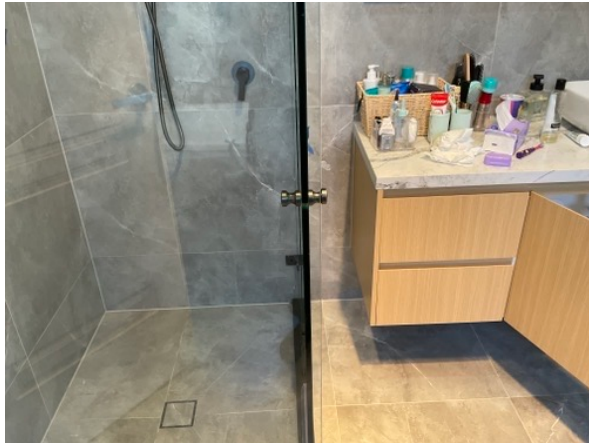
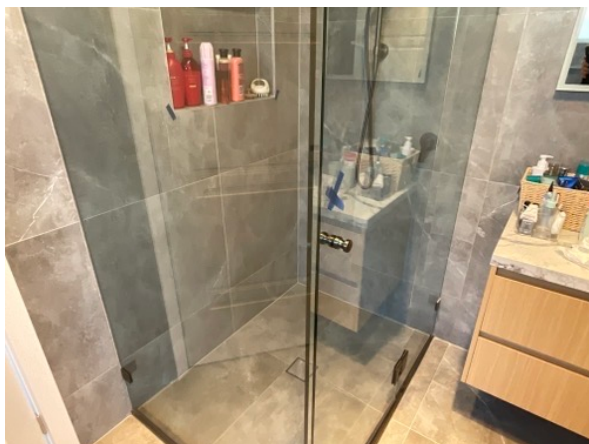
## Incomplete 2.30

**Location:** Bedroom 3 Including Bathroom

**Finding:** Shower screen door is not sitting tight  
Shower screen door is not sitting tight and will need to be repaired

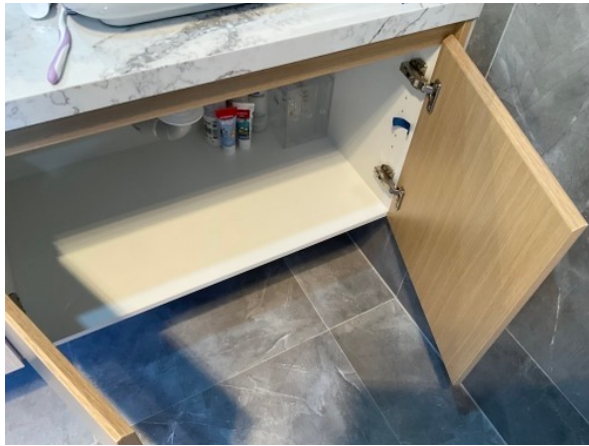
## Incomplete 2.31

**Location:** Bedroom 3 Including Bathroom

**Finding:** Missing shelf  
Missing shelf to be installed

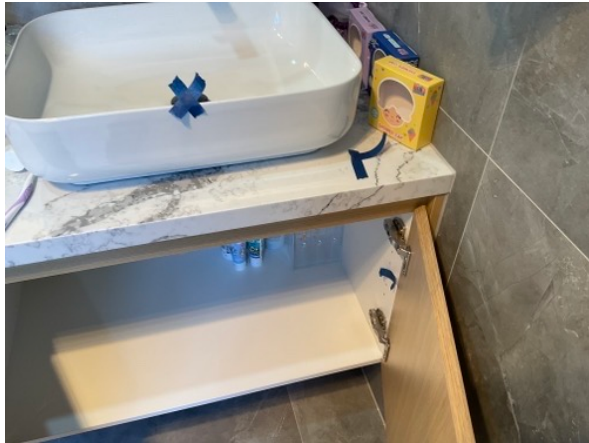
## Incomplete 2.32

**Location:** Bedroom 3 Including Bathroom

**Finding:** Basin  
Incomplete silicon to the base of the basin

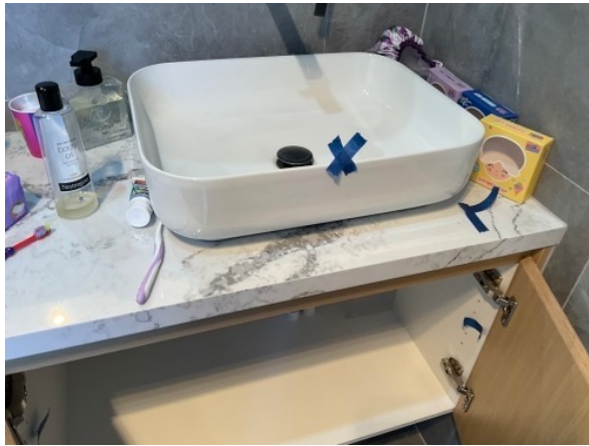
## Incomplete 2.33

**Location:** Bedroom 3 Including Bathroom

**Finding:** Slow draining basin

It has been observed that the basin is experiencing slow drainage. This issue suggests a potential blockage or other underlying problem within the plumbing system that requires further investigation. It is important to address this defect promptly to prevent any possible escalation, which could lead to more significant plumbing issues or water damage. A qualified professional should be engaged to thoroughly assess the situation, identify the root cause, and recommend the necessary corrective measures to restore proper drainage functionality.

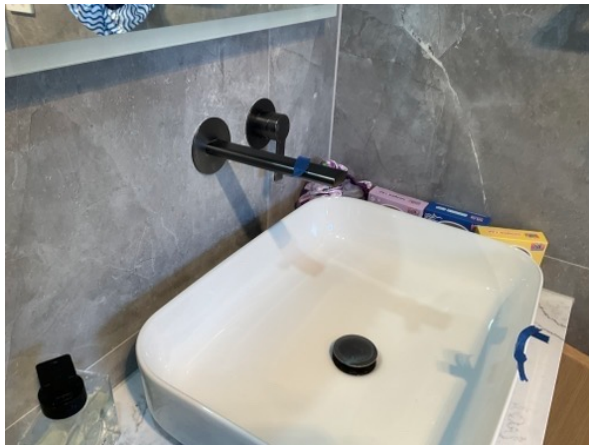
## Incomplete 2.34

**Location:** Bedroom 3 Including Bathroom

**Finding:** Loose tap  
Loose tap to be secured

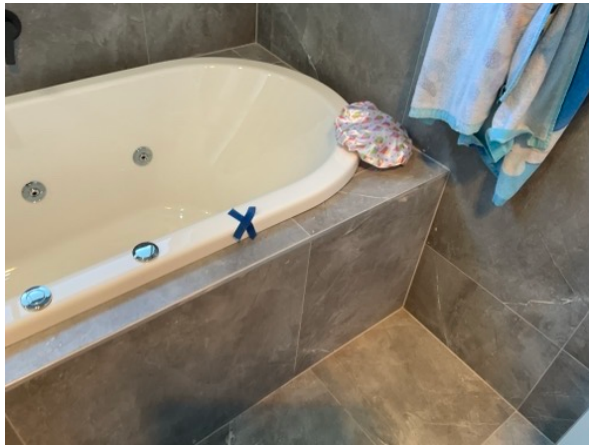
## Incomplete 2.35

**Location:** Bedroom 3 Including Bathroom

**Finding:** Loose bath  
The bath was not securely fixed, presenting looseness which may lead to further displacement or damage. Immediate corrective action is recommended to ensure compliance and to maintain the integrity of the installation.

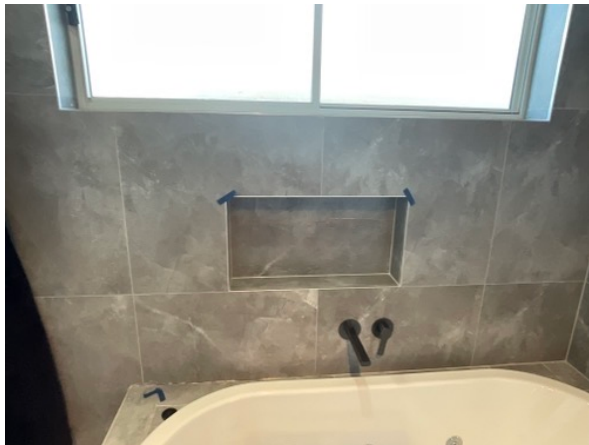
## Incomplete 2.36

**Location:** Bedroom 3 Including Bathroom

**Finding:** Sharp corners to the niche

Sharp corners to the niche will need to be repaired to restore appearance and safety

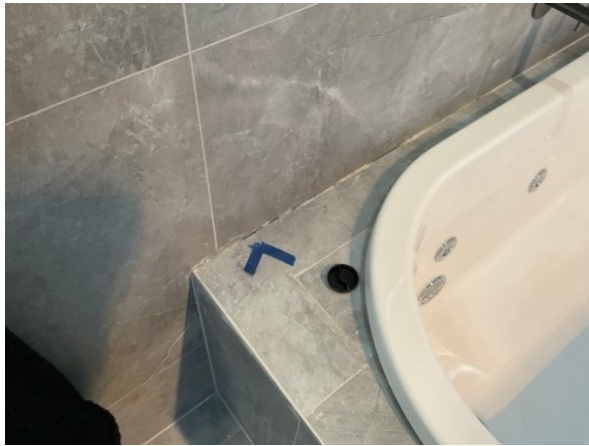
## Incomplete 2.37

**Location:** Bedroom 3 Including Bathroom

**Finding:** Damaged grout/silicon

Bath tub exhibits stained and damaged grout/silicon, which may compromise the waterproofing integrity of the area.

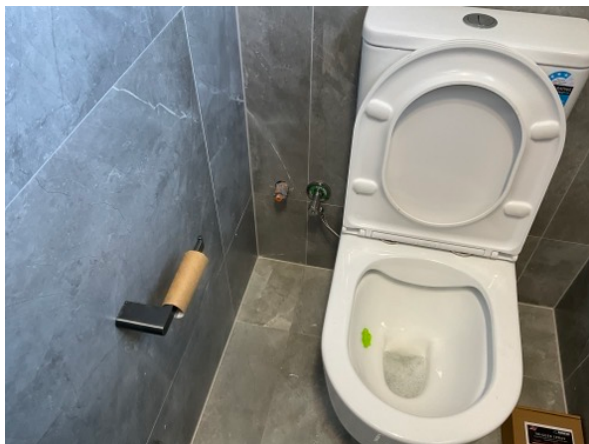
**Location:** Bedroom 3 Including Bathroom

**Finding:** Missing flange to the tap  
Issuing flange to the tap to be installed

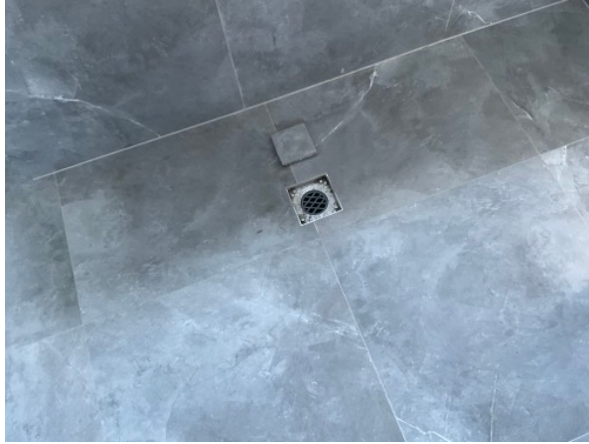
## Incomplete 2.41

**Location:** Bedroom 3 Including Bathroom

**Finding:** Floor waste  
Floor waste to be cleaned

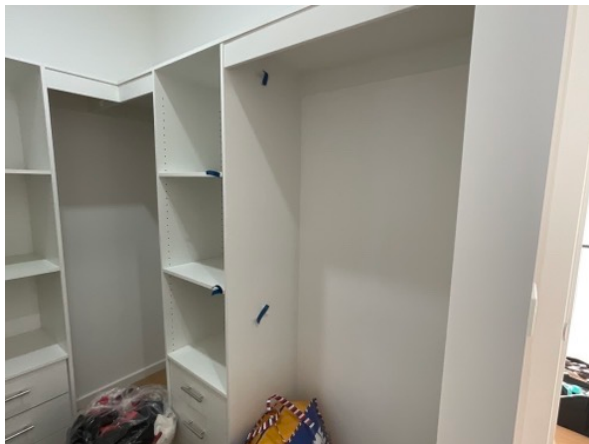
## Incomplete 2.42

**Location:** Bedroom 3 Including Bathroom

**Finding:** Hanging rod is missing  
Hanging rod to be installed

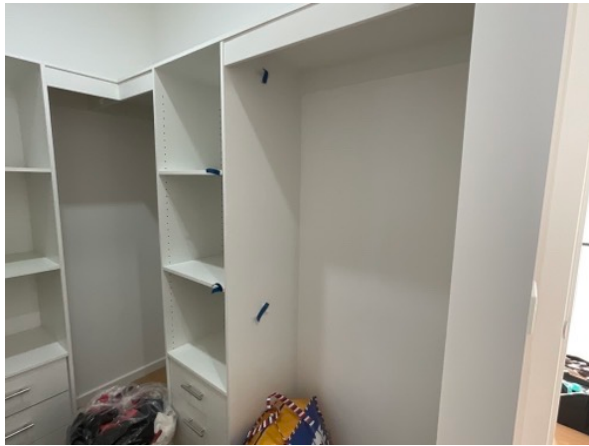
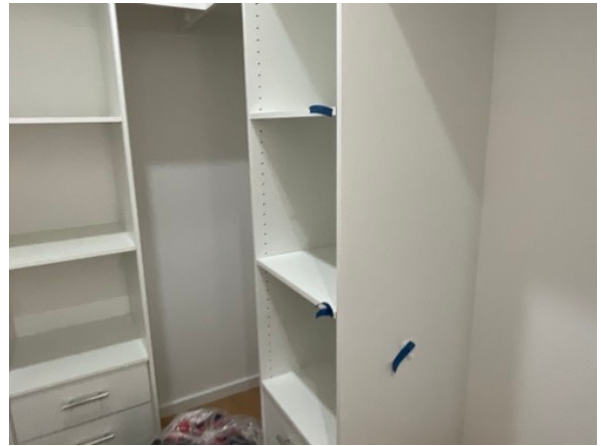
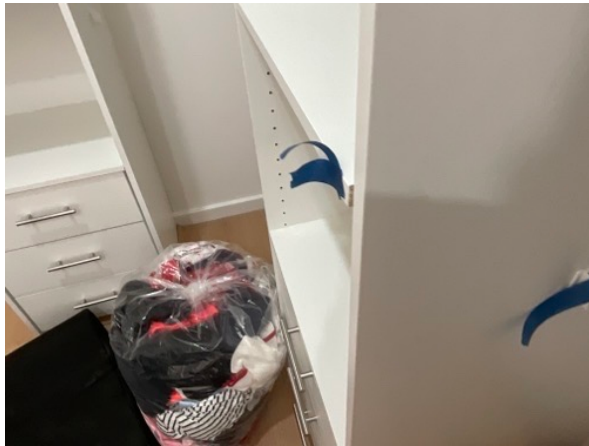
## Incomplete 2.43

**Location:** Bedroom 3 Including Bathroom

**Finding:** Cabinet alignment is required  
Cabinets are not sitting even with each other and will need to be repositioned

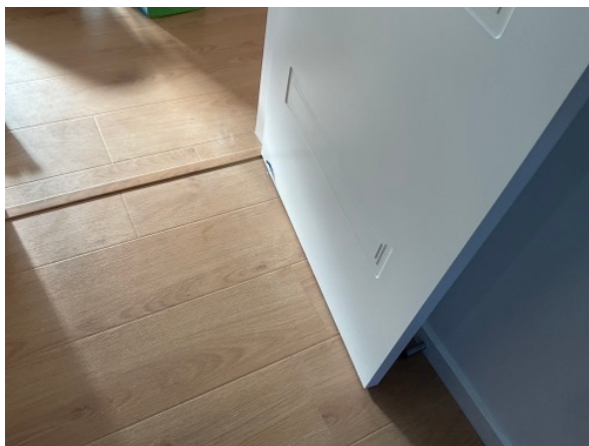
## Incomplete 2.44

**Location:** Bedroom 3 Including Bathroom

**Finding:** Damaged door  
Damaged edge needs repair to restore appearance

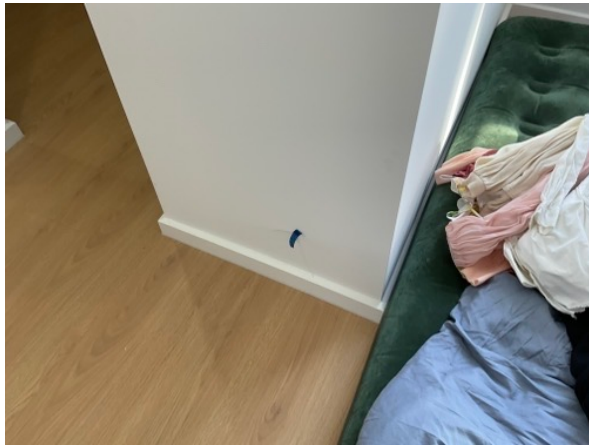
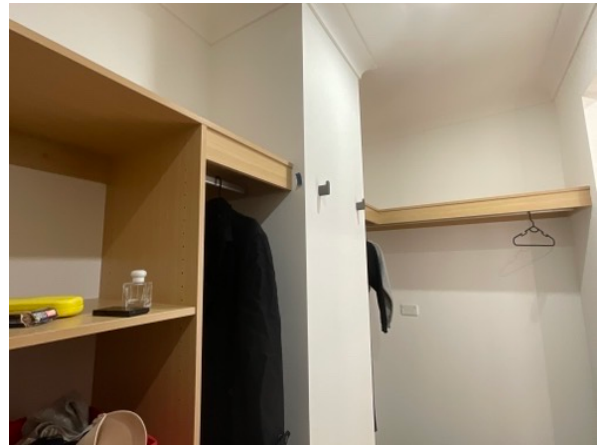
## Incomplete 2.45

**Location:** Master bedroom

**Finding:** Paint touchups required  
Minor paint touchups required as tagged on site to restore appearance

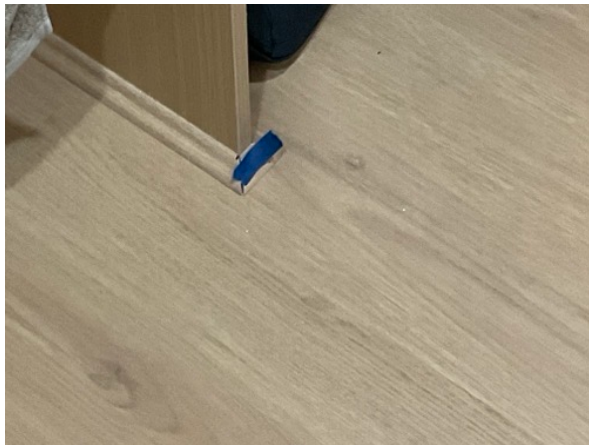
## Incomplete 2.46

**Location:** Master bedroom

**Finding:** Poorly finished quad

Poorly finished quad will need repair to restore appearance

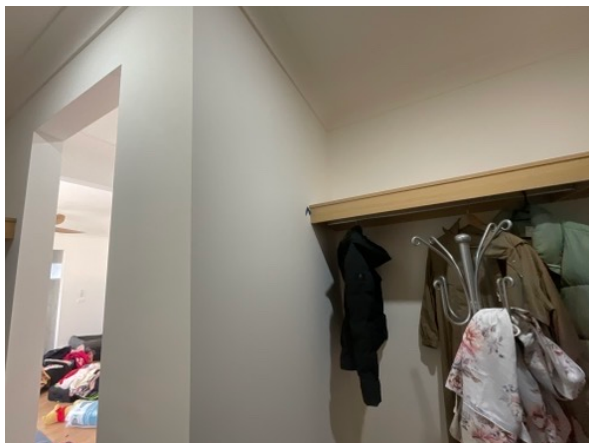
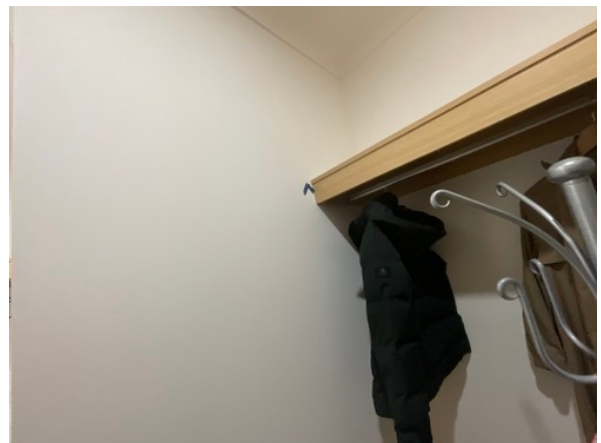
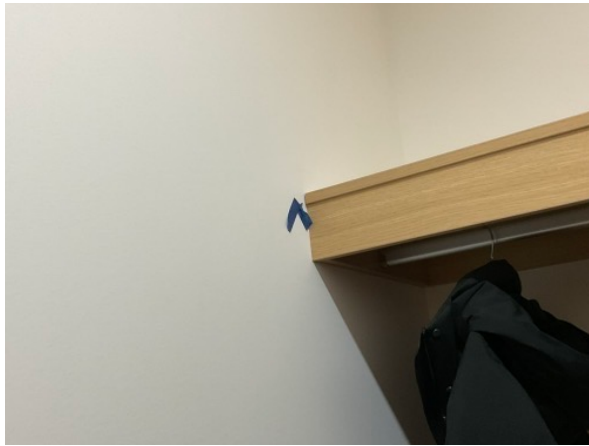
## Incomplete 2.47

**Location:** Master bedroom

**Finding:** Incomplete silicon to the cabinet

Incomplete silicon to the cabinet and wall junction

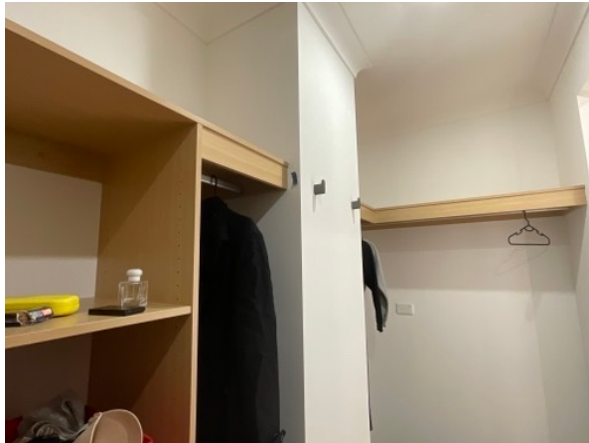
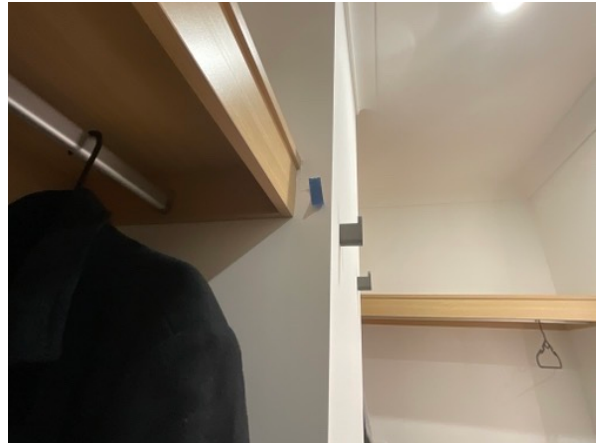
## Incomplete 2.48

**Location:** Master bedroom

**Finding:** Paint touchups required

Minor paint touchups required as tagged on site to restore appearance

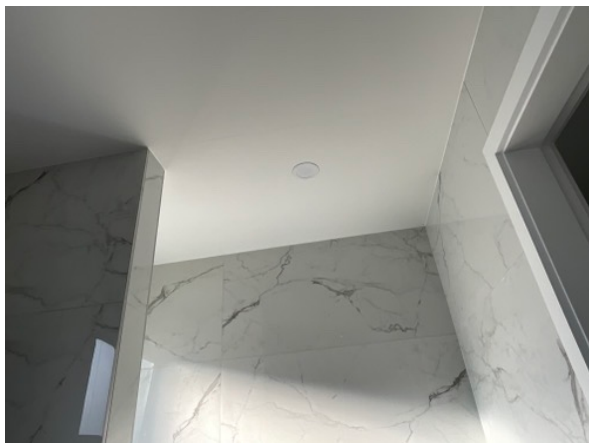
## Incomplete 2.49

**Location:** Ensuite

**Finding:** Paint touchups required

Minor paint touchups required as tagged on site to restore appearance

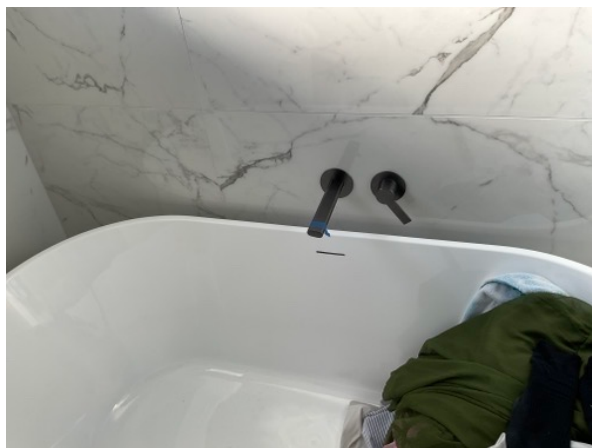
**Location:** Ensuite

**Finding:** Loose tap  
Loose tap to be secured

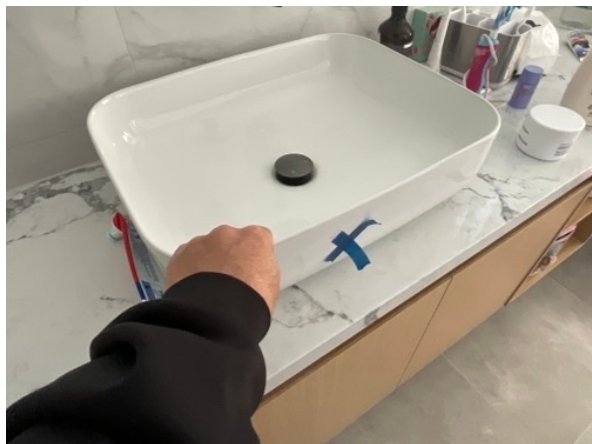
**Location:** Ensuite

**Finding:** Loose basin  
The basin was not securely fixed, presenting looseness which may lead to further displacement or damage. Immediate corrective action is recommended to ensure compliance and to maintain the integrity of the installation.

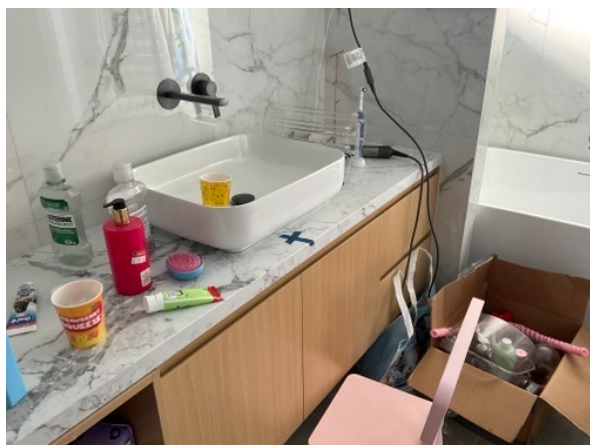
## Incomplete 2.53

**Location:** Ensuite

**Finding:** Slow draining basin

It has been observed that the basin is experiencing slow drainage. This issue suggests a potential blockage or other underlying problem within the plumbing system that requires further investigation. It is important to address this defect promptly to prevent any possible escalation, which could lead to more significant plumbing issues or water damage. A qualified professional should be engaged to thoroughly assess the situation, identify the root cause, and recommend the necessary corrective measures to restore proper drainage functionality.

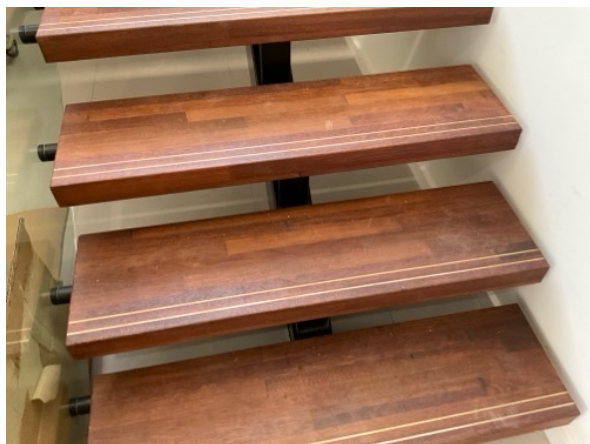
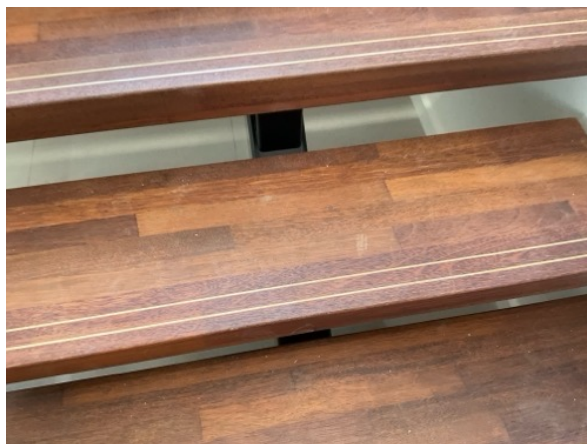
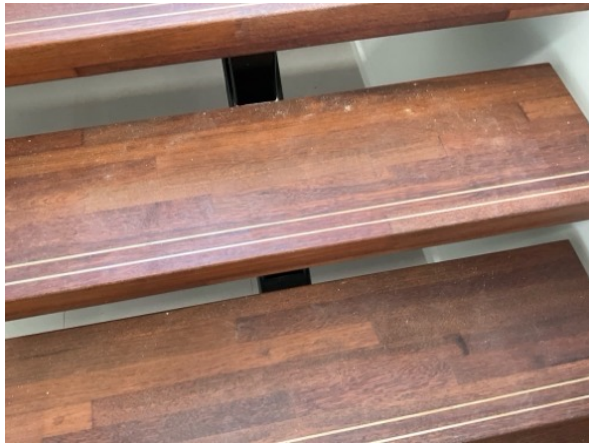
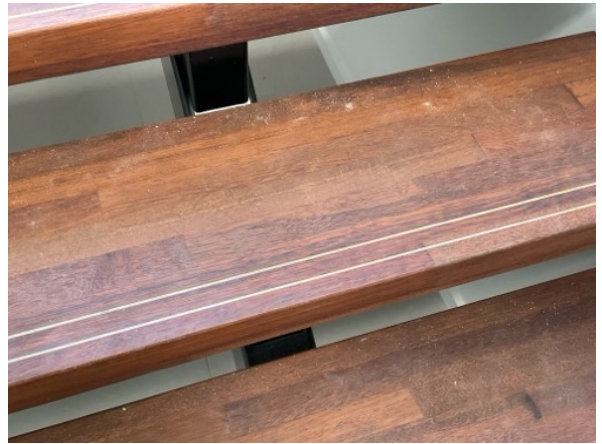
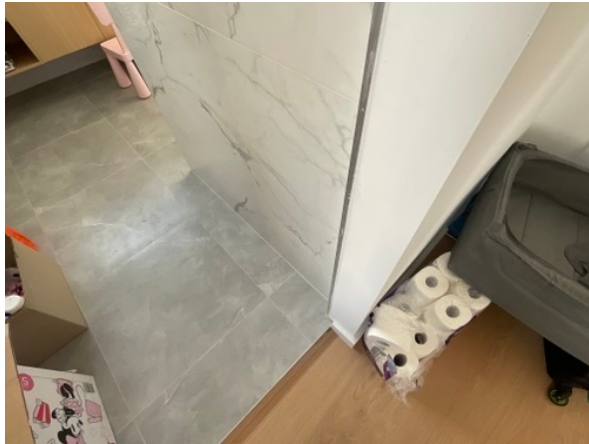
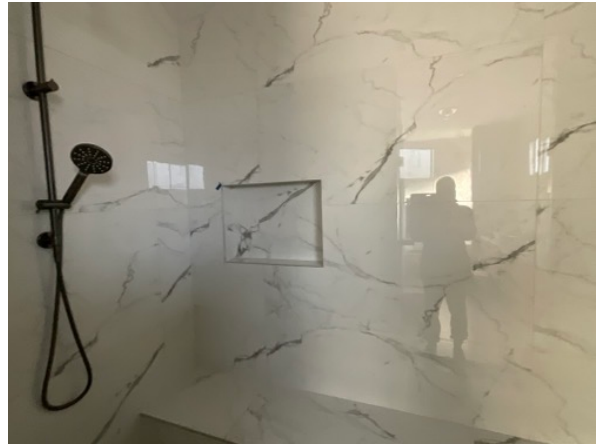
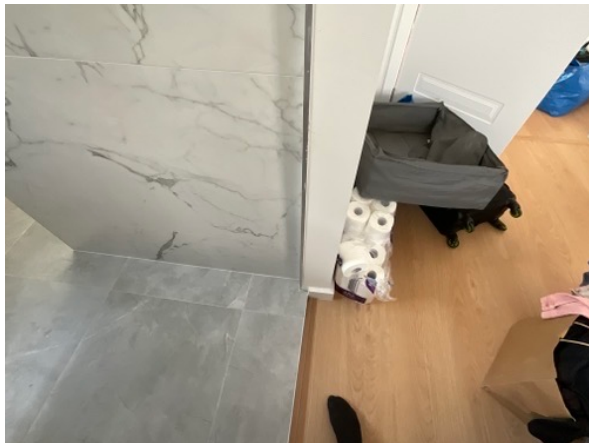
## Incomplete 2.54

**Location:** Stairwell

**Finding:** Incomplete painting to the treads and rises

Incomplete painting to the treads and rises to be completed

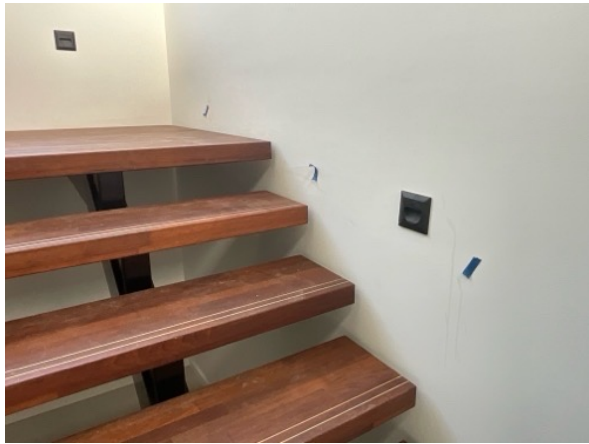
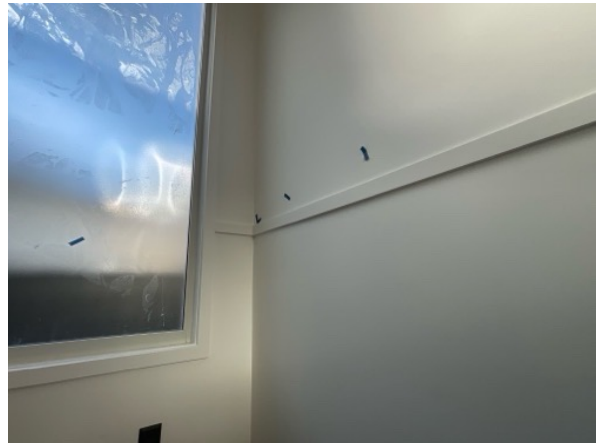
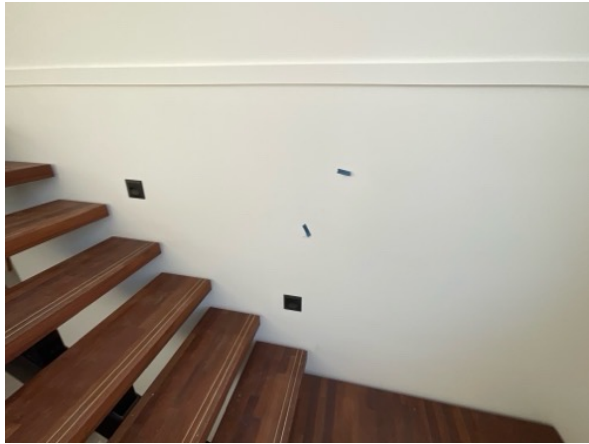
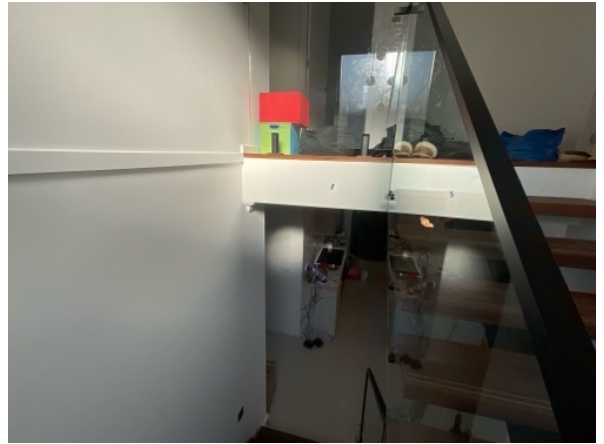
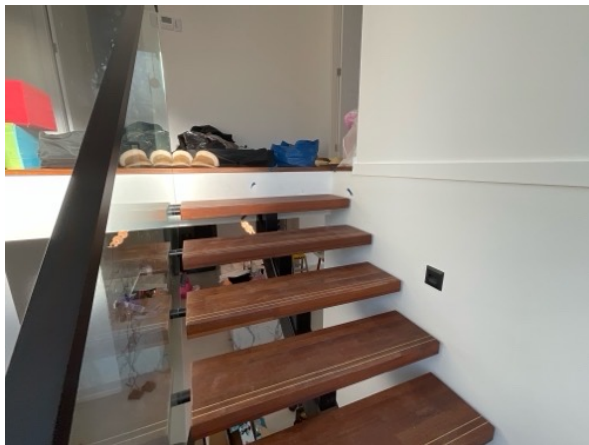
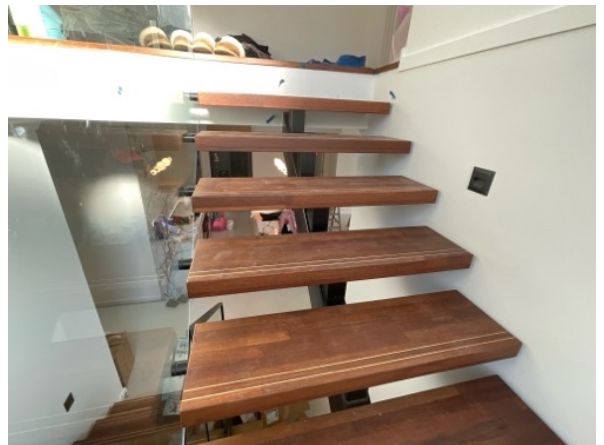
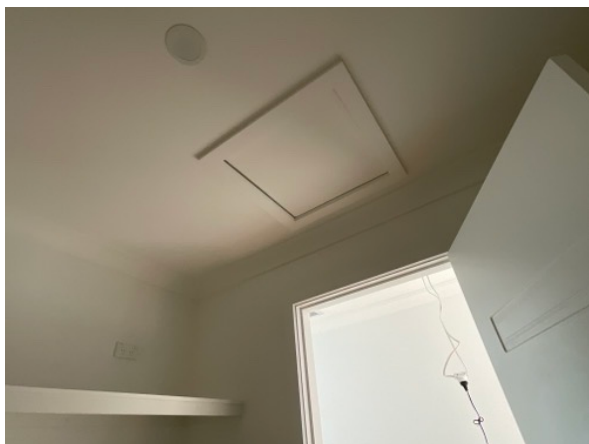
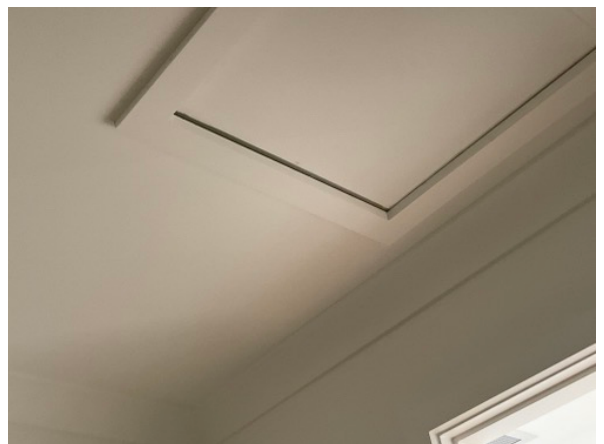
## Incomplete 2.55

**Location:** Stairwell

**Finding:** Paint touchups required

Minor paint touchups required as tagged on site to restore appearance

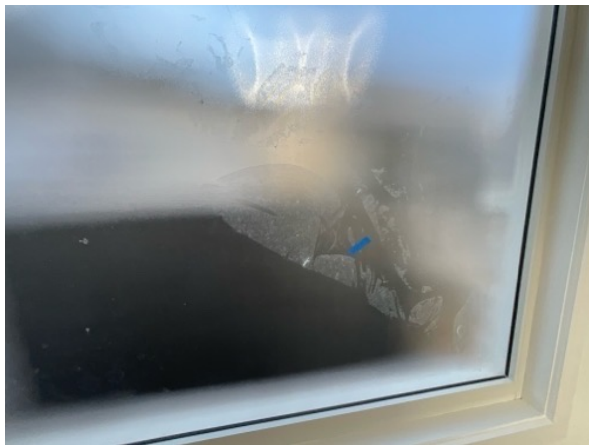
## Incomplete 2.56

**Location:** Stairwell

**Finding:** Window/door glass to be cleaned  
Glass to be cleaned to ensure there is no damage

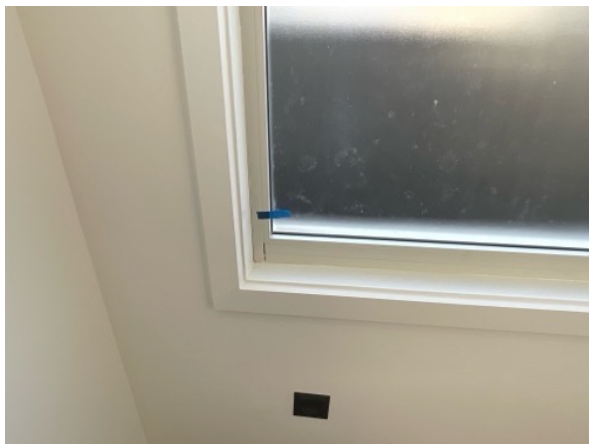
## Incomplete 2.57

**Location:** Stairwell

**Finding:** Window frame is missing silicon  
Missing silicon between the frame and the reveal

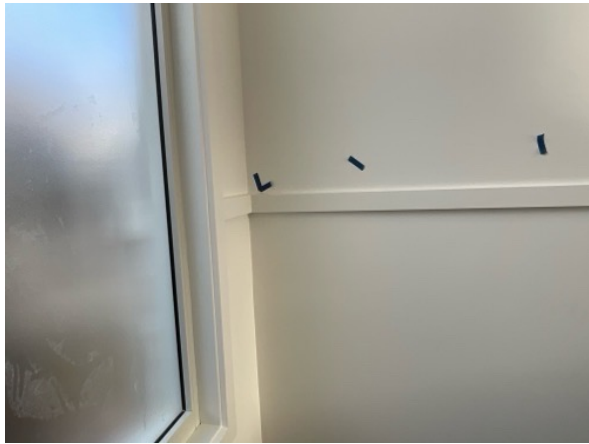
## Incomplete 2.58

**Location:** Stairwell

**Finding:** Wall patching is required  
Patches are incomplete and will need finishing to a good standard

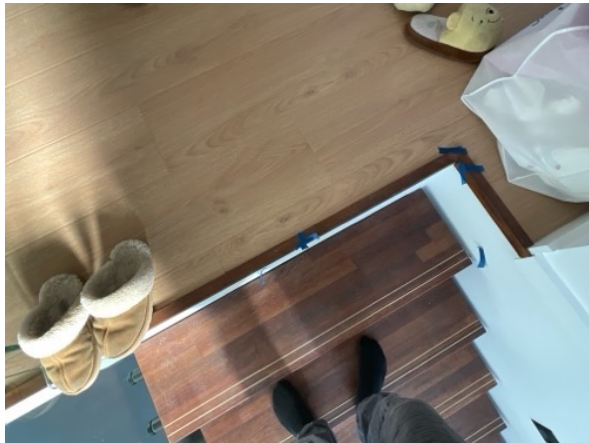
## Incomplete 2.59

**Location:** Stairwell

**Finding:** Flooring has a squeak

The flooring has a noticeable squeak, that will need repair

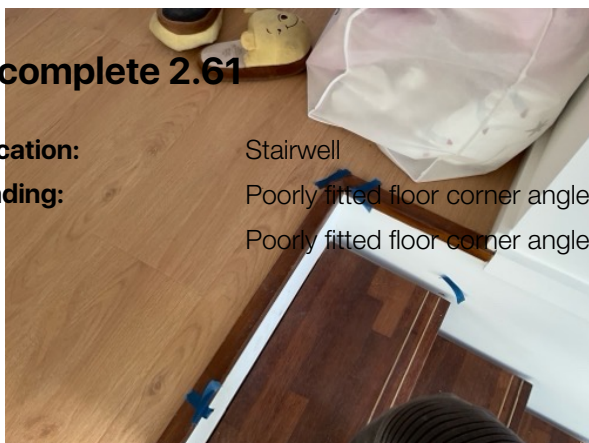
**Finding:** Poorly fitted floor corner angle

Poorly fitted floor corner angle to be repositioned and secured

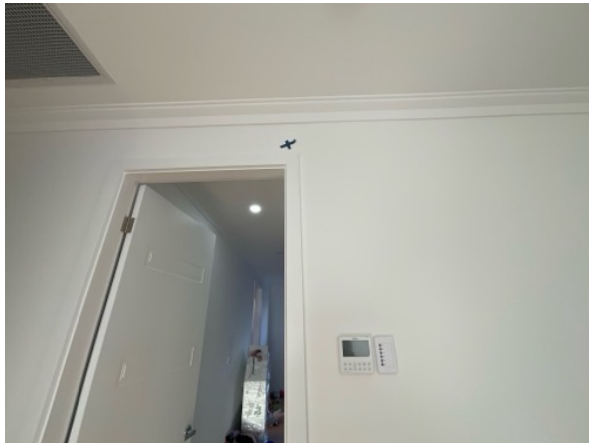
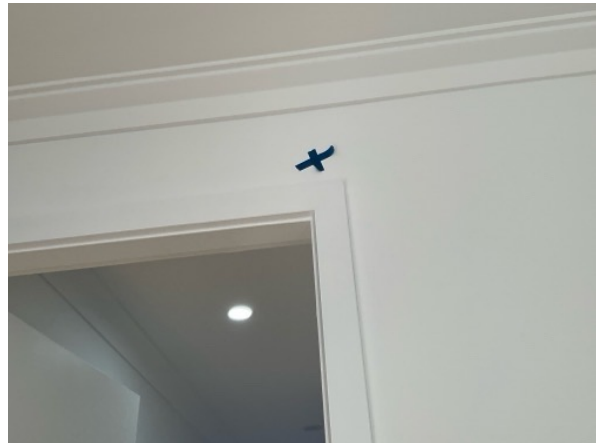
## Incomplete 2.62

**Location:** Stairwell

**Finding:** Wall cracking

Minor joint cracking to the wall will need repair to restore appearance
