# Sample Report - Practical Completion Inspection

Inspection Date: 2 Jul 2026

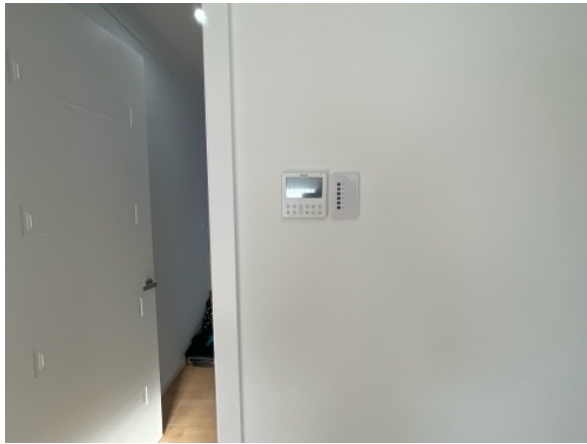
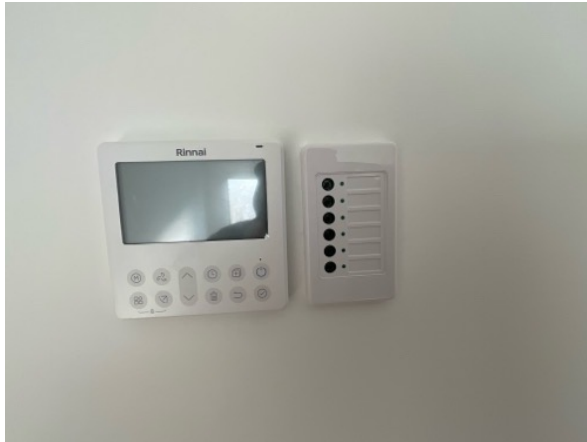
## Incomplete 2.63

**Location:** Stairwell

**Finding:** Air conditioner not tested

The air-conditioning requires a thorough testing period to assess its operational efficiency and functionality, as part of the evaluation process. To address this issue, it is recommended to engage a licensed technician to conduct a comprehensive assessment of the unit over an extended period to confirm its performance and rectify any identified deficiencies.

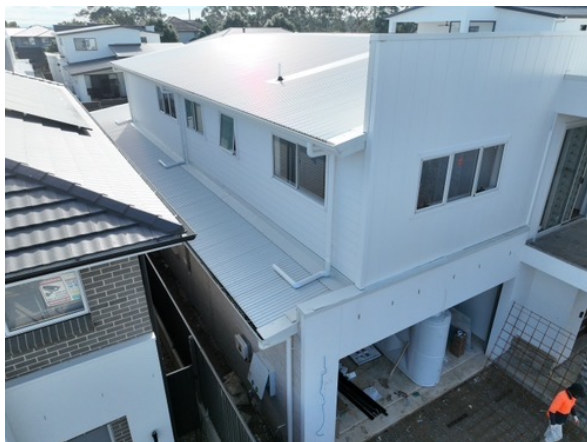
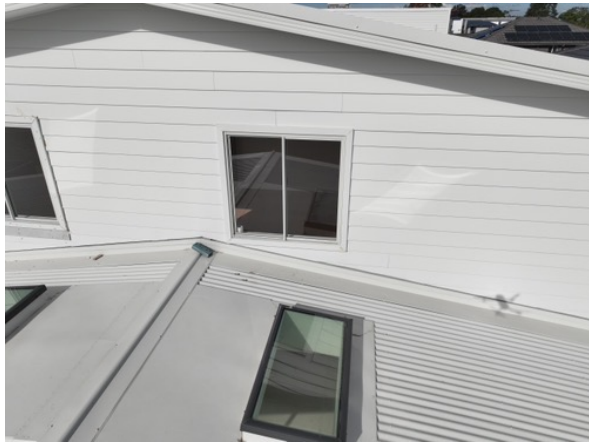
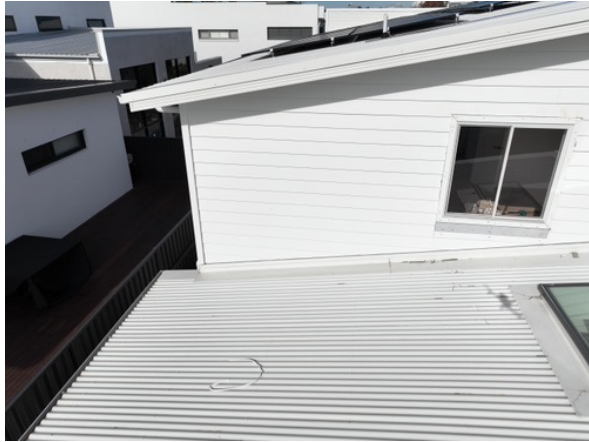
## Incomplete 2.64

**Location:** Roof exterior

**Finding:** Roof cladding to be cleaned

During the inspection of the roof exterior, it was observed that building waste, including remnants of construction materials, has accumulated across various sections of the roof surface. This buildup poses a potential obstruction to proper water drainage and could lead to long-term damage if not adequately addressed. It is important to have this waste promptly removed to ensure the integrity and functionality of the roofing system and to prevent any associated damages from occurring over time.

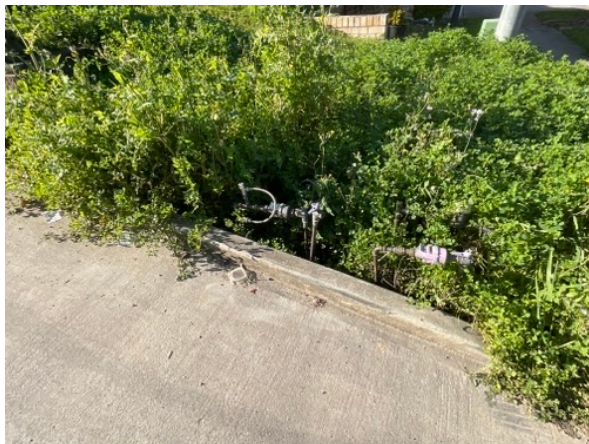
## Incomplete 2.65

**Location:** All External Areas

**Finding:** Missing recycling water meter

During the inspection, it was observed that a recycling water meter has not been installed in the external areas of the property. The absence of this meter means that there is currently no means to monitor or manage the usage of recycled water efficiently. This omission may lead to challenges in achieving sustainable water usage goals and could potentially result in increased water consumption costs. Installing a recycling water meter is recommended to facilitate effective monitoring and encourage the responsible use of recycled water resources.

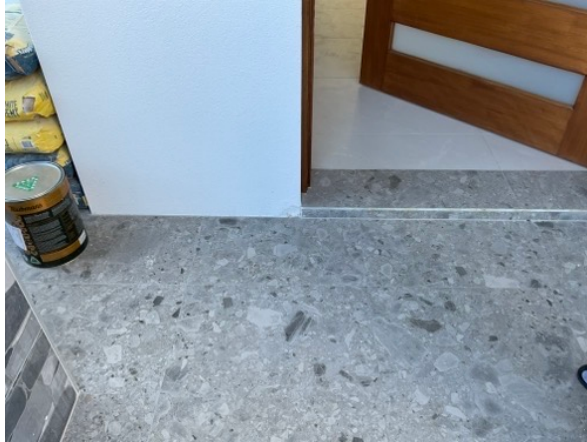
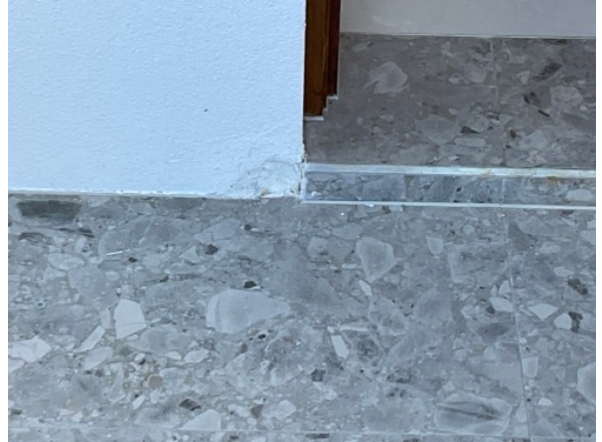
## Incomplete 2.66

**Location:** All External Areas

**Finding:** Damaged render

Damaged render will need repair to restore appearance

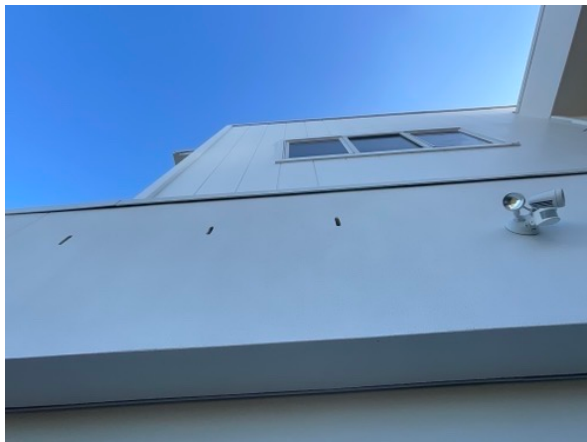
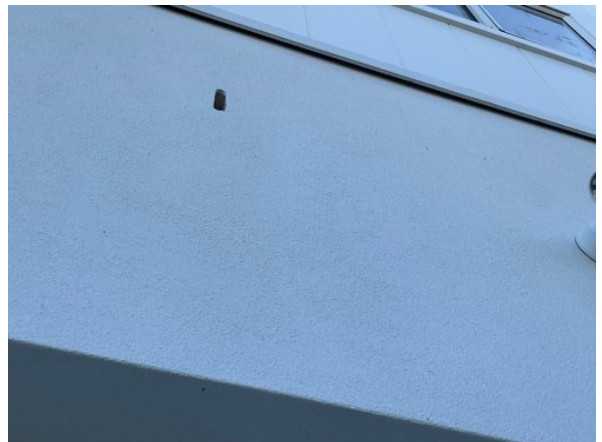
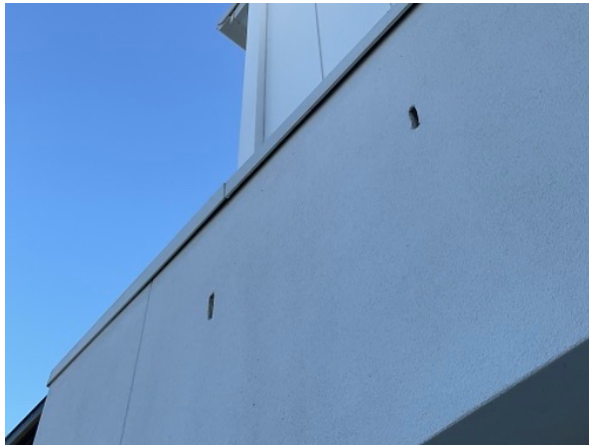
## Incomplete 2.67

**Location:** All External Areas

**Finding:** Capping is not sitting tight to the structure

It has been observed that the capping is sitting off the wall and requires corrective action to ensure it is repositioned tightly against the structure. This detachment, if left unaddressed, could potentially lead to issues such as water ingress or pest entry, compromising the longevity and integrity of the building. To prevent any adverse effects on the property's condition, it is recommended that the capping be properly realigned and secured, ensuring it is firmly fixed to the wall.

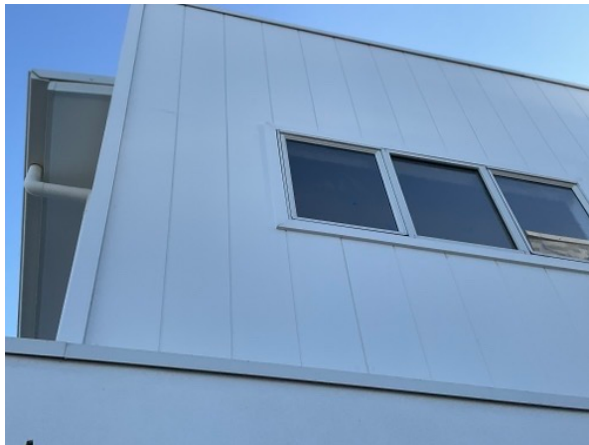
## Incomplete 2.68

**Location:** All External Areas

**Finding:** Loose moulding

Moulding has become loose to the corner joint that has separated. This will need repair to restore appearance.

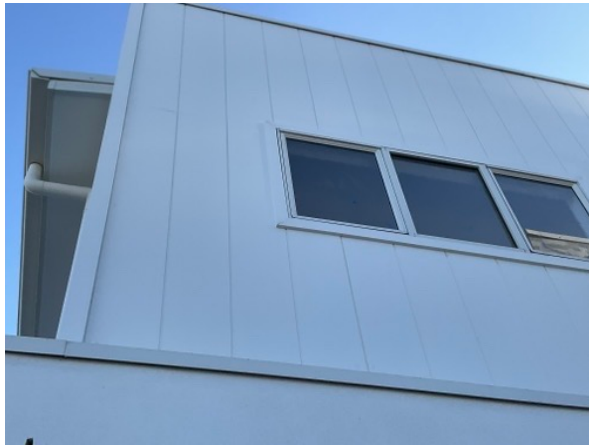
## Incomplete 2.69

**Location:** All External Areas

**Finding:** Loose cladding joint

Loose cladding joint will need to be repaired to ensure water tightness

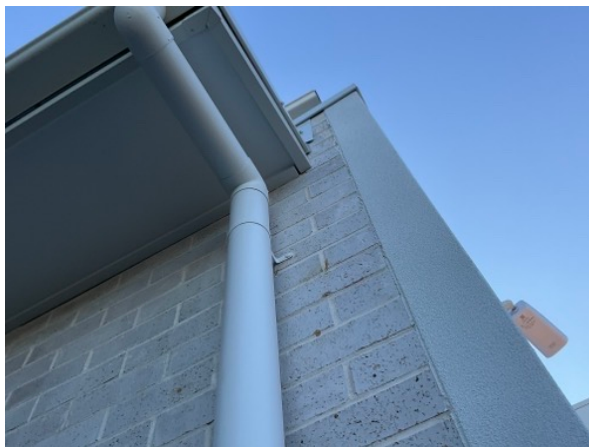
## Incomplete 2.70

**Location:** All External Areas

**Finding:** Missing or incomplete silicon to the moulding

Missing or incomplete silicone to the moulding will need repair to reduce adequate water tightness and appearance

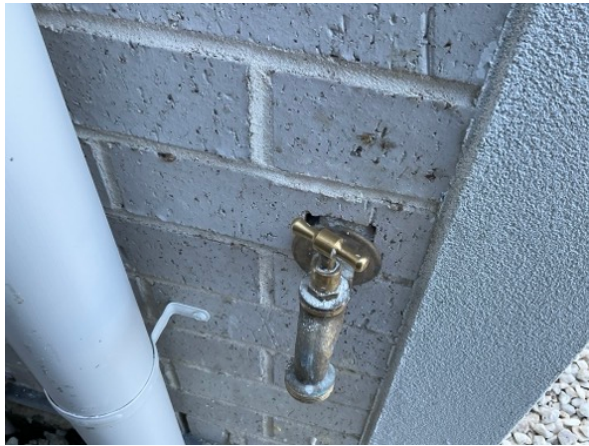
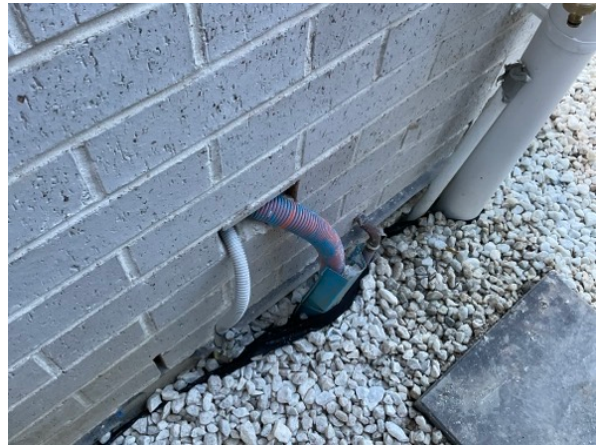
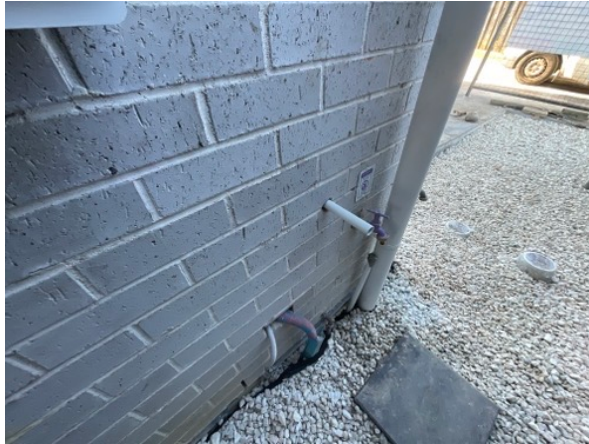
**Finding:** Pipe penetration

Pipe penetrations will need to be sealed

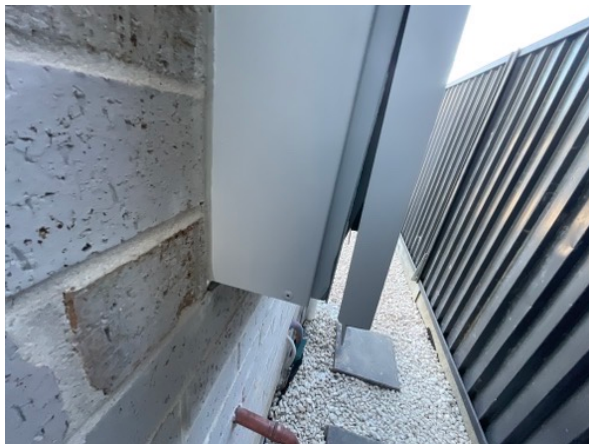
## Incomplete 2.73

**Location:** All External Areas  
**Finding:** Hot Water System cover  
Hot Water System cover is missing

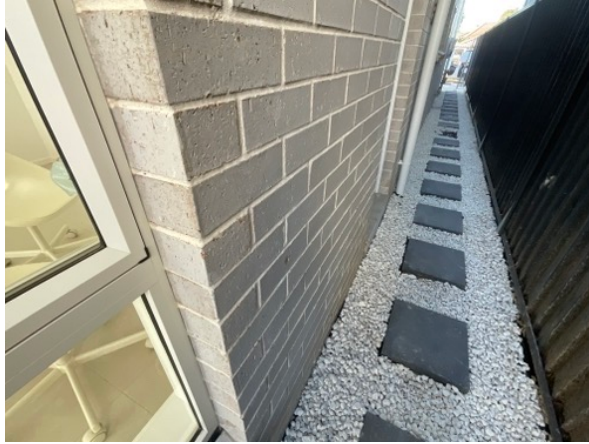
## Incomplete 2.77

**Finding:** DPC to be trimmed  
DPC to be trimmed back and made uniform

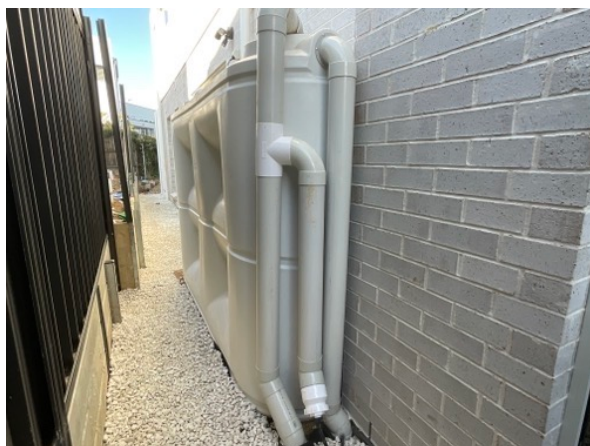
## Incomplete 2.82

**Finding:** Brick surface

Brick surfaces to be cleaned throughout the development

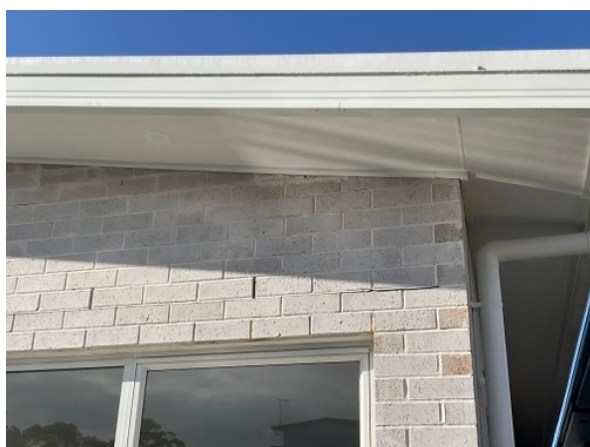
## Incomplete 2.83

**Finding:** Damaged capping/flashing

Damaged capping/flashing will need to be repaired to restore appearance.

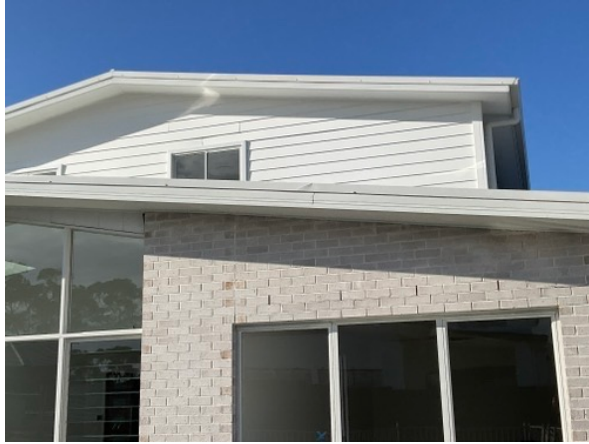
## Incomplete 2.84

**Finding:** Loose cladding joint

Loose cladding joint will need to be repaired to ensure water tightness

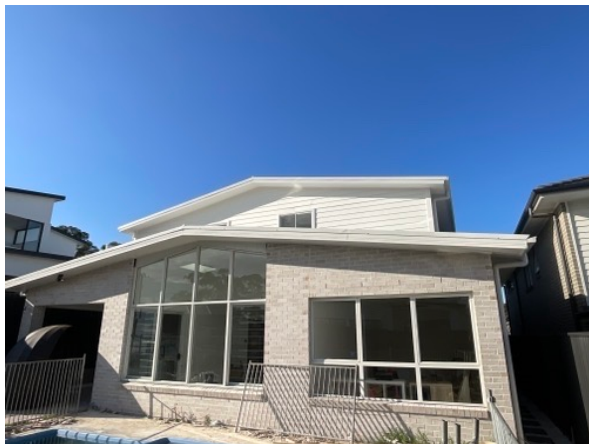
## Incomplete 2.85

**Finding:** DPC to be trimmed

DPC to be trimmed back and made uniformed

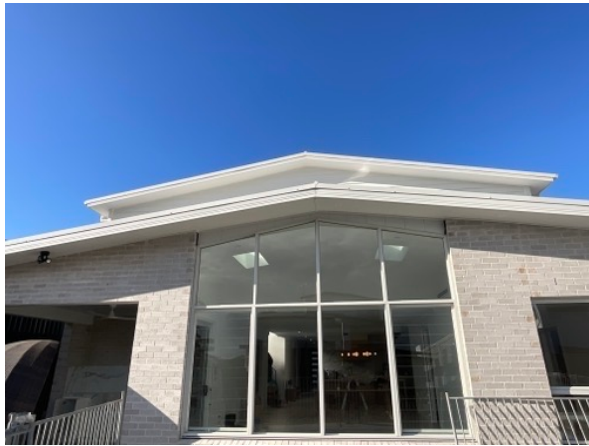
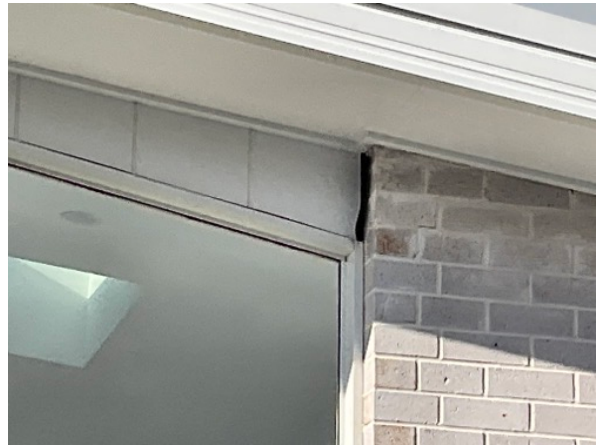
## Incomplete 2.86

**Finding:** Capping is not sitting tight to the structure

It has been observed that the capping is sitting off the wall and requires corrective action to ensure it is repositioned tightly against the structure. This detachment, if left unaddressed, could potentially lead to issues such as water ingress or pest entry, compromising the longevity and integrity of the building. To prevent any adverse effects on the property's condition, it is recommended that the capping be properly realigned and secured, ensuring it is firmly fixed to the wall.

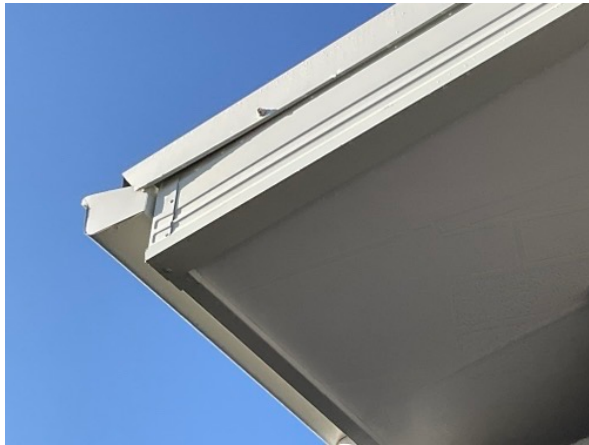
## Incomplete 2.87

**Finding:** Screw head surface to be cleaned

Screw heads exhibits notable rust stains, which should be addressed to prevent potential damage. Cleaning the stains is necessary to maintain the integrity and appearance of the fixture.

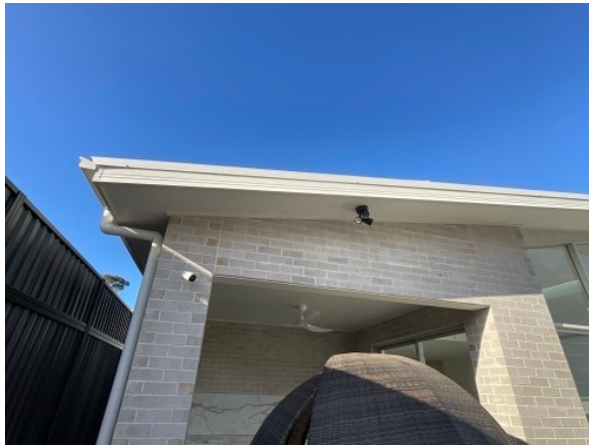
## Incomplete 2.88

**Finding:** Loose cladding joint

Loose cladding joint will need to be repaired to ensure water tightness

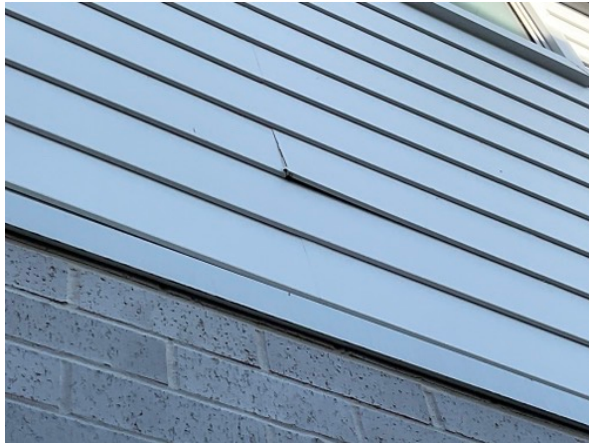
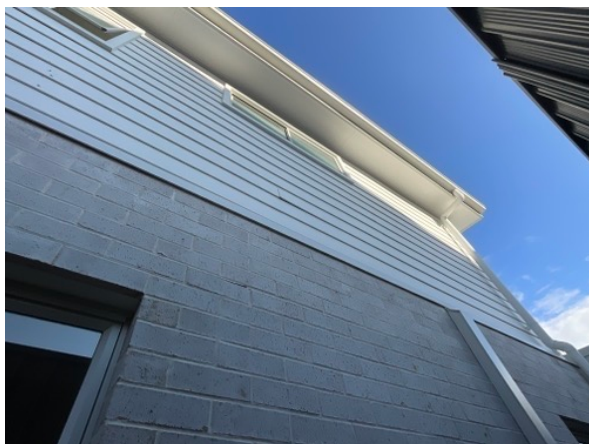
## Incomplete 2.89

**Finding:** Damaged/incomplete cladding

Damaged/incomplete cladding will need repair to prevent the ingress of moisture and the deterioration it can cause.

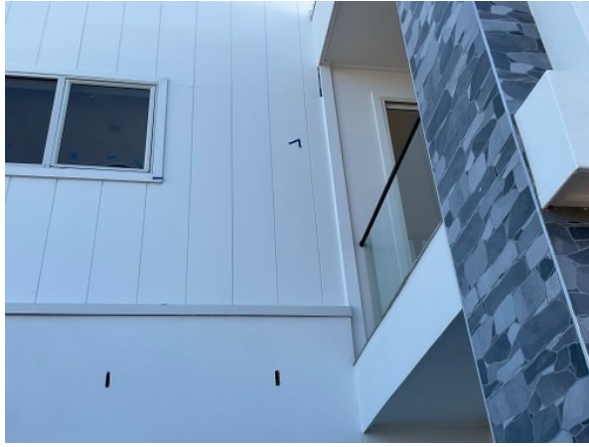
## Incomplete 2.90

**Finding:** Missing or incomplete silicon to the end of the cladding  
Missing or incomplete silicone to the end of the cladding will need repair to reduce adequate water tightness and appearance

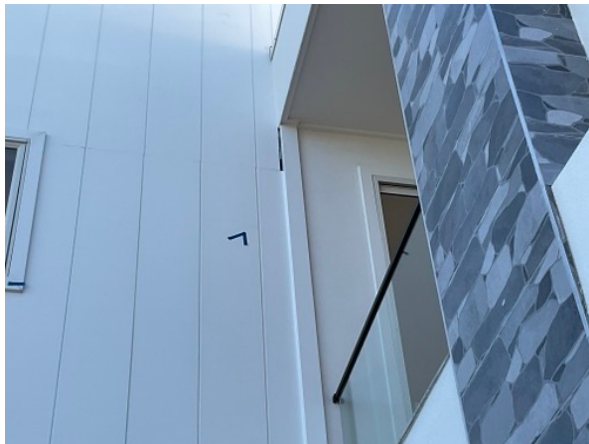
## Incomplete 2.91

**Finding:** Render is incomplete  
Incomplete render will need repair to restore appearance

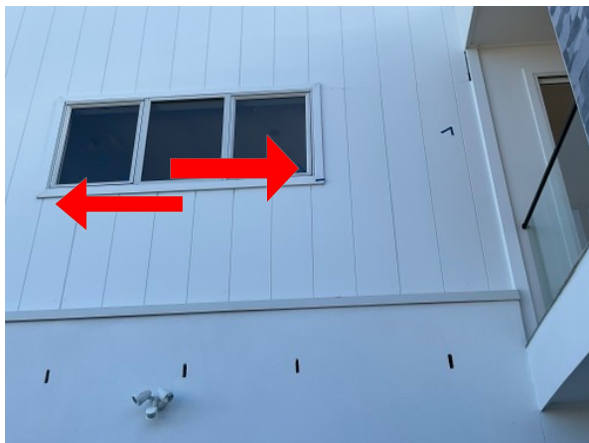
## Incomplete 2.94

**Finding:** Incomplete landscaping

The landscaping in all external areas of the property remains incomplete, impacting the overall aesthetic and functionality of the space. Several areas lack the necessary turf, and there is an absence of designated garden beds, which were originally outlined in the project's landscaping plan. Additionally, the irrigation system installation is unfinished, leaving certain sections prone to inadequate watering and potential plant stress. Addressing these issues promptly is essential to ensure the landscape environment matures as intended and enhances the property's curb appeal.

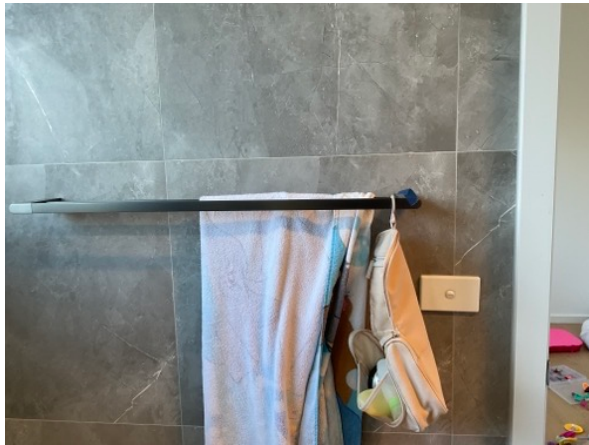
## For Your Information 3.18

**Finding:** Towel rail is loose  
Towel rail will need to be secured

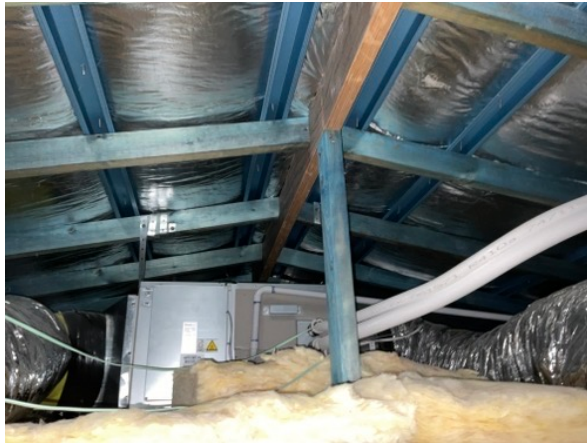
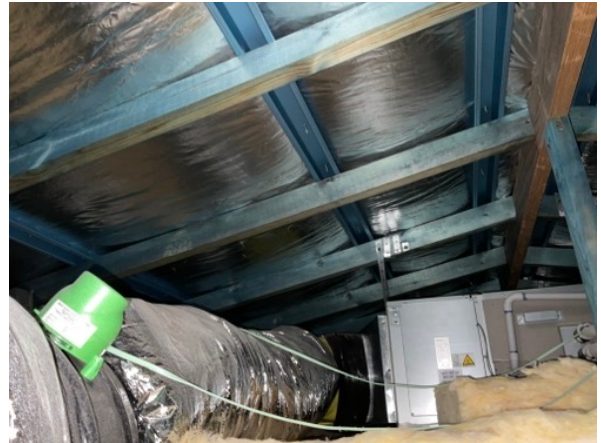
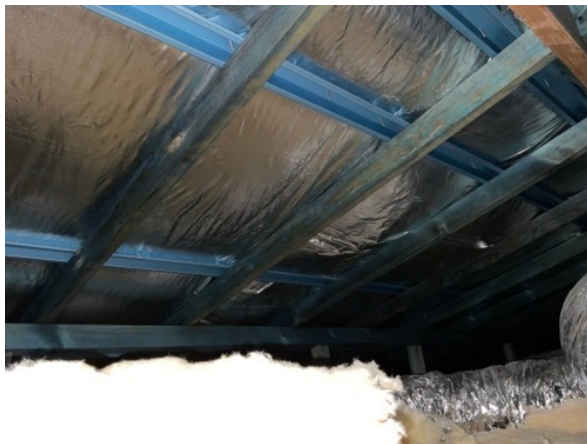
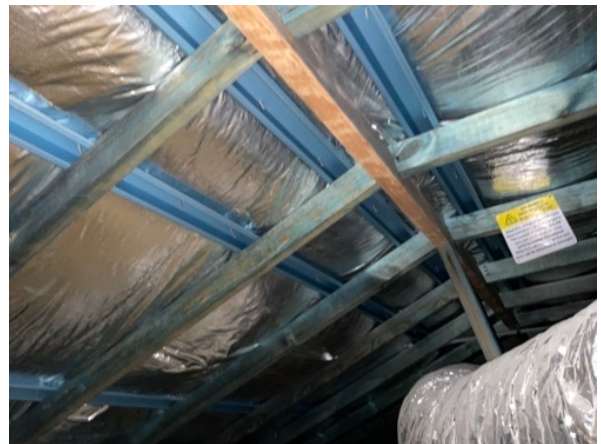
**Location:** Roofspace

## For Your Information 3.24
